FEDERAL EMERGENCY MANAGEMENT AGENCY

Above the Flood: **ELEVATING YOUR FLOODPRONE HOUSE**

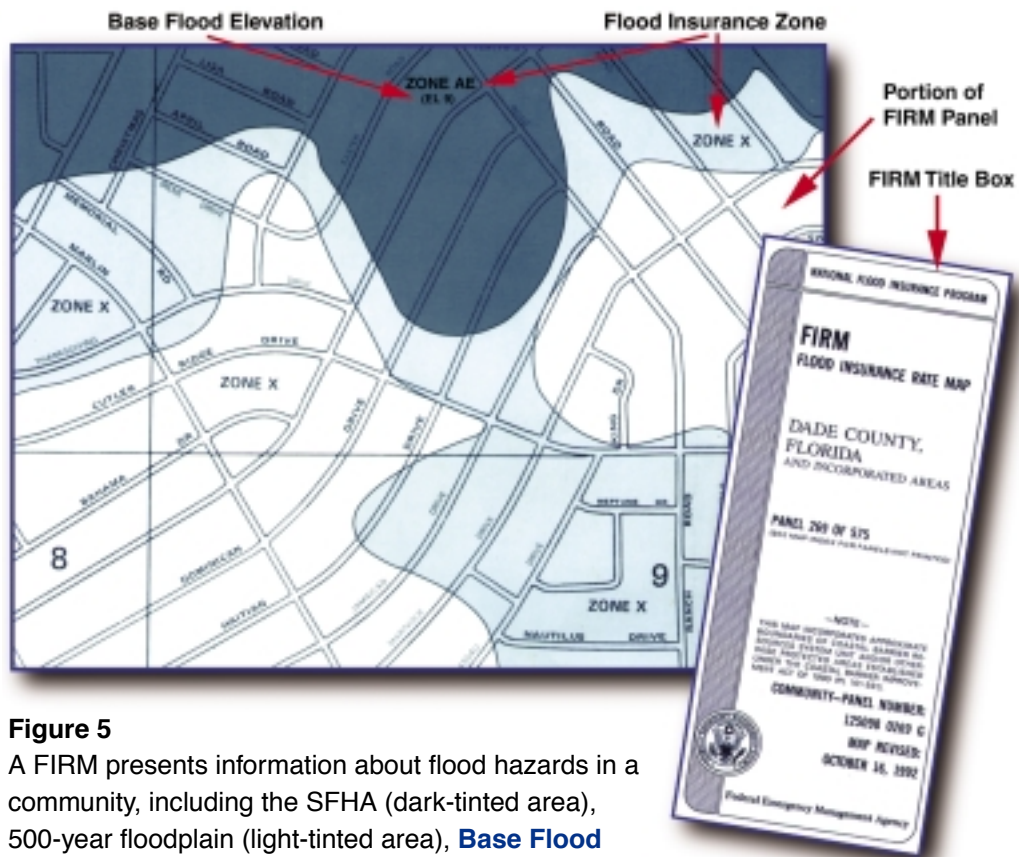
Figure 5
A FIRM presents information about flood hazards in a community, including the SFHA (dark-tinted area), 500-year floodplain (light-tinted area), **Base Flood Elevations**, (BFEs) (number in parentheses), and flood insurance zones (AE and X in this example).

Note that the SFHA in the example in Figure 5 is designated Zone AE. This zone is only one of several applied to SFHAs under the NFIP, including V, VE, VI-V30, A, AE, A1-A30, AO, and AH. These zones indicate differences in the types and severity of flood hazards in SFHAs. For the purposes of this publication, it is sufficient to focus on the basic differences between the two main types of SFHA zones—V zones and A zones. The distinction is important because regulatory requirements associated with V zones and A zones differ significantly. As explained later in this chapter, these requirements affect the types of building elevation techniques that may be used under the NFIP.

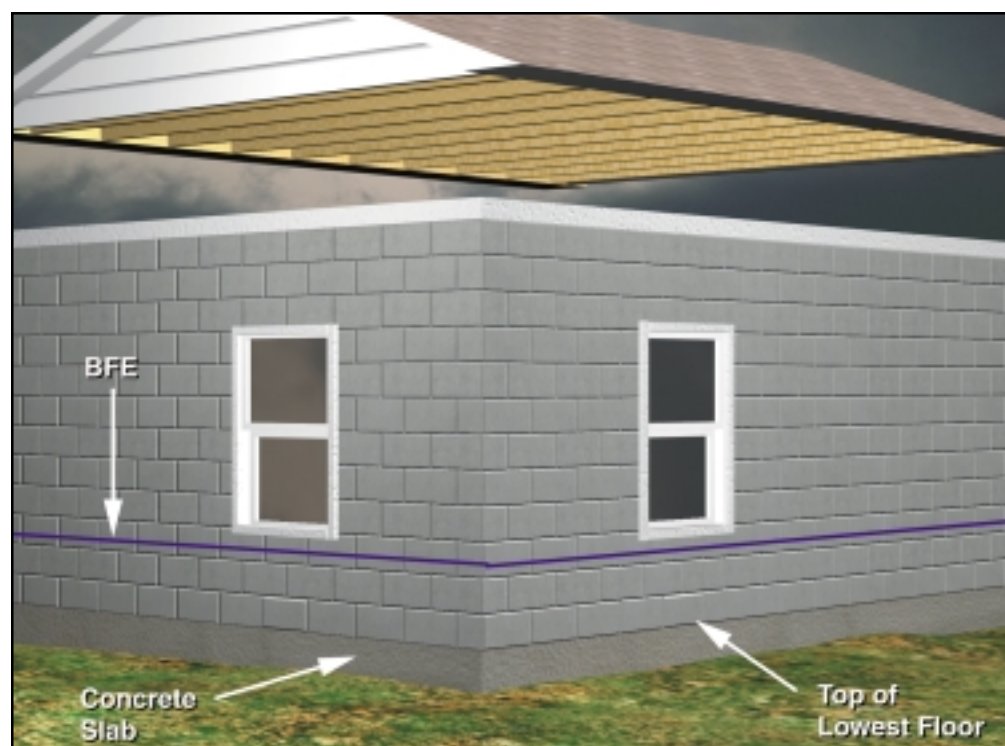
Figure 10
The first step in Technique 1 is removing the roof.

Technique 1 is appropriate for houses with concrete or masonry walls, but not for houses with other types of walls, such as those framed with wood studs, which would be more vulnerable to flood damage. This technique is usually appropriate when the depth of the base flood at the house is no more than 4 or 5 feet above grade. The elevation process begins with the temporary removal of the roof and roof framing, in a single piece if possible (Figure 10). This is commonly done with a crane. The roof is then stored on site so that it can be reinstalled later. The next step is to remove the windows and doors.

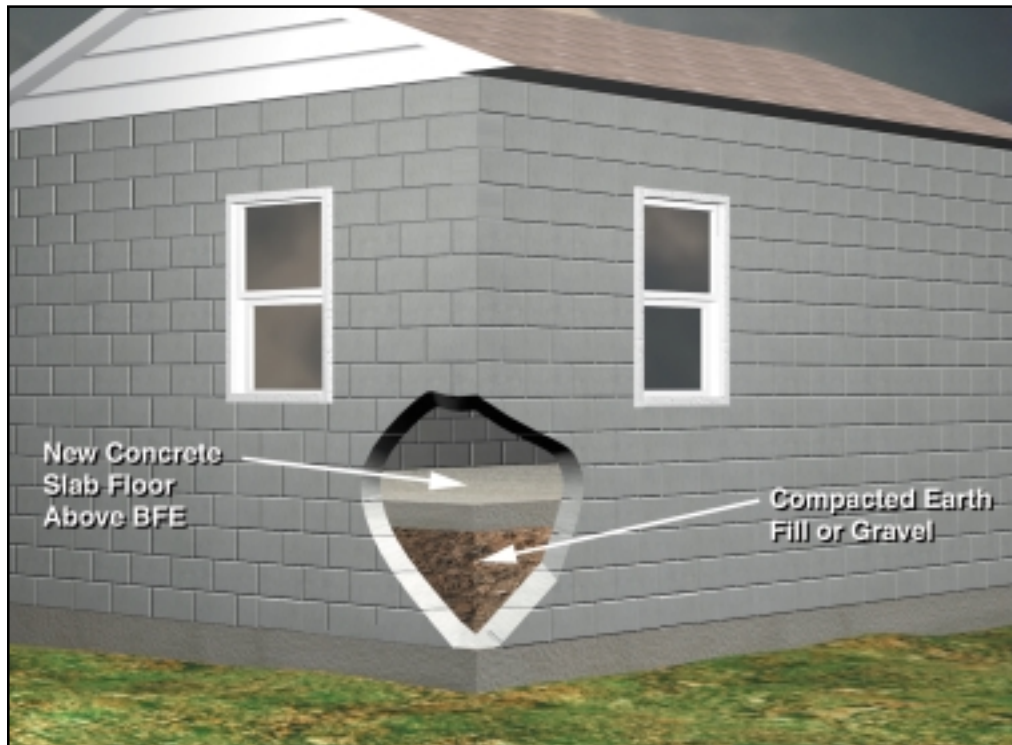
Figure 14
An alternative to building an elevated wood-frame floor is installing a new, elevated concrete slab floor on fill placed over the old slab.

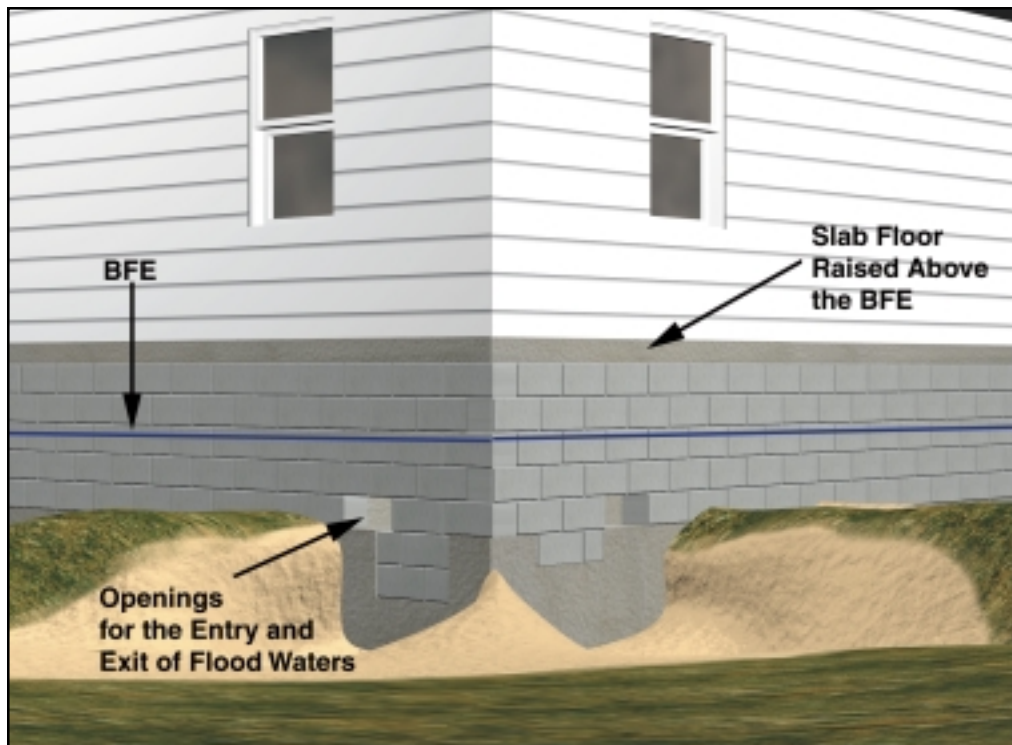
Figure 21
Elevated house and slab on new, extended foundation walls.

This process is repeated until the house is raised to the desired height. The foundation walls are then extended upward with additional rows of concrete block (Figure 20). As in the previous techniques, openings are made in the walls within 1 foot of the ground so that flood waters will be able to flow into and out of the area below the elevated floor. The jacks and beams are removed, and the openings left around the beams are filled with blocks (Figure 21).

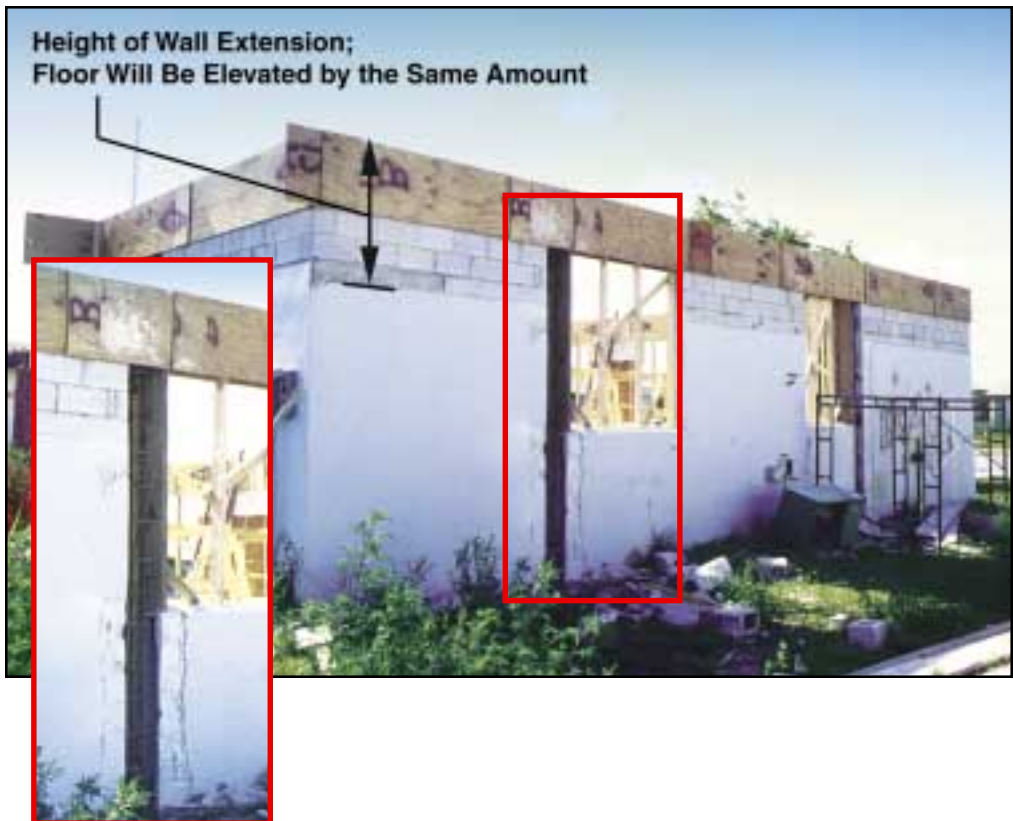
Another view of the extended walls. The vertical cuts in the walls next to the windows are for concrete tiedown columns that will be cast in place to further strengthen the extended walls against wind loads. The owner of this house was able to meet the elevation requirement by raising the floor only a few feet, as indicated by the amount that the walls have been extended.

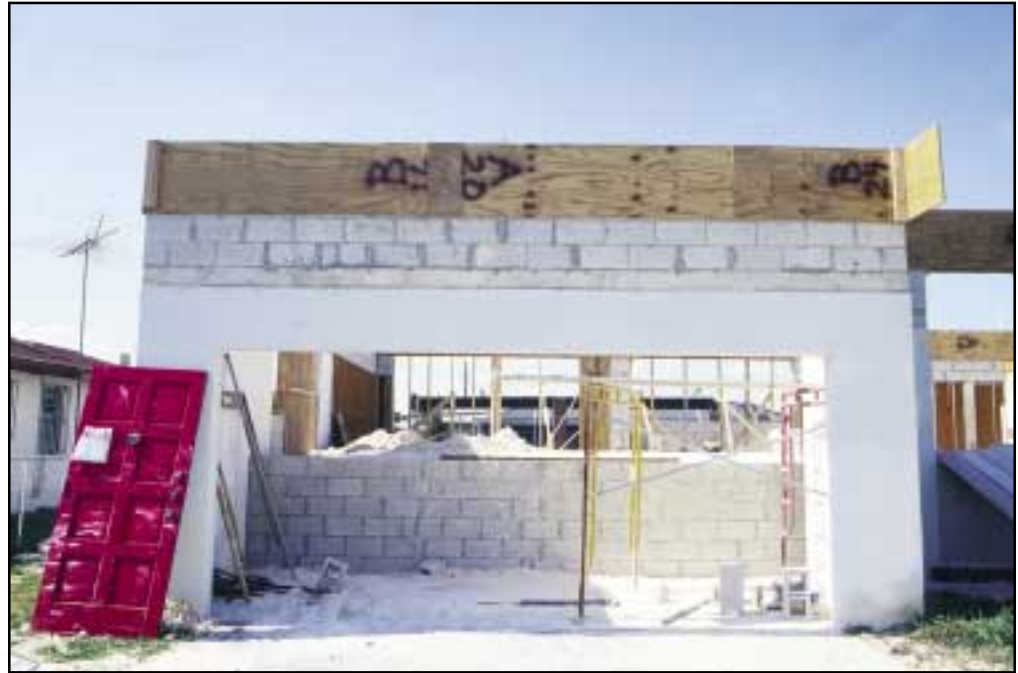
Figure 25

This view through the garage door reveals the different levels of the elevated slab floor, in the background, and the unelevated garage floor.

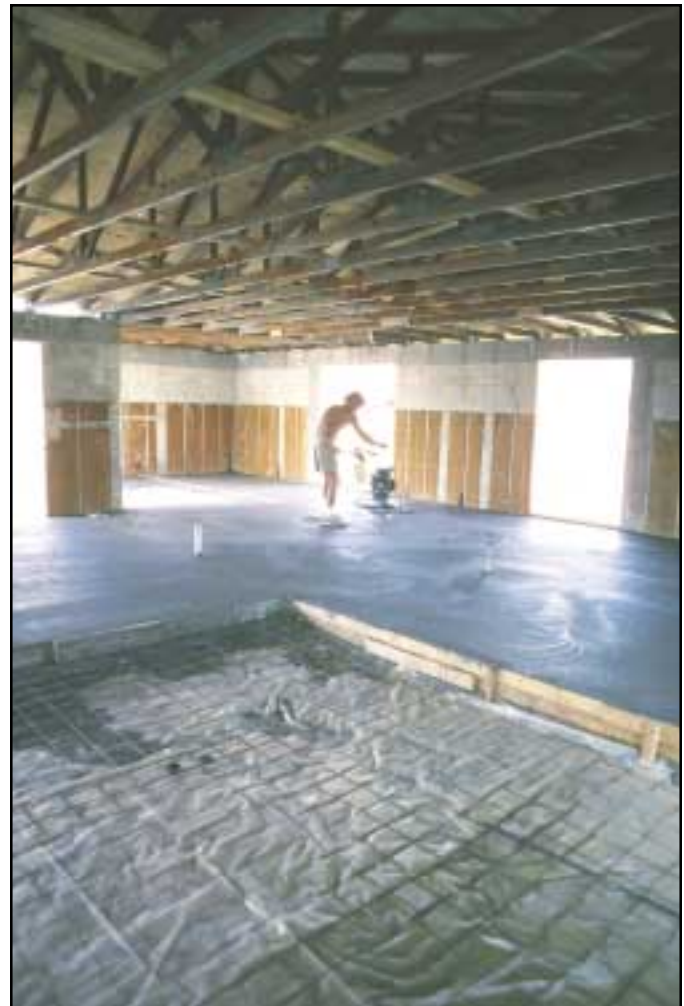
**Figure 26**

The roof has been rebuilt with the salvaged trusses, and most of the new concrete slab has been poured on top of the sand fill. The open area in the foreground, where plastic sheeting and wire reinforcement can be seen on top of the sand fill, is where the remaining part of the slab will be poured.

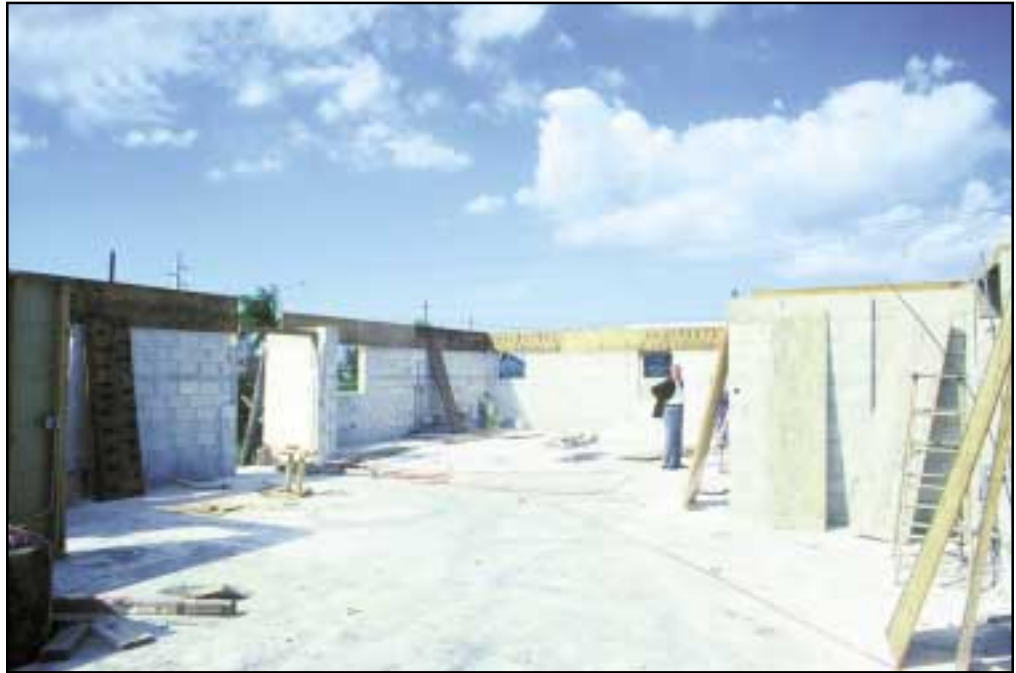
Figure 40

After the roof was removed and the storm-damaged interior gutted, the walls of the house were extended upward and a new bond beam added at the top.

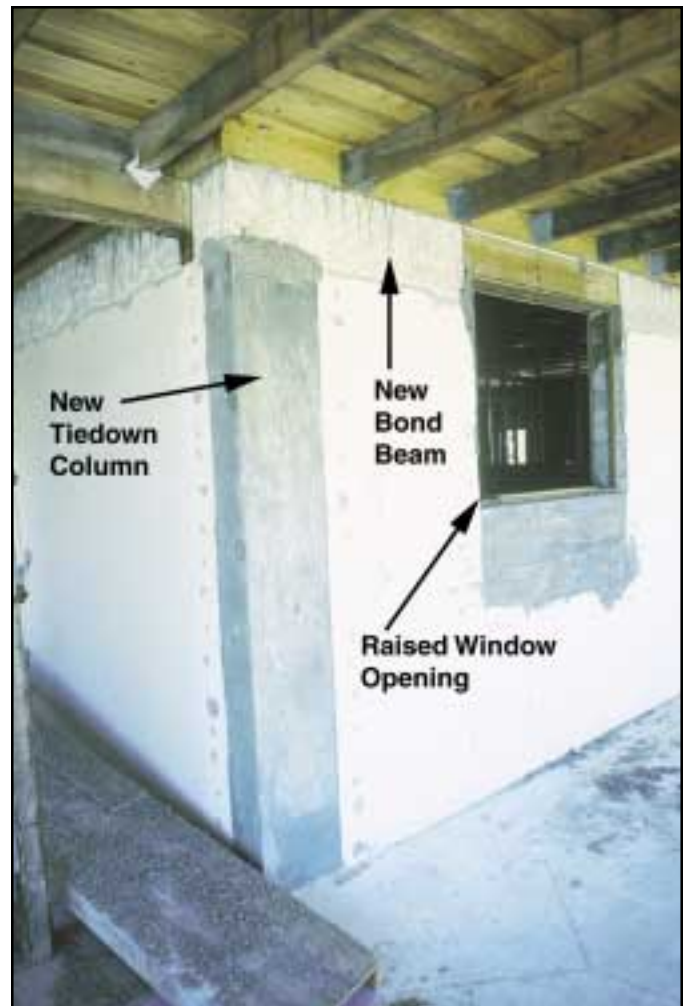
**Figure 41**

Note the new bond beam at the top of the extended wall, the new concrete tiedown column at the corner, and the raised window opening.

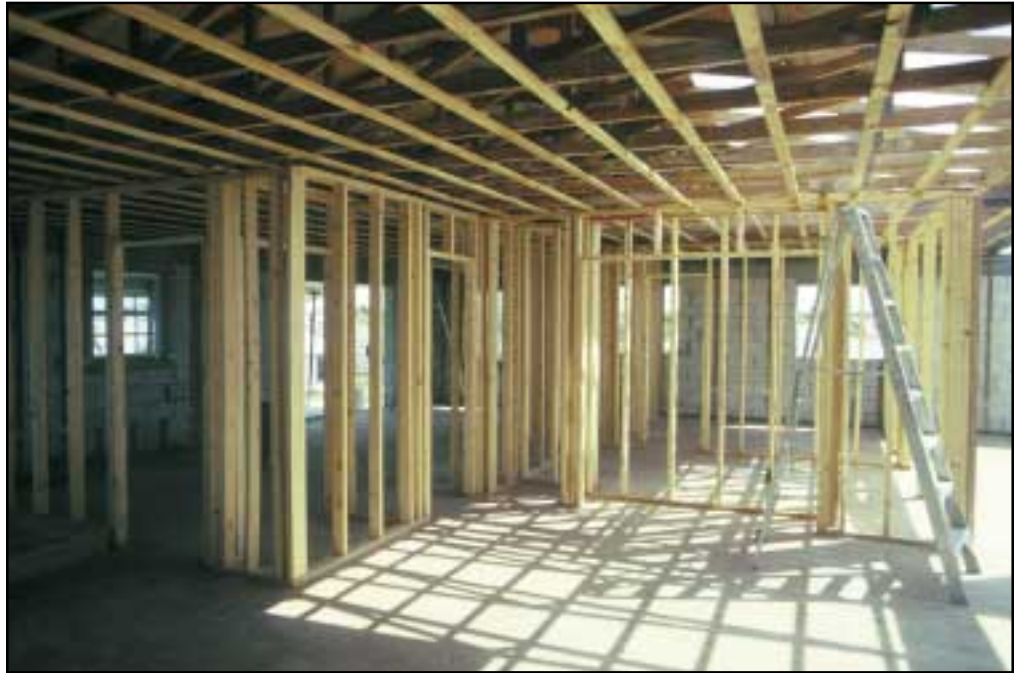
Figure 48
Wood 2 by 4 studs were used to frame the interior walls of the second story.

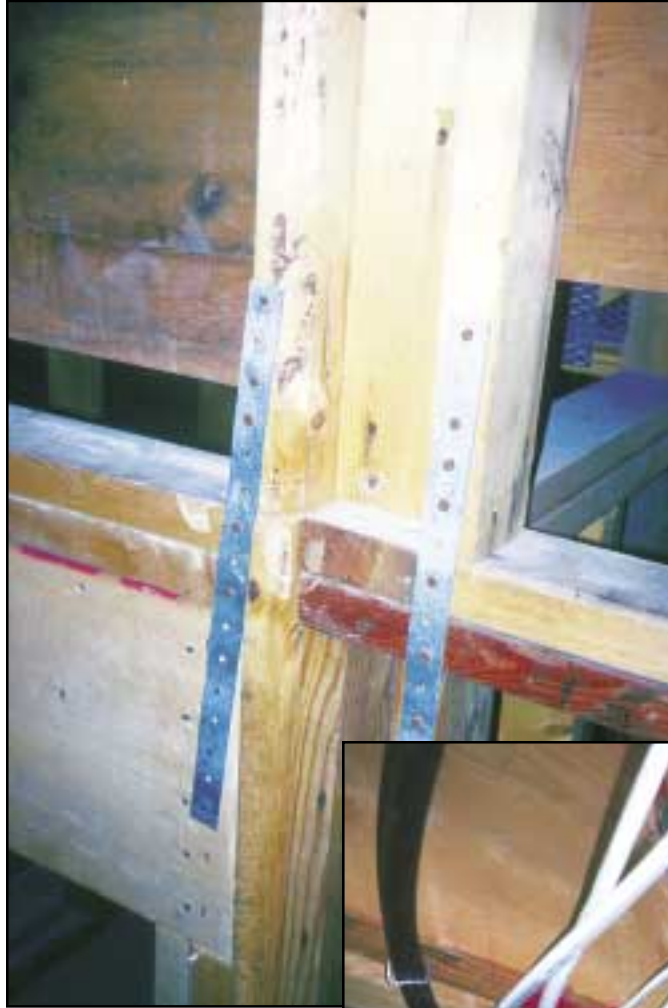
Figure 70

Metal hurricane straps are used to tie the structural members together and create a continuous load path from the roof to the foundation.

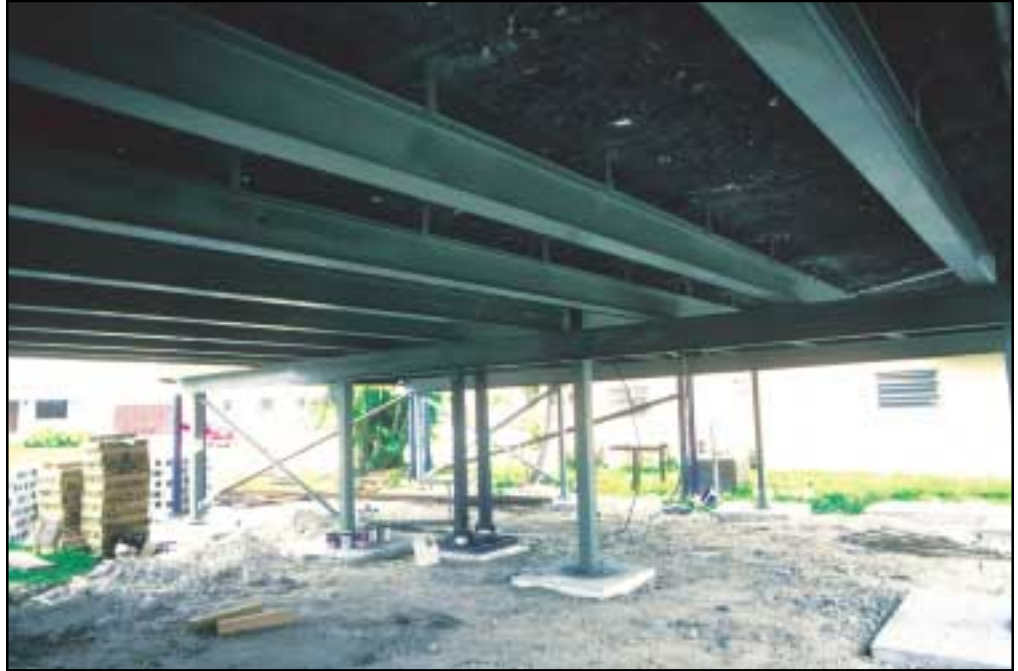
Figure 82

While the jacks and beams supported the house, new steel foundation members were installed below.
