# URBAN LEVEE DESIGN CRITERIA EVALUATION

MOSSDALE TRACT  
RECLAMATION DISTRICT NO. 17  
SAN JOAQUIN COUNTY, CALIFORNIA

Subject: Mossdale Tract  
Reclamation District No. 17  
San Joaquin County, California

## URBAN LEVEE DESIGN CRITERIA EVALUATION

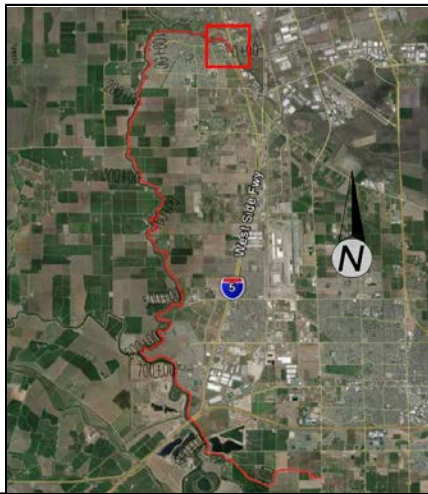
<b>Reach Description</b>				<b>Reach Overview</b>																																																			
Station Limits: 0+00 to 15+00 Feature(s) at Upstream Station Limit: South Manthey Road/dry land levee Feature(s) at Downstream Station Limit: Downing Ave Approx. Crown Elevation Range (feet, NAVD88): 19.5 to 22 Approx. Levee Height Range (feet): 8 to 10.5 Approx. Crown Width Range (feet): 17 to 47 Approx. Landside Slope (H:V) Range: 2:1 to 4.5:1 Approx. Waterside Slope (H:V) Range: 1.7:1 to 3:1 Waterside Constraint(s): Waterside bench between STA 0+00 and 8+00, overhead power lines Landside Constraint(s): STA 0+00 to 3+00 - agricultural land, STA 3+00 to 15+00 - commercial development Landside repairs associated with PL84-99: Levee raised in 1989 along French Camp Slough Improvements associated with LSRP P1: None Improvements associated with LSRP P2: None Proposed Improvements associated with LSRP P3: None

<b>Generalized Subsurface Conditions</b> Levee Prism Soils: SILT and Silty SAND Landside Surface Layer: Silty SAND, approx. 8 feet thick at levee toe Soils below surface layer: Approx. 10 to 15 feet of Silty SAND over Lean CLAY																																																							
<b>Historic Performance</b> No recorded events in ULE's 2014 SGDR Addendum																																																							
<b>Liquefiable Soils</b> Based on our liquefaction assessment, we are not considering liquefiable soils in our slope stability analyses.																																																							
<b>Seepage Analysis Results</b> <table border="1" style="width: 100%; border-collapse: collapse;"> <thead> <tr> <th rowspan="2">Station</th> <th rowspan="2">Water Surface</th> <th rowspan="2">Figure</th> <th colspan="3">Exit Gradient</th> <th rowspan="2">Through Seepage</th> <th rowspan="2">Breakout Height (ft)*</th> </tr> <tr> <th>Levee Toe</th> <th>Toe of Berm</th> <th>Field</th> </tr> </thead> <tbody> <tr> <td rowspan="2" style="text-align: center;"><b>7+56</b></td> <td>200-Year</td> <td>E-2-B</td> <td>0.02</td> <td>---</td> <td>---</td> <td>Yes**</td> <td>0.2</td> </tr> <tr> <td>HTOL</td> <td>E-2-C</td> <td>0.03</td> <td>---</td> <td>---</td> <td>n/a</td> <td>n/a</td> </tr> </tbody> </table> <p>*Vertical distance from the toe of the levee (ground surface) to where the phreatic surface is calculated to daylight on the levee slope. Through seepage under HTOL conditions are not part of this evaluation.                      **Exits onto slope flatter than 5:1 (H:V), therefore we report "meets criteria" for through seepage.</p>								Station	Water Surface	Figure	Exit Gradient			Through Seepage	Breakout Height (ft)*	Levee Toe	Toe of Berm	Field	<b>7+56</b>	200-Year	E-2-B	0.02	---	---	Yes**	0.2	HTOL	E-2-C	0.03	---	---	n/a	n/a

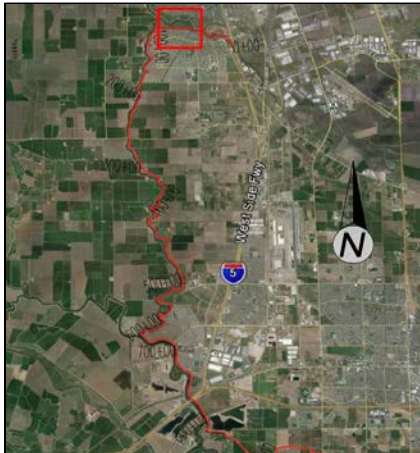
<b>Generalized Subsurface Conditions</b>							
Levee Prism Soils: Lean CLAY Landside Surface Layer: Lean Clay, approx. 10 feet thick at levee toe Soils below surface layer: Interbedded layers of SAND, Silty SAND and Lean CLAY							
<b>Historic Performance</b>							
Seepage and erosion during the 1997 flood event were reported in ULE's 2014 SGDR Addendum							
<b>Liquefiable Soils</b>							
Based on our liquefaction assessment, we identified potentially liquefiable soils within this Reach (Refer to Appendix E and Appendix F)							
<b>Seepage Analysis Results</b>							
Station	Water Surface	Figure	Exit Gradient			Through Seepage	Breakout Height (ft)*
			Levee Toe	Toe of Berm	Field		
<b>28+05</b>	200-Year	E-2-B	0.21	---	---	Yes**	2
	HTOL	E-2-C	0.30	---	---	n/a	n/a
*Vertical distance from the toe of the levee (ground surface) to where the phreatic surface is calculated to daylight on the levee slope. Through seepage under HTOL conditions are not part of this evaluation. **Exits onto fine grained slope flatter than 5:1 (H:V), therefore we report "meets criteria" for through seepage.

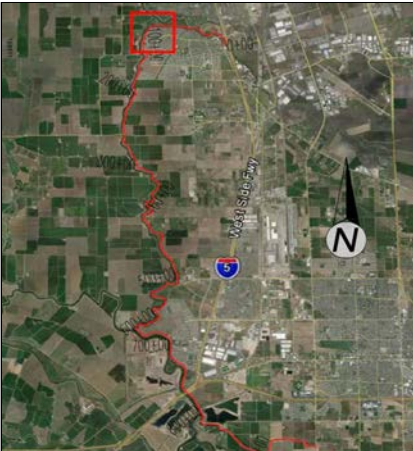
Feature(s) at Upstream Station Limit: None						
	Feature(s) at Downstream Station Limit: Levee access ramp/overhead high tension lines						
	Approx. Crown Elevation Range (feet, NAVD88):	20.5	to	23

Approx. Levee Height Range (feet):	10.5	to	13			
	Approx. Crown Width Range (feet):	10	to	27			
	Approx. Landside Slope (H:V) Range:	2.2:1	to	6:1			
	Approx. Waterside Slope (H:V) Range:	1.5:1	to	4.1:1			
	Waterside Constraint(s): None						
	Landside Constraint(s): Residential development						
	Landside repairs associated with PL84-99: None						
	Improvements associated with LSRP P1: None						
	Improvements associated with LSRP P2: None						
	Proposed Improvements associated with LSRP P3: None						
<b>Generalized Subsurface Conditions</b>							
Levee Prism Soils: Lean CLAY and Silty SAND							
Landside Surface Layer: Silty SAND at toe STA 79+72, Lean CLAY throughout other areas of the Reach and Lean CLAY in the field							
Soils below surface layer: Lean CLAY with Silty SAND lenses, approx. 5 feet thick at a depth of approx. 25 feet.							
<b>Historic Performance</b>							
None noted							
<b>Liquefiable Soils</b>

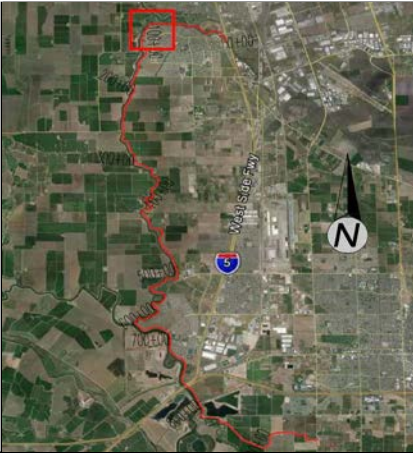
<b>Generalized Subsurface Conditions</b>							
Levee Prism Soils: Silty SAND to Lean Clay Landside Surface Layer: Lean CLAY, approx. 15 feet thick at toe of levee Soils below surface layer: Approx. 12 feet of Lean CLAY, over 4 feet of Silty SAND, over 50 feet of Lean CLAY							
<b>Historic Performance</b>							
No recorded events in ULE's 2014 SGDR Addendum							
<b>Liquefiable Soils</b>							
Based on our liquefaction assessment, we identified potentially liquefiable soils within this Reach (Refer to Appendix E and Appendix F)							
<b>Seepage Analysis Results</b>							
Station	Water Surface	Figure	Exit Gradient			Through Seepage	Breakout Height (ft)*
			Levee Toe	Toe of Berm	Field		
<b>100+10</b>	200-Year	E-5-B	0.03	---	0.02	Yes**	0.6
	HTOL	E-5-C	0.05	---	0.02	n/a	n/a
*Vertical distance from the toe of the levee (ground surface) to where the phreatic surface is calculated to daylight on the levee slope. Through seepage under HTOL conditions are not part of this evaluation. **Exits onto slope flatter than 5:1 (H:V), therefore we report "meets criteria" for through seepage.

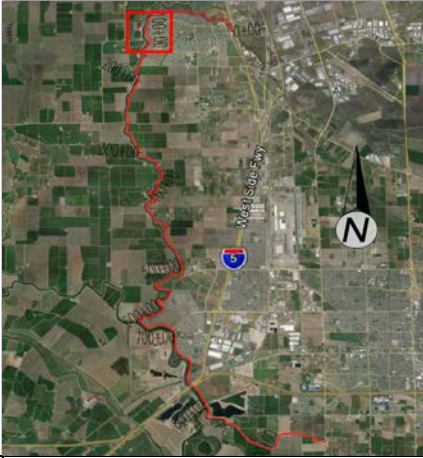
Feature(s) at Upstream Station Limit: Pump Station levee penetrations							
Feature(s) at Downstream Station Limit: William Moss Boulevard							
Approx. Crown Elevation Range (feet, NAVD88):		23.3 to 25

Approx. Levee Height Range (feet):		12 to 20					
Approx. Crown Width Range (feet):		11 to 46					
Approx. Landside Slope (H:V) Range:		1.5:1 to 3:1					
Approx. Waterside Slope (H:V) Range:		1.5:1 to 2.8:1					
Waterside Constraint(s): Waterside toe of slope at the waterway - no waterside bench.							
Landside Constraint(s): Residential improvements, gravel trench drain							
Landside Repairs associated with PL84-99: Partial LS subdrain, 3 LS Berns							
Improvements associated with LSRP P1: None							
Improvements associated with LSRP P2: None							
Proposed Improvements associated with LSRP P3: None							
<b>Generalized Subsurface Conditions</b>							
Levee Prism Soils: Poorly Graded SAND, SILT & Silty SAND transitioning to Lean Clay towards south							
Landside Surface Layer: Lean CLAY, approx. 10 to 40 feet thick at toe of levee							
Soils below surface layer: Interlayered Silty SAND and Lean CLAY

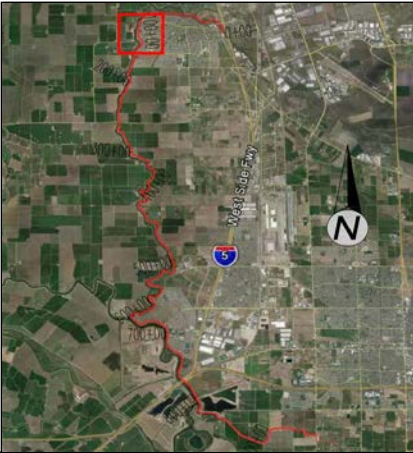
Generalized Subsurface Conditions Levee Prism Soils: Poorly Graded SAND, SILT & Silty SAND in north to Lean Clay towards south Landside Surface Layer: Lean CLAY, approx. 10 to 40 feet thick at toe of levee Soils below surface layer: Interlayered Silty SAND and Lean CLAY							
<b>Historic Performance</b>							
Seepage, landside boils and waterside erosion during 1997 flood event were reported in ULE's 2014 SGDR Addendum.							
<b>Liquefiable Soils</b>							
Based on our liquefaction assessment, we identified potentially liquefiable soils within this Reach (Refer to Appendix E and Appendix F)							
<b>Seepage Analysis Results</b>							
Station	Water Surface	Figure	Exit Gradient			Through Seepage	Breakout Height (ft)*
			Levee Toe	Toe of Berm	Field		
<b>138+25</b>	200-Year	E-7-B	0.38	---	0.35	Yes**	2.5
	HTOL	E-7-C	0.44	---	0.40	n/a	n/a
*Vertical distance from the toe of the levee (ground surface) to where the phreatic surface is calculated to daylight on the levee slope. Through seepage under HTOL conditions are not part of this evaluation. **Exits onto a fine grained slope, therefore we report "meets criteria" for through seepage.

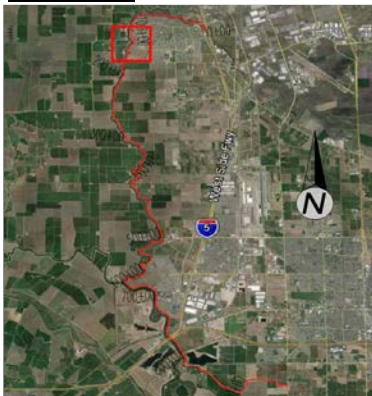
Generalized Subsurface Conditions Levee Prism Soils: Silty SAND and Lean CLAY Landside Surface Layer: Lean CLAY, approx. 3 to 16 feet thick at toe of levee Soils below surface layer: Interlayered Silty SAND and Lean CLAY							
<b>Historic Performance</b> Landside seepage and ponded water during 1997 flood event in addition to three areas of waterside erosion from the 2006 event were reported in ULE's 2014 SGDR Addendum.							
<b>Liquefiable Soils</b> Based on our liquefaction assessment, we identified potentially liquefiable soils within this Reach (Refer to Appendix E and Appendix F)							
<b>Seepage Analysis Results</b>							
Station	Water Surface	Figure	Exit Gradient			Through Seepage	Breakout Height (ft)*
			Levee Toe	Toe of Berm	Field		
150+99	200-Year	E-8-B	0.60	---	0.76	Yes**	2.2
	HTOL	E-8-C	0.77	---	0.86	n/a	n/a
*Vertical distance from the toe of the levee (ground surface) to where the phreatic surface is calculated to day light on the levee slope. Through seepage under HTOL conditions are not part of this evaluation. **Exits onto a fine grained slope, therefore we report "meets criteria" for through seepage.

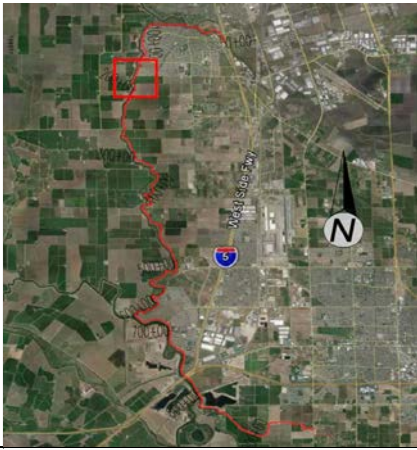
<b>Generalized Subsurface Conditions</b>							
Levee Prism Soils: Lean CLAY with some Silty SAND Landside Surface Layer: Silty SAND and Lean CLAY (approx. 12 to 14 feet thick) Soils below surface layer: Lean CLAY with interlayered Poorly Graded SAND with SILT							
<b>Historic Performance</b>							
Waterside erosion, low to medium seepage and pin boils, and longitudinal cracking on waterside crown reported in ULE's 2014 SGDR Addendum.							
<b>Liquefiable Soils</b>							
Based on our liquefaction assessment, we are not considering liquefiable soils in our slope stability analyses.							
<b>Seepage Analysis Results</b>							
Station	Water Surface	Figure	Exit Gradient			Through Seepage	Breakout Height (ft)*
			Levee Toe	Toe of Berm	Field		
181+00	200-Year	E-11-B	0.27	---	0.55	No	n/a
	HTOL	E-11-C	0.32	---	0.60	n/a	n/a
*Vertical distance from the toe of the levee (ground surface) to where the phreatic surface is calculated to daylight on the levee slope. Through seepage under HTOL conditions are not part of this evaluation.

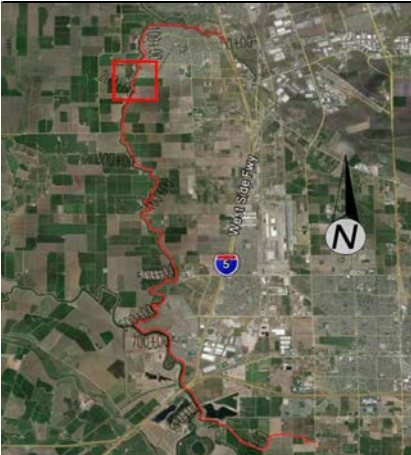
<b>Generalized Subsurface Conditions</b>							
Levee Prism Soils: Lean CLAY with some Silty SAND Landside Surface Layer: Silty SAND and Lean CLAY (approx. 12 to 14 feet thick) Soils below surface layer: Lean CLAY with interlayered Poorly Graded SAND with SILT							
<b>Historic Performance</b>							
Waterside erosion, low to medium seepage and pin boils, and longitudinal cracking on waterside crown reported in ULE's 2014 SGDR Addendum.							
<b>Liquefiable Soils</b>							
Based on our liquefaction assessment, we identified potentially liquefiable soils within this Reach (Refer to Appendix E and Appendix F)							
<b>Seepage Analysis Results</b>							
Station	Water Surface	Figure	Exit Gradient			Through Seepage	Breakout Height (ft)*
			Levee Toe	Toe of Berm	Field		
<b>191+45</b>	200-Year	E-12-B	0.16	---	---	Yes	3
	HTOL	E-12-C	0.18	---	---	n/a	n/a
*Vertical distance from the toe of the levee (ground surface) to where the phreatic surface is calculated to daylight on the levee slope. Through seepage under HTOL conditions are not part of this evaluation.

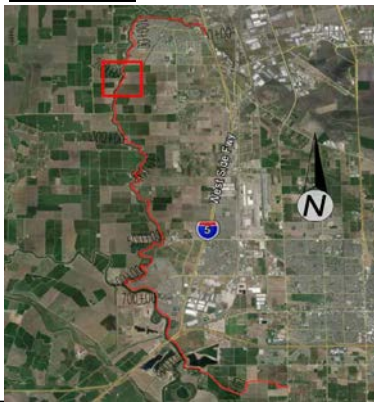
<b>Generalized Subsurface Conditions</b> Levee Prism Soils: Lean CLAY to SILT Landside Surface Layer: Lean CLAY, approx. 7 feet thick at toe of levee Soils below surface layer: Interbedded layers of silty SAND and poorly-graded SAND and CLAY							
<b>Historic Performance</b>							
Seepage and pin boils reported in ULE's 2014 SGDR Addendum.							
<b>Liquefiable Soils</b>							
Based on our liquefaction assessment, we identified potentially liquefiable soils within this Reach (Refer to Appendix E and Appendix F)							
<b>Seepage Analysis Results</b>							
Station	Water Surface	Figure	Exit Gradient			Through Seepage	Breakout Height (ft)*
			Levee Toe	Toe of Berm	Field		
201+57	200-Year	E-13-B	1.11	---	1.86	Yes**	4.5
	HTOL	E-13-C	1.24	---	2.03	n/a	n/a
*Vertical distance from the toe of the levee (ground surface) to where the phreatic surface is calculated to day light on the levee slope. Through seepage under HTOL conditions are not part of this evaluation.

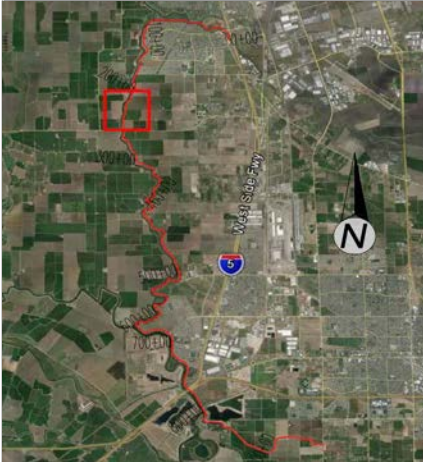
<b>Generalized Subsurface Conditions</b>							
Levee Prism Soils: Silty to Clayey SAND							
Landside Surface Layer: Lean CLAY, approx. 5 feet thick at toe of levee							
Soils below surface layer: Approx. 5 feet of Silty SAND underlain by interbedded layers of Lean CLAY and Poorly-graded SAND							
<b>Historic Performance</b>							
Landside seepage and pin boils reported in ULE's 2014 SGDR Addendum.							
<b>Liquefiable Soils</b>							
Based on our liquefaction assessment, we identified potentially liquefiable soils within this Reach (Refer to Appendix E and Appendix F)							
<b>Seepage Analysis Results</b>							
Station	Water Surface	Figure	Exit Gradient			Through Seepage	Breakout Height (ft)*
			Levee Toe	Toe of Berm	Field		
<b>231+75</b>	200-Year	E-14-B	0.54	---	0.83	Yes	3.5
	HTOL	E-14-C	0.62	---	0.86	n/a	n/a
*Vertical distance from the toe of the levee (ground surface) to where the phreatic surface is calculated to daylight on the levee slope. Through seepage under HTOL conditions are not part of this evaluation.

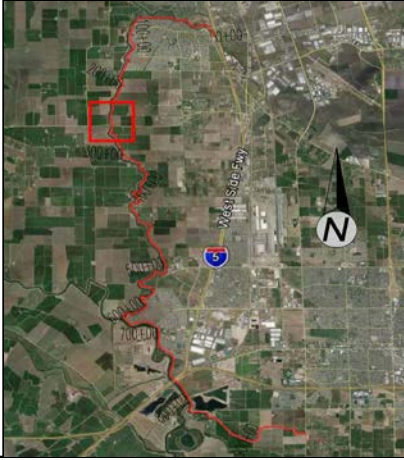
### 10.14 PROJECT REACH D2B, STATION 251+50

<b>REACH D2B - STA 251+50</b>							
<b>Based on our evaluation, this reach meets the ULDC Criteria.</b>							
<b>Seepage Evaluation Summary</b>				<b>Slope Stability Evaluation Summary</b>			
200-Year DWSEL, Under Seepage:		<b>Meets Criteria</b>		Steady State Seepage 200-Year DWSEL, LS:		<b>Meets Criteria</b>	
200-Year DWSEL, Through Seepage:		<b>Meets Criteria</b>		Steady State Seepage HTOL, LS:		<b>Meets Criteria</b>	
HTOL, Under Seepage:		<b>Meets Criteria</b>		Rapid Drawdown, WS:		<b>Meets Criteria</b>	
				Seismic Slope Stability, WS:		<b>Meets Criteria</b>	
				Seismic Slope Stability, LS:		<b>Meets Criteria</b>	
<b>Reach Description</b>				<b>Reach Overview</b>			
Station Limits: 247+00 to 255+50 Feature(s) at Upstream Station Limit: Levee access ramp from farm road Feature(s) at Downstream Station Limit: Just south of levee pipe penetration Approx. Crown Elevation Range (feet, NAVD88): 24 to 25 Approx. Levee Height Range (feet): 14 to 18.5 Approx. Crown Width Range (feet): 17 to 48 Approx. Landside Slope (H:V) Range: 1.4:1 to 2.5:1 Approx. Waterside Slope (H:V) Range: 1.5:1 to 2.9:1 Waterside Constraint(s): None Landside Constraint(s): High voltage towers STA 248+00 to 250+00 and Howard Road STA 253+00 Landside repairs associated with PL84-99: Yes, berms between STA 248+00 and 252+00 Improvements associated with LSRP P1: None Improvements associated with LSRP P2: None Proposed Improvements associated with LSRP P3: Drained seepage berm and chimney drain, fill low area south of Howard Rd

<b>Generalized Subsurface Conditions</b>							
Levee Prism Soils: Silty SAND to Clayey SAND Landside Surface Layer: Silty to Clayey SAND near levee toe, approx. 12 feet of CLAY near berm toe Soils below surface layer: Approx. 5 feet of Silty SAND underlain by interbedded layers of CLAY and Poorly-graded SAND							
<b>Historic Performance</b>							
Seepage and six to eight pin boils reported in ULE's 2014 SGDR Addendum.							
<b>Liquefiable Soils</b>							
Based on our liquefaction assessment, we are not considering liquefiable soils in our slope stability analyses.							
<b>Seepage Analysis Results</b>							
Station	Water Surface	Figure	Exit Gradient			Through Seepage	Breakout Height (ft)*
			Levee Toe	Toe of Berm	Field		
<b>251+50</b>	200-Year	E-15-B	No Positive Gradient	0.18	---	No	n/a
	HTOL	E-15-C	No Positive Gradient	0.20	---	n/a	n/a
*Vertical distance from the toe of the levee (ground surface) to where the phreatic surface is calculated to daylight on the levee slope. Through seepage under HTOL conditions are not part of this evaluation.

<b>Slope Stability Analysis Results</b>							
Station	Case Analyzed	Water Surface	Figure	Factor of Safety (Circular)		Factor of Safety (Non-Circular)	
				Waterside	Landside	Waterside	Landside
<b>251+50</b>	SS - 200yr	19.2	E-15-D	---	2.2	n/a	n/a
	SS - HTOL	20.3	E-15-E	---	2.2	n/a	n/a
	RDD	13.6	E-15-D	1.3	---	n/a	n/a
	PS	4.8	E-15-F	1.0	1.6	n/a	n/a
	Post-EQ	n/a	n/a	n/a	n/a	n/a	n/a

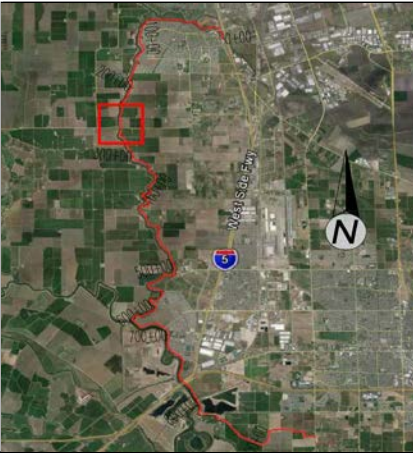
### 10.15 PROJECT REACH D2B, STATION 254+50

<b>REACH D2B - STA 254+50</b>							
<b>Based on our evaluation, this reach meets the ULDC Criteria.</b>							
Seepage Evaluation Summary				Slope Stability Evaluation Summary			
200-Year DWSEL, Under Seepage:		<b>Meets Criteria</b>		Steady State Seepage 200-Year DWSEL, LS:		<b>Meets Criteria</b>	
200-Year DWSEL, Through Seepage:		<b>Meets Criteria</b>		Steady State Seepage HTOL, LS:		<b>Meets Criteria</b>	
HTOL, Under Seepage:		<b>Meets Criteria</b>		Rapid Drawdown, WS:		<b>Meets Criteria</b>	
				Seismic Slope Stability, WS:		<b>Meets Criteria</b>	
				Seismic Slope Stability, LS:		<b>Meets Criteria</b>	
Reach Description				Reach Overview			
Station Limits: 247+00 to 255+50 Feature(s) at Upstream Station Limit: Levee access ramp from farm road Feature(s) at Downstream Station Limit: Just south of levee pipe penetration Approx. Crown Elevation Range (feet, NAVD88): 24 to 25 Approx. Levee Height Range (feet): 14 to 18.5 Approx. Crown Width Range (feet): 17 to 48 Approx. Landside Slope (H:V) Range: 1.4:1 to 2.5:1 Approx. Waterside Slope (H:V) Range: 1.5:1 to 2.9:1 Waterside Constraint(s): None Landside Constraint(s): High voltage towers (STA 248+00 to 250+00) and Howard Road (STA 253+00) Landside repairs associated with PL84-99: Yes, berms between STA 248+00 and 252+00 Improvements associated with LSRP P1: None Improvements associated with LSRP P2: None Proposed Improvements associated with LSRP P3: Drained seepage berm and chimney

Generalized Subsurface Conditions							
Levee Prism Soils: Silty to Clayey SAND Landside Surface Layer: Silty to Clayey SAND near levee toe, approx. 12 feet of CLAY near berm toe Soils below surface layer: Approx. 5 feet of Silty SAND underlain by interbedded layers of CLAY and Poorly-graded SAND							
Historic Performance							
Low to medium landside seepage and six to eight pin boils reported in ULE's 2014 SGDR Addendum.							
Liquefiable Soils							
Based on our liquefaction assessment, we are not considering liquefiable soils in our slope stability analyses.							
Seepage Analysis Results							
Station	Water Surface	Figure	Exit Gradient			Through Seepage	Breakout Height (ft)*
			Levee Toe	Toe of Berm	Field		
<b>254+50</b>	200-Year	E-16-B	0.06	0.34	---	No	n/a
	HTOL	E-16-C	0.10	0.37	---	n/a	n/a
*Vertical distance from the toe of the levee (ground surface) to where the phreatic surface is calculated to daylight on the levee slope. Through seepage under HTOL conditions are not part of this evaluation.

Slope Stability Analysis Results							
Station	Case Analyzed	Water Surface	Figure	Factor of Safety (Circular)		Factor of Safety (Non-Circular)	
				Waterside	Landside	Waterside	Landside
<b>254+50</b>	SS - 200yr	19.4	E-16-D	---	2.2	n/a	n/a
	SS - HTOL	20.5	E-16-E	---	2.1	n/a	n/a
	RDD	13.6	E-16-D	1.2	---	n/a	n/a
	PS	4.9	E-16-F	1.1	1.6	n/a	n/a
	Post-EQ	n/a	n/a	n/a	n/a	n/a	n/a

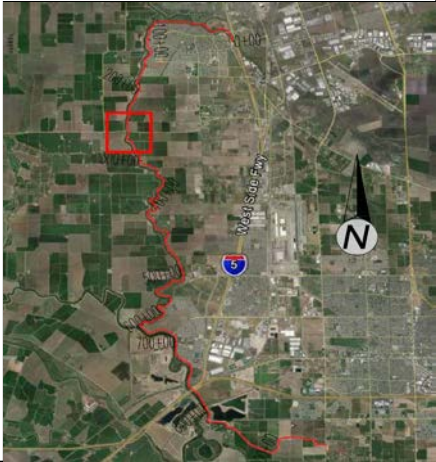
**10.16 PROJECT REACH D2C, STATION 259+00**

<b>REACH D2C - STA 259+00</b>							
<b>Based on our evaluation, this reach does not meet the ULDC Criteria.</b>							
<b>Seepage Evaluation Summary</b>				<b>Slope Stability Evaluation Summary</b>			
200-Year DWSEL, Under Seepage:		<b>Fails Criteria</b>		Steady State Seepage 200-Year DWSEL, LS:		<b>Fails Criteria</b>	
200-Year DWSEL, Through Seepage:		<b>Fails Criteria</b>		Steady State Seepage HTOL, LS:		<b>Meets Criteria</b>	
HTOL, Under Seepage:		<b>Fails Criteria</b>		Rapid Drawdown, WS:		<b>Meets Criteria</b>	
				Seismic Slope Stability, WS:		<b>Meets Criteria</b>	
				Seismic Slope Stability, LS:		<b>Meets Criteria</b>	
<b>Reach Description</b>				<b>Reach Overview</b>			
Station Limits: 255+50 to 259+50 Feature(s) at Upstream Station Limit: Transition to Phase II drained seepage berm associated with Rach EIA Feature(s) at Downstream Station Limit: Levee access ramp near Howard Road crossing Approx. Crown Elevation Range (feet, NAVD88): 23 to 25 Approx. Levee Height Range (feet): 14 to 18.5 Approx. Crown Width Range (feet): 17 to 21.5 Approx. Landside Slope (H:V) Range: 1.4:1 to 2.5:1 Approx. Waterside Slope (H:V) Range: 1.5:1 to 2.9:1 Waterside Constraint(s): Levee penetration at STA 259+00 Landside Constraint(s): Farm road/ramp at STA 255+50 Landside repairs associated with PL84-99: None Improvements associated with LSRP P1: None Improvements associated with LSRP P2: None Proposed Improvements associated with LSRP P3: None

<b>Generalized Subsurface Conditions</b>							
Levee Prism Soils: Silty to Clayey SAND Landside Surface Layer: Approx. 10 feet of CLAY near levee toe Soils below surface layer: Approx. 5 feet of Silty SAND underlain by interbedded layers of CLAY and Poorly-graded SAND							
<b>Historic Performance</b>							
No events reported in ULE's 2014 SGDR Addendum.							
<b>Liquefiable Soils</b>							
Based on our liquefaction assessment, we identified potentially liquefiable soils within this Reach (Refer to Appendix E and Appendix F)							
<b>Seepage Analysis Results</b>							
Station	Water Surface	Figure	Exit Gradient			Through Seepage	Breakout Height (ft)*
			Levee Toe	Toe of Berm	Field		
<b>259+00</b>	200-Year	E-17-B	0.54	---	---	Yes	3.7
	HTOL	E-17-C	0.61	---	---	n/a	n/a
*Vertical distance from the toe of the levee (ground surface) to where the phreatic surface is calculated to daylight on the levee slope. Through seepage under HTOL conditions are not part of this evaluation.

<b>Slope Stability Analysis Results</b>							
Station	Case Analyzed	Water Surface	Figure	Factor of Safety (Circular)		Factor of Safety (Non-Circular)	
				Waterside	Landside	Waterside	Landside
<b>259+00</b>	SS - 200yr	19.5	E-17-D	---	1.3	n/a	n/a
	SS - HTOL	20.7	E-17-E	---	1.3	n/a	n/a
	RDD	13.6	E-17-D	1.9	---	n/a	n/a
	PS	5.0	E-17-F	1.2	1.4	n/a	n/a
	Post-EQ	5.0	E-17-G/H	1.5	1.7	1.0	2.4

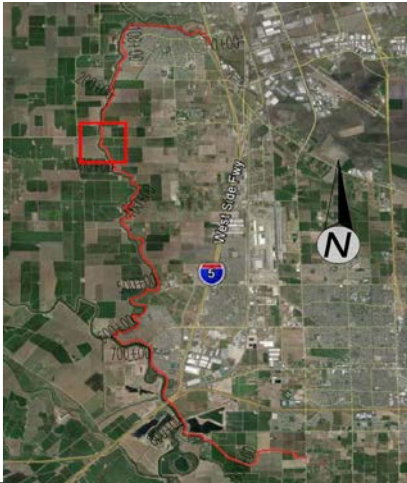
### 10.17 PROJECT REACH E1A, STATION 281+41 WITH BERM

<b>REACH E1A - STA 281+41 WITH BERM</b>							
<b>Based on our evaluation, this reach meets the ULDC criteria.</b>							
<b>Seepage Evaluation Summary</b>				<b>Slope Stability Evaluation Summary</b>			
200-Year DWSEL, Under Seepage:		<b>Meets Criteria</b>		Steady State Seepage 200-Year DWSEL, LS:		<b>Meets Criteria</b>	
200-Year DWSEL, Through Seepage:		<b>Meets Criteria</b>		Steady State Seepage HTOL, LS:		<b>Meets Criteria</b>	
HTOL, Under Seepage:		<b>Meets Criteria</b>		Rapid Drawdown, WS:		<b>Meets Criteria</b>	
				Seismic Slope Stability, WS:		<b>Meets Criteria</b>	
				Seismic Slope Stability, LS:		<b>Meets Criteria</b>	
<b>Reach Description</b>				<b>Reach Overview</b>			
Station Limits: 259+50 to 270+00 Feature(s) at Upstream Station Limit: End of Phase II drained berm for Reach E1A Feature(s) at Downstream Station Limit: Ends at raised grade or PL84-99 berm Approx. Crown Elevation Range (feet, NAVD88): 24 to 25 Approx. Levee Height Range (feet): 14 to 18 Approx. Crown Width Range (feet): 16 to 40 Approx. Landside Slope (H:V) Range: 2:1 to 3:1 Approx. Waterside Slope (H:V) Range: 1.2:1 to 2:1 Waterside Constraint(s): Waterside toe of slope at the waterway - no waterside bench. Landside Constraint(s): Agricultural fields/occasional overhead poles Landside Repairs associated with PL84-99: None Improvements associated with LSRP P1: None Improvements associated with LSRP P2: Drained Seepage Berm & Chimney Drain - STA 259+50 to 270+00 Proposed Improvements associated with LSRP P3: None

<b>Generalized Subsurface Conditions</b>							
Levee Prism Soils: Silty SAND and Clayey SAND Landside Surface Layer: Lean CLAY (10 to 30 feet thick) and Silty SAND Soils below surface layer: Lean CLAY and Silty SAND							
<b>Historic Performance</b>							
Landside seepage and pin boils reported during 1997 flood event in ULE's 2014 SGDR Addendum.							
<b>Liquefiable Soils</b>							
Based on our liquefaction assessment, we are not considering liquefiable soils in our slope stability analyses.							
<b>Seepage Analysis Results</b>							
Station	Water Surface	Figure	Exit Gradient**			Through Seepage	Breakout Height (ft)*
			Levee Toe	Toe of Berm	Field		
<b>281+41</b>	200-Year	E-18-B	No Positive Gradient	0.06	0.16	No	n/a
<b>W/BERM</b>	HTOL	E-18-C	No Positive Gradient	0.07	0.16	n/a	n/a
*Vertical distance from the toe of the levee (ground surface) to where the phreatic surface is calculated to daylight on the levee slope. Through seepage under HTOL conditions are not part of this evaluation. **Exit Gradient includes 3D effects

<b>Slope Stability Analysis Results</b>							
Station	Case Analyzed	Water Surface (feet)	Figure	Factor of Safety (Circular)		Factor of Safety (Non-Circular)	
				Waterside	Landside	Waterside	Landside
<b>281+41</b> <b>W/BERM</b>	SS - 200yr	20.1	E-18-D	---	2.3	n/a	n/a
	SS - HTOL	21.2	E-18-E	---	2.2	n/a	n/a
	RDD	14.0	E-18-D	1.2	---	n/a	n/a
	PS	5.2	E-18-F	1.1	1.7	n/a	n/a
	Post-EQ	n/a	n/a	n/a	n/a	n/a	n/a

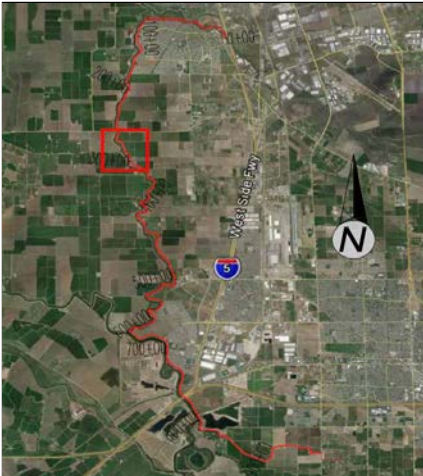
### 10.18 PROJECT REACH E1B, STATION 281+41 WITHOUT BERM

<b>REACH E1B - STA 281+41 WITHOUT BERM</b>							
<b>Based on our evaluation, this reach does not meet the ULDC Criteria.</b>							
<b>Seepage Evaluation Summary</b>				<b>Slope Stability Evaluation Summary</b>			
200-Year DWSEL, Under Seepage:	<b>Meets Criteria</b>			Steady State Seepage 200-Year DWSEL, LS:	<b>Meets Criteria</b>		
200-Year DWSEL, Through Seepage:	<b>Fails Criteria</b>			Steady State Seepage HTOL, LS:	<b>Meets Criteria</b>		
HTOL, Under Seepage:	<b>Meets Criteria</b>			Rapid Drawdown, WS:	<b>Meets Criteria</b>		
				Seismic Slope Stability, WS:	<b>Meets Criteria</b>		
				Seismic Slope Stability, LS:	<b>Meets Criteria</b>		
<b>Reach Description</b>				<b>Reach Overview</b>			
Station Limits: 270+00 to 297+75 Feature(s) at Upstream Station Limit: Begin Phase II drained seepage berm associated with Reach E2 Feature(s) at Downstream Station Limit: End of Phase II drained berm associated with Reach E1A Approx. Crown Elevation Range (feet, NAVD88): 24 to 25 Approx. Levee Height Range (feet): 14 to 18 Approx. Crown Width Range (feet): 16 to 40 Approx. Landside Slope (H:V) Range: 2:1 to 3:1 Approx. Waterside Slope (H:V) Range: 1.2:1 to 2:1 Waterside Constraint(s): Waterside toe of slope at the waterway - no waterside bench. Landside Constraint(s): Agricultural field Landside Repairs associated with PL84-99: None Improvements associated with LSRP P1: None Improvements associated with LSRP P2: None Proposed Improvements associated with LSRP P3: None

<b>Generalized Subsurface Conditions</b>							
Levee Prism Soils: Silty SAND and Lean CLAY Landside Surface Layer: Lean CLAY (10 to 30 feet thick) and Silty SAND Soils below surface layer: Lean CLAY and Silty SAND							
<b>Historic Performance</b>							
Low to medium landside seepage and pin boils reported during 1997 flood event in ULE's 2014 SGDR Addendum.							
<b>Liquefiable Soils</b>							
Based on our liquefaction assessment, we identified potentially liquefiable soils within this Reach (Refer to Appendix E and Appendix F)							
<b>Seepage Analysis Results</b>							
Station	Water Surface	Figure	Exit Gradient			Through Seepage	Breakout Height (ft)*
			Levee Toe	Toe of Berm	Field		
<b>281+41</b> <b>NO</b> <b>BERM</b>	200-Year	E-19-B	0.18	---	---	Yes	2.0
	HTOL	E-19-C	0.20	---	---	n/a	n/a
*Vertical distance from the toe of the levee (ground surface) to where the phreatic surface is calculated to daylight on the levee slope. Through seepage under HTOL conditions are not part of this evaluation.

<b>Slope Stability Analysis Results</b>							
Station	Case Analyzed	Water Surface (feet)	Figure	Factor of Safety (Circular)		Factor of Safety (Non-Circular)	
				Waterside	Landside	Waterside	Landside
<b>281+41</b> <b>NO</b> <b>BERM</b>	SS - 200yr	20.1	E-19-D	---	1.5	n/a	n/a
	SS - HTOL	21.2	E-19-E	---	1.4	n/a	n/a
	RDD	14	E-19-D	1.2	---	n/a	n/a
	PS	5.2	E-19-F	1.1	1.4	n/a	n/a
	Post-EQ	5.2	E-19-G/H	1.3	1.9	1.2	3.0

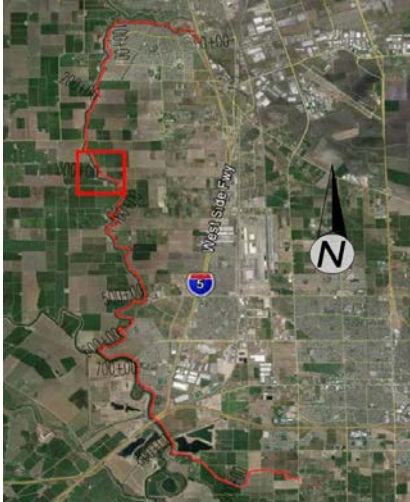
### 10.19 PROJECT REACH E2, STATION 301+07

<b>REACH E2 - STA 301+07</b>							
<b>Based on our evaluation, this reach meets the ULDC Criteria.</b>							
<b>Seepage Evaluation Summary</b>				<b>Slope Stability Evaluation Summary</b>			
200-Year DWSEL, Under Seepage:		<b>Meets Criteria</b>		Steady State Seepage 200-Year DWSEL, LS:		<b>Meets Criteria</b>	
200-Year DWSEL, Through Seepage:		<b>Meets Criteria</b>		Steady State Seepage HTOL, LS:		<b>Meets Criteria</b>	
HTOL, Under Seepage:		<b>Meets Criteria</b>		Rapid Drawdown, WS:		<b>Meets Criteria</b>	
				Seismic Slope Stability, WS:		<b>Meets Criteria</b>	
				Seismic Slope Stability, LS:		<b>Meets Criteria</b>	
<b>Reach Description</b>				<b>Reach Overview</b>			
Station Limits: 297+75 to 305+75 Feature(s) at Upstream Station Limit: Transition to Phase III drained seepage berm associated with Reach F Feature(s) at Downstream Station Limit: End of Phase II seepage berm associated with Reach E2 Approx. Crown Elevation Range (feet, NAVD88): 25 to 26 Approx. Levee Height Range (feet): 15 to 16 Approx. Crown Width Range (feet): 19 to 48 Approx. Landside Slope (H:V) Range: 2:1 to 3:1 Approx. Waterside Slope (H:V) Range: 1.6:1 to 3.4:1 Waterside Constraint(s): Waterside toe of slope at the waterway - no waterside bench. Landside Constraint(s): None - agricultural land. Landside repairs associated with PL84-99: Yes, berms between STA 303+00 and Improvements associated with LSRP P1: Drained Seepage Berm w/chimney drain from STA 297+75 to 305+75 - the Reach Limits Improvements associated with LSRP P2: None Proposed Improvements associated with LSRP P3: None

<b>Generalized Subsurface Conditions</b>							
Levee Prism Soils: Silty SAND, SAND and Lean CLAY Landside Surface Layer: Lean CLAY, approx. 17 feet thick at toe of berm Soils below surface layer: Interbedded layers of Silty SAND, SAND and Lean CLAY							
<b>Historic Performance</b>							
Seepage, pin boils and scour reported during 1997 flood event in ULE's 2014 SGDR Addendum.							
<b>Liquefiable Soils</b>							
Based on our liquefaction assessment, we identified potentially liquefiable soils within this Reach (Refer to Appendix E and Appendix F)							
<b>Seepage Analysis Results</b>							
Station	Water Surface	Figure	Exit Gradient**			Through Seepage	Breakout Height (ft)*
			Levee Toe	Toe of Berm	Field		
301+07	200-Year	E-20-B	0.10	0.58	---	No	n/a
	HTOL	E-20-C	0.14	0.65	---	n/a	n/a
*Vertical distance from the toe of the levee (ground surface) to where the phreatic surface is calculated to daylight on the levee slope. Through seepage under HTOL conditions are not part of this evaluation. **Exit Gradient includes 3D effects

<b>Slope Stability Analysis Results</b>							
Station	Case Analyzed	Water Surface	Figure	Factor of Safety (Circular)		Factor of Safety (Non-Circular)	
				Waterside	Landside	Waterside	Landside
301+07	SS - 200yr	20.4	E-20-D	---	2.1	n/a	n/a
	SS - HTOL	21.5	E-20-E	---	2.1	n/a	n/a
	RDD	14.1	E-20-D	2.1	---	n/a	n/a
	PS	5.2	E-20-F	1.1	1.5	n/a	n/a
	Post-EQ	5.2	E-20-G/H	1.3	2.1	1.7	3.4

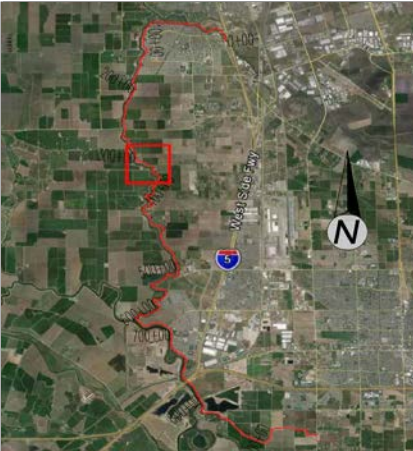
## 10.22 PROJECT REACH F1C, STATION 320+65

<b>REACH F1C - STA 320+65</b>							
<b>Based on our evaluation, this reach does not meet the ULDC Criteria.</b>							
<b>Seepage Evaluation Summary</b>				<b>Slope Stability Evaluation Summary</b>			
200-Year DWSEL, Under Seepage:	<b>Fails Criteria</b>			Steady State Seepage 200-Year DWSEL, LS:	<b>Fails Criteria</b>		
200-Year DWSEL, Through Seepage:	<b>Fails Criteria</b>			Steady State Seepage HTOL, LS:	<b>Fails Criteria</b>		
HTOL, Under Seepage:	<b>Fails Criteria</b>			Rapid Drawdown, WS:	<b>Meets Criteria</b>		
				Seismic Slope Stability, WS:	<b>Meets Criteria</b>		
				Seismic Slope Stability, LS:	<b>Meets Criteria</b>		
<b>Reach Description</b>				<b>Reach Overview</b>			
Station Limits: 315+00 to 321+00 Feature(s) at Upstream Station Limit: Gate on levee near mill Feature(s) at Downstream Station Limit: Bowman Road Approx. Crown Elevation Range (feet, NAVD88): 25 to 26 Approx. Levee Height Range (feet): 19 to 20 Approx. Crown Width Range (feet): 20 to 35 Approx. Landside Slope (H:V) Range: 2:1 to 2.2:1 Approx. Waterside Slope (H:V) Range: 1.5:1 to 2.4:1 Waterside Constraint(s): None  Landside Constraint(s): None - open land  Landside repairs associated with PL84-99: Yes, berms constructed between STA Improvements associated with LSRP P1: None Improvements associated with LSRP P2: None Proposed Improvements associated with LSRP P3: None

<b>Generalized Subsurface Conditions</b>							
Levee Prism Soils: Silty SAND to Lean CLAY Landside Surface Layer: Lean CLAY, approx. 15 feet thick at toe of levee Soils below surface layer: Approx. 8 feet of Silty SAND, over 18 feet Lean CLAY, over 40 feet of SAND							
<b>Historic Performance</b>							
Landside seepage and pin boils reported during 1997 flood event in ULE's 2014 SGDR Addendum.							
<b>Liquefiable Soils</b>							
Based on our liquefaction assessment, we are not considering liquefiable soils in our slope stability analyses.							
<b>Seepage Analysis Results</b>							
Station	Water Surface	Figure	Exit Gradient			Through Seepage	Breakout Height (ft)*
			Levee Toe	Toe of Berm	Field		
<b>320+65</b>	200-Year	E-23-B	1.2	---	0.42	Yes	6.8
	HTOL	E-23-C	1.3	---	0.46	n/a	n/a
*Vertical distance from the toe of the levee (ground surface) to where the phreatic surface is calculated to daylight on the levee slope. Through seepage under HTOL conditions are not part of this evaluation.

<b>Slope Stability Analysis Results</b>							
Station	Case Analyzed	Water Surface	Figure	Factor of Safety (Circular)		Factor of Safety (Non-Circular)	
				Waterside	Landside	Waterside	Landside
<b>320+65</b>	SS - 200yr	21.9	E-23-D	---	1.1	n/a	n/a
	SS - HTOL	22.1	E-23-E	---	1.0	n/a	n/a
	RDD	14.4	E-23-D	1.5	---	n/a	n/a
	PS	5.2	E-23-F	1.1	1.2	n/a	n/a
	Post-EQ	n/a	n/a	n/a	n/a	n/a	n/a

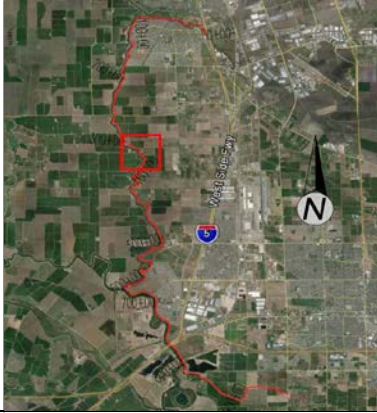
**10.23 PROJECT REACH F2, STATION 329+00**

<b>REACH F2 - STA 329+00</b>							
Based on our evaluation, this reach does not meet the ULDC Criteria. Seismic deformations are not anticipated to degrade below 10-Year WSE+3 feet.							
<b>Seepage Evaluation Summary</b>				<b>Slope Stability Evaluation Summary</b>			
200-Year DWSEL Under Seepage:		Fails Criteria		Steady State Seepage 200-Year DWSEL, LS:		Meets Criteria	
200-Year DWSEL, Through Seepage:		Fails Criteria		Steady State Seepage HTOL, LS:		Meets Criteria	
HTOL, Under Seepage:		Fails Criteria		Rapid Drawdown, WS:		Meets Criteria	
				Seismic Slope Stability, WS:		Fails Criteria	
				Seismic Slope Stability, LS:		Meets Criteria	
<b>Reach Description</b>				<b>Reach Overview</b>			
Station Limits: 321+00 to 339+00 Feature(s) at Upstream Station Limit: Between two levee access ramps Feature(s) at Downstream Station Limit: Gate on levee crown Approx. Crown Elevation Range (feet, NAVD88): 25 to 26 Approx. Levee Height Range (feet): 11 to 19.5 Approx. Crown Width Range (feet): 12 to 22.5 Approx. Landside Slope (H:V) Range: 2.1:1 to 3.8:1 Approx. Waterside Slope (H:V) Range: 1.5:1 to 3.1:1 Waterside Constraint(s): Platform (STA 331+80)  Landside Constraint(s): Existing structures (STA 322+00 to 329+00), small structure (STA 331+80) Landside repairs associated with PL84-99: Seepage berm repairs between STA Improvements associated with LSRP P1: None Improvements associated with LSRP P2: None Proposed Improvements associated with LSRP P3: None

<b>Generalized Subsurface Conditions</b>							
Levee Prism Soils: Silty SAND Landside Surface Layer: Lean CLAY, approx. 5 feet thick at toe of levee with silty SAND lens Soils below surface layer: Interbedded layers of silty SAND, Lean CLAY, and Poorly Graded SAND with Silt							
<b>Historic Performance</b>							
Landside seepage and pin boils reported in ULE's 2014 SGDR Addendum.							
<b>Liquefiable Soils</b>							
Based on our liquefaction assessment, we identified potentially liquefiable soils within this Reach (Refer to Appendix E and Appendix F)							
<b>Seepage Analysis Results</b>							
Station	Water Surface	Figure	Exit Gradient**			Through Seepage	Breakout Height (ft)*
			Levee Toe	Toe of Berm	Field		
329+00	200-Year	E-24-B	1.19	---	0.34	Yes	1
	HTOL	E-24-C	1.33	---	0.38	n/a	n/a
*Vertical distance from the toe of the levee (ground surface) to where the phreatic surface is calculated to day light on the levee slope. Through seepage under HTOL conditions are not part of this evaluation. **Exit Gradient includes 3D effects

<b>Slope Stability Analysis Results</b>							
Station	Case Analyzed	Water Surface	Figure	Factor of Safety (Circular)		Factor of Safety (Non-Circular)	
				Waterside	Landside	Waterside	Landside
329+00	SS - 200yr	21.0	E-24-D	---	1.6	n/a	n/a
	SS - HTOL	22.1	E-24-E	---	1.5	n/a	n/a
	RDD	14.4	E-24-D	1.7	---	n/a	n/a
	PS	5.3	E-24-F	1.3	1.5	n/a	n/a
	Post-EQ	5.3	E-24-G/H	0.8	2.1	0.7	2.0
<b>Post 200-Year Seismic Event Restoration Estimates</b>							
Reach	Damage Length (feet)	Estimated Lateral Movement (feet)	Estimated Vertical Movement (feet)	Fill Volume (10 year WSE+3 feet Freeboard) (cubic yards)	Fill Volume (Fully Restored Levee Geometry) (cubic yards)		
F2	750	2	1.5	No Fill Anticipated	100

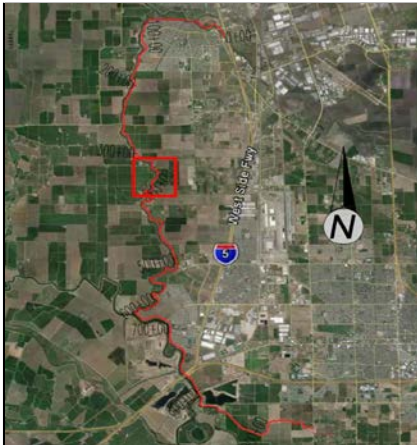
## 10.24 PROJECT REACH F3, STATION 350+00

<b>REACH F3 - STA 350+00</b>							
Based on our evaluation, this reach does not meet the ULDC Criteria.							
<b>Seepage Evaluation Summary</b>				<b>Slope Stability Evaluation Summary</b>			
200-Year DWSEL, Under Seepage:		Fails Criteria		Steady State Seepage 200-Year DWSEL, LS:		Fails Criteria	
200-Year DWSEL, Through Seepage:		Fails Criteria		Steady State Seepage HTOL, LS:		Meets Criteria	
HTOL, Under Seepage:		Fails Criteria		Rapid Drawdown, WS:		Meets Criteria	
				Seismic Slope Stability, WS:		Meets Criteria	
				Seismic Slope Stability, LS:		Meets Criteria	
<b>Reach Description</b>				<b>Reach Overview</b>			
Station Limits: 339+00 to 362+50 Feature(s) at Upstream Station Limit: Transition to Phase III cutoff wall Feature(s) at Downstream Station Limit: Near levee access ramp from farm road Approx. Crown Elevation Range (feet, NAVD88): 26 to 27.5 Approx. Levee Height Range (feet): 11 to 19.5 Approx. Crown Width Range (feet): 13 to 25 Approx. Landside Slope (H:V) Range: 2:1 to 3.8:1 Approx. Waterside Slope (H:V) Range: 1.5:1 to 3.1:1 Waterside Constraint(s): Levee penetration (STA 354+00)  Landside Constraint(s): None - agricultural land  Landside repairs associated with PL84-99: None Improvements associated with LSRP P1: None Improvements associated with LSRP P2: None Proposed Improvements associated with LSRP P3: None

<b>Generalized Subsurface Conditions</b>							
Levee Prism Soils: Silty SAND Landside Surface Layer: Lean CLAY, approx. 15 feet thick at toe of levee Soils below surface layer: Interbedded layers of Silty SAND, Clayey SAND, Lean CLAY, and Poorly Graded SAND							
<b>Historic Performance</b>							
No observations reported in ULE's 2014 SGDR Addendum.							
<b>Liquefiable Soils</b>							
Based on our liquefaction assessment, we are not considering liquefiable soils in our slope stability analyses							
<b>Seepage Analysis Results</b>							
Station	Water Surface	Figure	Exit Gradient**			Through Seepage	Breakout Height (ft)*
			Levee Toe	Toe of Berm	Field		
350+00	200-Year	E-25-B	0.81	---	0.78	Yes	2
	HTOL	E-25-C	0.91	---	0.86	n/a	n/a
*Vertical distance from the toe of the levee (ground surface) to where the phreatic surface is calculated to daylight on the levee slope. Through seepage under HTOL conditions are not part of this evaluation. **Exit Gradient includes 3D effects

<b>Slope Stability Analysis Results</b>							
Station	Case Analyzed	Water Surface	Figure	Factor of Safety (Circular)		Factor of Safety (Non-Circular)	
				Waterside	Landside	Waterside	Landside
350+00	SS - 200yr	21.6	E-25-D	---	1.3	n/a	n/a
	SS - HTOL	22.8	E-25-E	---	1.2	n/a	n/a
	RDD	14.8	E-25-D	1.5	---	n/a	n/a
	PS	5.3	E-25-F	1.0	1.4	n/a	n/a
	Post-EQ	n/a	n/a	n/a	n/a	n/a	n/a

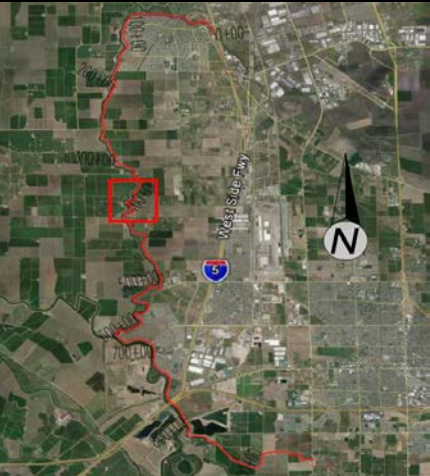
**10.25 PROJECT REACH G, STATION 375+50**

<b>REACH G - STA 375+50</b>							
<b>Based on our evaluation, this reach meets the ULDC Criteria.</b>							
<b>Seepage Evaluation Summary</b>				<b>Slope Stability Evaluation Summary</b>			
200-Year DWSEL, Under Seepage:		<b>Meets Criteria</b>		Steady State Seepage 200-Year DWSEL, LS:		<b>Meets Criteria</b>	
200-Year DWSEL, Through Seepage Seepage:		<b>Meets Criteria</b>		Steady State Seepage HTOL, LS:		<b>Meets Criteria</b>	
HTOL, Under Seepage:		<b>Meets Criteria</b>		Rapid Drawdown, WS:		<b>Meets Criteria</b>	
				Seismic Slope Stability, WS:		<b>Meets Criteria</b>	
				Seismic Slope Stability, LS:		<b>Meets Criteria</b>	
<b>Reach Description</b>				<b>Reach Overview</b>			
Station Limits: 362+50 to 388+00 Feature(s) at Upstream Station Limit: Waterside mobile home park/waterside Feature(s) at Downstream Station Limit: Near levee access ramp from farm road Approx. Crown Elevation Range (feet, NAVD88): 27 to 28 Approx. Levee Height Range (feet): 13.5 to 21 Approx. Crown Width Range (feet): 17 to 37 Approx. Landside Slope (H:V) Range: 1.8:1 to 2.7:1 Approx. Waterside Slope (H:V) Range: 1.7:1 to 3.2:1 Waterside Constraint(s): Waterside toe of slope at the waterway - waterside bench begins at STA 377+75 Landside Constraint(s): Lake and equestrian arena Landside repairs associated with PL84-99: Yes, berm constructed from STA 374+50 to 382+00 Improvements associated with LSRP P1: None Improvements associated with LSRP P2: None Proposed Improvements associated with LSRP P3: Fully penetrating cutoff wall STA 362+50 to 388+00

<b>Generalized Subsurface Conditions</b>							
Levee Prism Soils: Clayey SAND to Silty SAND Landside Surface Layer: Lean CLAY approx. 6 feet thick at levee toe Soils below surface layer: Approx. 4 feet of Silty SAND, over 4 feet of Lean Clay, over 23 feet of Silty SAND							
<b>Historic Performance</b>							
Seepage and boils reported in ULE's 2014 SGDR Addendum.							
<b>Liquefiable Soils</b>							
Based on our liquefaction assessment, we are not considering liquefiable soils in our slope stability analyses.							
<b>Seepage Analysis Results</b>							
Station	Water Surface	Figure	Exit Gradient			Through Seepage	Breakout Height (ft)*
			Levee Toe	Toe of Berm	Field		
<b>375+50</b>	200-Year	E-26-B	No Positive Gradient	---	---	No	n/a
	HTOL	E-26-C	No Positive Gradient	---	---	n/a	n/a
*Vertical distance from the toe of the levee (ground surface) to where the phreatic surface is calculated to daylight on the levee slope. Through seepage under HTOL conditions are not part of this evaluation.

<b>Slope Stability Analysis Results</b>							
Station	Case Analyzed	Water Surface	Figure	Factor of Safety (Circular)		Factor of Safety (Non-Circular)	
				Waterside	Landside	Waterside	Landside
<b>375+50</b>	SS - 200yr	22.0	E-26-D/E	---	1.5	---	1.7
	SS - HTOL	23.1	E-26-F	---	1.5	---	1.7
	RDD	14.8	E-26-D/E	1.6	---	1.7	---
	PS	5.3	E-26-G/H	1.4	1.2	1.3	1.4
	Post-EQ	n/a	n/a	n/a	n/a	n/a	n/a

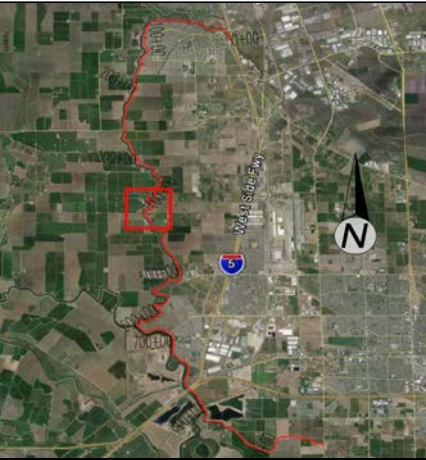
## 10.27 PROJECT REACH H1A, STATION 408+00

<b>REACH H1A - STA 408+00</b>							
<b>Based on our evaluation, this reach does not meet the ULDC Criteria.</b>							
<b>Seepage Evaluation Summary</b>				<b>Slope Stability Evaluation Summary</b>			
200-Year DWSEL, Under Seepage:		<b>Fails Criteria</b>		Steady State Seepage 200-Year DWSEL, LS:		<b>Fails Criteria</b>	
200-Year DWSEL, Through Seepage:		<b>Fails Criteria</b>		Steady State Seepage HTOL, LS:		<b>Fails Criteria</b>	
HTOL, Under Seepage:		<b>Fails Criteria</b>		Rapid Drawdown, WS:		<b>Meets Criteria</b>	
				Seismic Slope Stability, WS:		<b>Meets Criteria</b>	
				Seismic Slope Stability, LS:		<b>Meets Criteria</b>	
<b>Reach Description</b>				<b>Reach Overview</b>			
Station Limits: 388+00 to 411+00 Feature(s) at Upstream Station Limit: End of PL84-99 berm within Reach H1B Feature(s) at Downstream Station Limit: Terminous of LSRP Phase III cutoff wall in Reach G Approx. Crown Elevation Range (feet, NAVD88): 27 to 28 Approx. Levee Height Range (feet): 11 to 17 Approx. Crown Width Range (feet): 14 to 30 Approx. Landside Slope (H:V) Range: 1.8:1 to 2.5:1 Approx. Waterside Slope (H:V) Range: 1.7:1 to 3.2:1 Waterside Constraint(s): Waterside residential improvements Landside Constraint(s): None - Agricultural/undeveloped land Landside repairs associated with PL84-99: Yes, berm constructed between STA 402+00 and 411+00 Improvements associated with LSRP P1: None Improvements associated with LSRP P2: None Proposed Improvements associated with LSRP P3: None

<b>Generalized Subsurface Conditions</b>							
Levee Prism Soils: Silty SAND with Lean CLAY lenses Landside Surface Layer: Lean CLAY to Fat CLAY, approx. 5 feet thick at toe of levee Soils below surface layer: 7 feet of Silty SAND, over 12 feet of Poorly Graded SAND, over interbedded layers of Lean CLAY and Silty SAND							
<b>Historic Performance</b>							
Seepage and boils reported in ULE's 2014 SGDR Addendum.							
<b>Liquefiable Soils</b>							
Based on our liquefaction assessment, we identified potentially liquefiable soils within this Reach (Refer to Appendix E and Appendix F)							
<b>Seepage Analysis Results</b>							
Station	Water Surface	Figure	Exit Gradient			Through Seepage	Breakout Height (ft)*
			Levee Toe	Toe of Berm	Field		
<b>408+00</b>	200-Year	E-28-B	0.99	---	1.06	Yes	1.5
	HTOL	E-28-B	1.13	---	1.21	n/a	n/a
*Vertical distance from the toe of the levee (ground surface) to where the phreatic surface is calculated to daylight on the levee slope. Through seepage under HTOL conditions are not part of this evaluation.

<b>Slope Stability Analysis Results</b>							
Station	Case Analyzed	Water Surface	Figure	Factor of Safety (Circular)		Factor of Safety (Non-Circular)	
				Waterside	Landside	Waterside	Landside
<b>408+00</b>	SS - 200yr	22.5	E-28-D	---	1.3	n/a	n/a
	SS - HTOL	23.6	E-28-E	---	1.1	n/a	n/a
	RDD	14.3	E-28-D	1.8	---	n/a	n/a
	PS	5.3	E-28-F	1.2	1.3	n/a	n/a
	Post-EQ	5.3	E-28-G/H	1.2	1.6	1.4	3.0

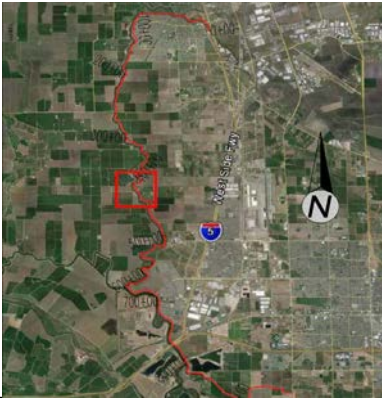
<b>REACH H1B - STA 416+86</b>							
Based on our evaluation, this reach does not meet the ULDC criteria. Seismic deformations are not anticipated to degrade below 10-Year WSE + 3 feet.							
<b>Seepage Evaluation Summary</b>				<b>Slope Stability Evaluation Summary</b>			
200-Year DWSEL, Under Seepage:		Fails Criteria		Steady State Seepage 200-Year DWSEL, LS:		Meets Criteria	
200-Year DWSEL, Through Seepage:		Meets Criteria		Steady State Seepage HTOL, LS:		Meets Criteria	
HTOL, Under Seepage:		Fails Criteria		Rapid Drawdown, WS:		Meets Criteria	
				Seismic Slope Stability, WS:		Fails Criteria	
				Seismic Slope Stability, LS:		Meets Criteria	
<b>Reach Description</b>				<b>Reach Overview</b>			
Station Limits: 411+00 to 420+00 Feature(s) at Upstream Station Limit: Gate and levee access road Feature(s) at Downstream Station Limit: End of PL84-99 berm within Reach H1B Approx. Crown Elevation Range (feet, NAVD88): 27 to 28 Approx. Levee Height Range (feet): 10.5 to 11.5 Approx. Crown Width Range (feet): 18 to 30 Approx. Landside Slope (H:V) Range: 1.8:1 to 2.5:1 Approx. Waterside Slope (H:V) Range: 1.7:1 to 3.2:1 Waterside Constraint(s): Levee penetration at STA 413+40 Landside Constraint(s): Existing structures at toe of levee Landside repairs associated with PL84-99: Yes, berm constructed between STA 411+00 and 420+00 Improvements associated with LSRP P1: None Improvements associated with LSRP P2: None Proposed Improvements associated with LSRP P3: None

<b>Generalized Subsurface Conditions</b> Levee Prism Soils: Variable layers of Silty Lean CLAY and Silty SAND Landside Surface Layer: Lean CLAY to Fat CLAY, approx. 4 feet thick at toe of levee, less than 1 foot thick landward of levee toe Soils below surface layer: Approx. 16-feet of Silty SAND to Poorly Graded SAND, underlain by approximately 25 feet of Lean CLAY							
<b>Historic Performance</b> Seepage and boils reported in ULE's 2014 SGDR Addendum.							
<b>Liquefiable Soils</b> Based on our liquefaction assessment, we identified potentially liquefiable soils within this Reach (Refer to Appendix E and Appendix F)							
<b>Seepage Analysis Results</b>							
Station	Water Surface	Figure	Exit Gradient			Through Seepage	Breakout Height (ft)*
			Levee Toe	Toe of Berm	Field		
<b>416+86</b>	200-Year	E-29-B	1.62	---	2.48	Yes**	6.6
	HTOL	E-29-C	1.82	---	2.74	n/a	n/a
*Vertical distance from the toe of the levee (ground surface) to where the phreatic surface is calculated to day light on the levee slope. Through seepage under HTOL conditions are not part of this evaluation. **Exits onto slope flatter than 5:1 (H:V), therefore we report "meets criteria" for through seepage.

<b>Slope Stability Analysis Results</b>							
Station	Case Analyzed	Water Surface	Figure	Factor of Safety (Circular)		Factor of Safety (Non-Circular)	
				Waterside	Landside	Waterside	Landside
<b>416+86</b>	SS - 200yr	22.7	E-29-D	---	1.8	n/a	n/a
	SS - HTOL	23.8	E-29-E	---	1.8	n/a	n/a
	RDD	14.5	E-29-D	1.6	---	n/a	n/a
	PS	5.3	E-29-F	0.8	1.8	n/a	n/a
	Post-EQ	5.3	E-29-G/H	1.3	2.3	1.4	3.0
<b>Post 200-Year Seismic Event Restoration Estimates</b>							
Reach	Damage Length (feet)	Estimated Lateral Movement (feet)	Estimated Vertical Movement (feet)	Fill Volume (10 year WSE+3 feet Freeboard) (cubic yards)	Fill Volume (Fully Restored Levee Geometry) (cubic yards)		
<b>H1B</b>	2,000	2	1.5	No Fill Anticipated	250

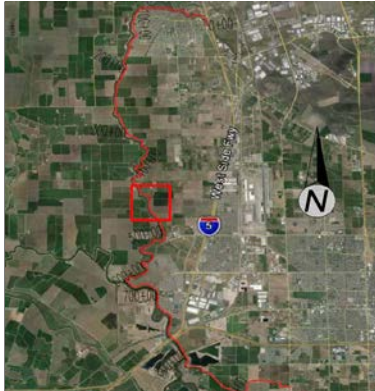
<b>REACH H3 - STA 455+55</b>							
Based on our evaluation, this reach does not meet the ULDC criteria. Seismic deformations are not anticipated to degrade below 10-Year WSE+3 feet.							
<b>Seepage Evaluation Summary</b>				<b>Slope Stability Evaluation Summary</b>			
200-Year DWSEL, Under Seepage:		Fails Criteria		Steady State Seepage 200-Year DWSEL, LS:		Fails Criteria	
200-Year DWSEL, Through Seepage:		Meets Criteria		Steady State Seepage HTOL, LS:		Fails Criteria	
HTOL, Under Seepage:		Fails Criteria		Rapid Drawdown, WS:		Meets Criteria	
				Seismic Slope Stability, WS:		Fails Criteria	
				Seismic Slope Stability, LS:		Meets Criteria	
<b>Reach Description</b>				<b>Reach Overview</b>			
Station Limits: 445+00 to 466+00 Feature(s) at Upstream Station Limit: Small waterside bench Feature(s) at Downstream Station Limit: 250' north of levee access ramp Approx. Crown Elevation Range (feet, NAVD88): 28 to 29 Approx. Levee Height Range (feet): 15 to 17 Approx. Crown Width Range (feet): 15 to 50 Approx. Landside Slope (H:V) Range: 2.0:1 to 2.8:1 Approx. Waterside Slope (H:V) Range: 1.4:1 to 3.6:1 Waterside Constraint(s): Waterside bench/residence from STA Landside Constraint(s): Well/levee penetration at STA 459+00 Landside repairs associated with PL84-99: Possibly, berm constructed from STA 452+00 to 456+00 Improvements associated with LSRP P1: None Improvements associated with LSRP P2: None Proposed Improvements associated with LSRP P3: None

<b>Generalized Subsurface Conditions</b>							
Levee Prism Soils: Lean Clay to Clayey SILT Landside Surface Layer: Silty SAND, approx. 5 feet thick at toe of levee Soils below surface layer: Approx. 20 feet of Poorly Graded SAND with Silt, over Lean CLAY							
<b>Historic Performance</b>							
Seepage, boils and erosion reported in ULE's 2014 SGDR Addendum.							
<b>Liquefiable Soils</b>							
Based on our liquefaction assessment, we identified potentially liquefiable soils within this Reach (Refer to Appendix E and Appendix F)							
<b>Seepage Analysis Results</b>							
Station	Water Surface	Figure	Exit Gradient			Through Seepage	Breakout Height (ft)*
			Levee Toe	Toe of Berm	Field		
455+55	200-Year	E-31-B	0.66	---	---	Yes**	2.3
	HTOL	E-31-C	0.75	---	---	n/a	n/a
*Vertical distance from the toe of the levee (ground surface) to where the phreatic surface is calculated to daylight on the levee slope. Through seepage under HTOL conditions are not part of this evaluation. **Exits onto a fine grained slope, therefore we report "meets criteria" for through seepage.

<b>Slope Stability Analysis Results</b>							
Station	Case Analyzed	Water Surface	Figure	Factor of Safety (Circular)		Factor of Safety (Non-Circular)	
				Waterside	Landside	Waterside	Landside
455+55	SS - 200yr	23.3	E-31-D	---	1.1	n/a	n/a
	SS - HTOL	24.6	E-31-E	---	1.0	n/a	n/a
	RDD	14.9	E-31-D	2.1	---	n/a	n/a
	PS	5.3	E-31-F	1.7	1.5	n/a	n/a
	Post-EQ	5.3	E-31-G/H	1.8	1.2	0.9	1.1
<b>Post 200-Year Seismic Event Restoration Estimates</b>							
Reach	Damage Length (feet)	Estimated Lateral Movement (feet)	Estimated Vertical Movement (feet)	Fill Volume (10 year WSE+3 feet Freeboard) (cubic yards)	Fill Volume (Fully Restored Levee Geometry) (cubic yards)		
H3	1,600	3	2	No Fill Anticipated	400

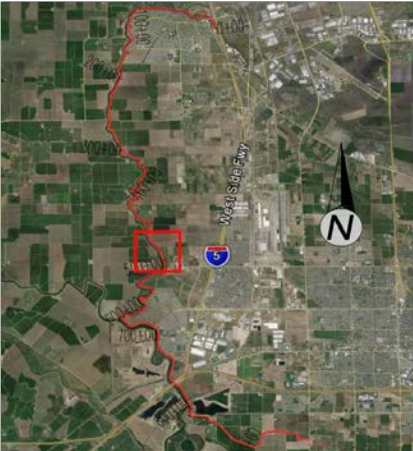
<b>REACH I - STA 476+00</b>							
Based on our evaluation, this reach does not meet ULDC Criteria.							
Seepage Evaluation Summary				Slope Stability Evaluation Summary			
200-Year DWSEL, Under Seepage:		Fails Criteria		Steady State Seepage 200-Year DWSEL, LS:		Fails Criteria	
200-Year DWSEL, Through Seepage:		Fails Criteria		Steady State Seepage HTOL, LS:		Meets Criteria	
HTOL, Under Seepage:		Fails Criteria		Rapid Drawdown, WS:		Meets Criteria	
				Seismic Slope Stability, WS:		Meets Criteria	
				Seismic Slope Stability, LS:		Meets Criteria	
Reach Description				Reach Overview			
Station Limits: 466+00 to 506+00 Feature(s) at Upstream Station Limit: Lathrop High School Improvements Feature(s) at Downstream Station Limit: 500 feet north of De Lima Road Approx. Crown Elevation Range (feet, NAVD88): 28 to 30 Approx. Levee Height Range (feet): 15.5 to 18 Approx. Crown Width Range (feet): 15 to 42 Approx. Landside Slope (H:V) Range: 1.7:1 to 3.8:1 Approx. Waterside Slope (H:V) Range: 1.6:1 to 4.6:1 Waterside Constraint(s): Penetration near STA 478+50 and Landside Constraint(s): Dos Reis Rd. and parking lot from STA 483+00 to 493+00 Landside Repairs associated with PL84-99: Yes, berm constructed from STA 472+00 to 477+00 Improvements associated with LSRP P1: None Improvements associated with LSRP P2: None Proposed Improvements associated with LSRP P3: Drained seepage berm with chimney

Generalized Subsurface Conditions							
Levee Prism Soils: Silty SAND Landside Surface Layer: Lean CLAY approx. 2 ft thick at toe of levee Soils below surface layer: Alternating layers of Silty SAND and Lean CLAY							
Historic Performance							
Seepage, landside boils, and waterside erosion during 1997 flood event were reported in ULE's 2014 SGDR Addendum.							
Liquefiable Soils							
Based on our liquefaction assessment, we are not considering liquefiable soils in our slope stability analyses.							
Seepage Analysis Results							
Station	Water Surface	Figure	Exit Gradient			Through Seepage	Breakout Height (ft)*
			Levee Toe	Toe of Berm	Field		
476+00	200-Year	E-32-B	1.61	---	---	Yes	6
	HTOL	E-32-C	1.75	---	---	n/a	n/a
*Vertical distance from the toe of the levee (ground surface) to where the phreatic surface is calculated to daylight on the levee slope. Through seepage under HTOL conditions are not part of this evaluation.

Slope Stability Analysis Results							
Station	Case Analyzed	Water Surface (feet)	Figure	Factor of Safety (Circular)		Factor of Safety (Non-Circular)	
				Waterside	Landside	Waterside	Landside
476+00	SS - 200yr	23.6	E-32-D	---	1.3	n/a	n/a
	SS - HTOL	24.9	E-32-E	---	1.2	n/a	n/a
	RDD	15	E-32-D	1.5	---	n/a	n/a
	PS	5.3	E-32-F	1.1	1.4	n/a	n/a
	Post-EQ	n/a	n/a	n/a	n/a	n/a	n/a

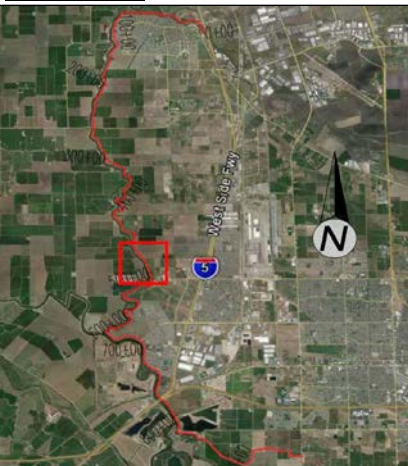
<b>REACH I - STA 496+28</b>							
Based on our evaluation, this reach does not meet ULDC criteria.							
<b>Seepage Evaluation Summary</b>				<b>Slope Stability Evaluation Summary</b>			
200-Year DWSEL, Under Seepage:	<b>Fails Criteria</b>			Steady State Seepage 200-Year DWSEL, LS:	<b>Meets Criteria</b>		
200-Year DWSEL, Through Seepage:	<b>Fails Criteria</b>			Steady State Seepage HTOL, LS:	<b>Meets Criteria</b>		
HTOL, Under Seepage:	<b>Fails Criteria</b>			Rapid Drawdown, WS:	<b>Meets Criteria</b>		
				Seismic Slope Stability, WS:	<b>Meets Criteria</b>		
				Seismic Slope Stability, LS:	<b>Meets Criteria</b>		
<b>Reach Description</b>				<b>Reach Overview</b>			
Station Limits: 466+00 to 506+00 Feature(s) at Upstream Station Limit: Lathrop High School Improvements Feature(s) at Downstream Station Limit: 500 feet north of De Lima Road Approx. Crown Elevation Range (feet, NAVD88): 28 to 30 Approx. Levee Height Range (feet): 15.5 to 18 Approx. Crown Width Range (feet): 15 to 42 Approx. Landside Slope (H:V) Range: 1.7:1 to 3.8:1 Approx. Waterside Slope (H:V) Range: 1.6:1 to 4.6:1 Waterside Constraint(s): Penetration near STA 478+50 and dock/boat ramp near STA 491+00 Landside Constraint(s): Dos Reis Rd. and parking lot from STA 483+00 to 493+00 Landside Repairs associated with PL84-99: Yes, berm constructed from STA 472+00 to 477+00 Improvements associated with LSRP P1: None Improvements associated with LSRP P2: None Proposed Improvements associated with LSRP P3: Drained seepage berm with chimney

<b>Generalized Subsurface Conditions</b>							
Levee Prism Soils: Clayey SAND and Poorly Graded SAND with Silt Landside Surface Layer: Lean CLAY, approx. 10 ft thick at toe of levee Soils below surface layer: Alternating layers of Poorly Graded SAND to Silty SAND and Lean CLAY							
<b>Historic Performance</b>							
Seepage, landside boils, and waterside erosion during 1997 flood event were reported in ULE's 2014 SGDR Addendum.							
<b>Liquefiable Soils</b>							
Based on our liquefaction assessment, we are not considering liquefiable soils in our slope stability analyses							
<b>Seepage Analysis Results</b>							
Station	Water Surface	Figure	Exit Gradient			Through Seepage	Breakout Height (ft)*
			Levee Toe	Toe of Berm	Field		
<b>496+28</b>	200-Year	E-33-B	0.97	---	---	Yes	4
	HTOL	E-33-C	1.08	---	---	n/a	n/a
*Vertical distance from the toe of the levee (ground surface) to where the phreatic surface is calculated to daylight on the levee slope. Through seepage under HTOL conditions are not part of this evaluation.

<b>Slope Stability Analysis Results</b>							
Station	Case Analyzed	Water Surface (feet)	Figure	Factor of Safety (Circular)		Factor of Safety (Non-Circular)	
				Waterside	Landside	Waterside	Landside
<b>496+28</b>	SS - 200yr	23.6	E-33-D	---	1.7	n/a	n/a
	SS - HTOL	24.9	E-33-E	---	1.5	n/a	n/a
	RDD	15	E-33-D	2.0	---	n/a	n/a
	PS	5.3	E-33-F	1.2	1.9	n/a	n/a
	Post-EQ	n/a	n/a	n/a	n/a	n/a	n/a
