# URBAN LEVEE DESIGN CRITERIA EVALUATION

MOSSDALE TRACT  
RECLAMATION DISTRICT NO. 17  
SAN JOAQUIN COUNTY, CALIFORNIA

Subject: Mossdale Tract  
Reclamation District No. 17  
San Joaquin County, California

## URBAN LEVEE DESIGN CRITERIA EVALUATION

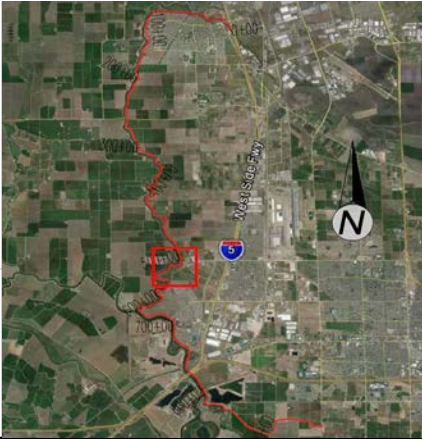
<b>REACH J1B - STA 516+00</b>							
<b>Based on our evaluation, this reach meets the ULDC Criteria.</b>							
<b>Seepage Evaluation Summary</b>				<b>Slope Stability Evaluation Summary</b>			
200-Year DWSEL, Under Seepage:		<b>Meets Criteria</b>		Steady State Seepage 200-Year DWSEL, LS:		<b>Meets Criteria</b>	
200-Year DWSEL, Through Seepage:		<b>Meets Criteria</b>		Steady State Seepage HTOL, LS:		<b>Meets Criteria</b>	
HTOL, Under Seepage:		<b>Meets Criteria</b>		Rapid Drawdown, WS:		<b>Meets Criteria</b>	
				Seismic Slope Stability, WS:		<b>Meets Criteria</b>	
				Seismic Slope Stability, LS:		<b>Meets Criteria</b>	
<b>Reach Description</b>				<b>Reach Overview</b>			
Station Limits: 515+50 to 534+00 Feature(s) at Upstream Station Limit: Landside agricultural land Feature(s) at Downstream Station Limit: Levee access ramp Approx. Crown Elevation Range (feet, NAVD88): 29 to 30 Approx. Levee Height Range (feet): 14.5 to 18.5 Approx. Crown Width Range (feet): 15 to 35 Approx. Landside Slope (H:V) Range: 1.9:1 to 2.5:1 Approx. Waterside Slope (H:V) Range: 1.5:1 to 3.1:1 Waterside Constraint(s): Bench between STA 515+00 to 529+00 Landside Constraint(s): None - agricultural land Landside Repairs associated with PL84-99: None Improvements associated with LSRP P1: Drained seepage berm from STA 151+50 to 534+00 - the reach limits Improvements associated with LSRP P2: None Proposed Improvements associated with LSRP P3: Chimney Drain

<b>Generalized Subsurface Conditions</b>							
Levee Prism Soils: Silty to Clayey SAND and Lean CLAY Landside Surface Layer: Silty SAND, approx. 20 feet thick at levee toe Soils below surface layer: Alternating layers of Lean CLAY and Poorly Graded SAND with Silt							
<b>Historic Performance</b>							
No records of documented seepage, slope stability, or erosion events according to ULE's 2015 GER Volume 1.							
<b>Liquefiable Soils</b>							
Based on our liquefaction assessment, we are not considering liquefiable soils in our slope stability analyses							
<b>Seepage Analysis Results</b>							
Station	Water Surface	Figure	Exit Gradient			Through Seepage	Breakout Height (ft)*
			Levee Toe	Toe of Berm	Field		
<b>516+00</b>	200-Year	E-35-B	No Positive Gradient	0.14	---	No	n/a
	HTOL	E-35-C	No Positive Gradient	0.14	---	n/a	n/a
*Vertical distance from the toe of the levee (ground surface) to where the phreatic surface is calculated to daylight on the levee slope. Through seepage under HTOL conditions are not part of this evaluation.

<b>Slope Stability Analysis Results</b>							
Station	Case Analyzed	Water Surface (feet)	Figure	Factor of Safety (Circular)		Factor of Safety (Non-Circular)	
				Waterside	Landside	Waterside	Landside
<b>516+00</b>	SS - 200yr	24.1	E-35-D	---	2.3	n/a	n/a
	SS - HTOL	25.4	E-35-E	---	2.3	n/a	n/a
	RDD	15.3	E-35-D	1.8	---	n/a	n/a
	PS	5.3	E-35-F	1.4	1.7	n/a	n/a
	Post-EQ	n/a	n/a	n/a	n/a	n/a	n/a

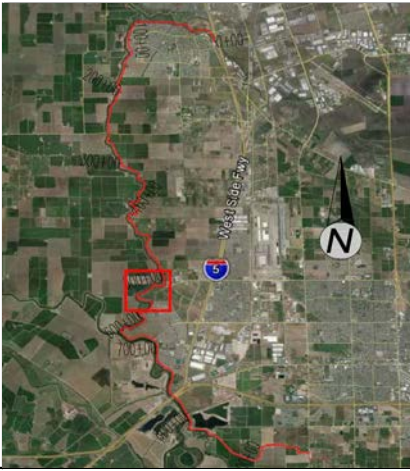
<b>REACH J2 - STA 544+33</b>							
<b>Based on our evaluation, this reach meets the ULDC Criteria.</b>							
<b>Seepage Evaluation Summary</b>				<b>Slope Stability Evaluation Summary</b>			
200-Year DWSEL, Under Seepage:	<b>Meets Criteria</b>			Steady State Seepage 200-Year DWSEL, LS:	<b>Meets Criteria</b>		
200-Year DWSEL, Through Seepage:	<b>Meets Criteria</b>			Steady State Seepage HTOL, LS:	<b>Meets Criteria</b>		
HTOL, Under Seepage:	<b>Meets Criteria</b>			Rapid Drawdown, WS:	<b>Meets Criteria</b>		
				Seismic Slope Stability, WS:	<b>Meets Criteria</b>		
				Seismic Slope Stability, LS:	<b>Meets Criteria</b>		
<b>Reach Description</b>				<b>Reach Overview</b>			
Station Limits: 534+00 to 544+50

Feature(s) at Upstream Station Limit: Adjoining Phase 1 LSRP drained seepage berm - Reach J3A							
Feature(s) at Downstream Station Limit: Adjoining Phase 1 LSRP drained seepage berm - Reach J1B

Approx. Crown Elevation Range (feet, NAVD88):	29	to	30				
Approx. Levee Height Range (feet):	18	to	19				
Approx. Crown Width Range (feet):	16	to	27				
Approx. Landside Slope (H:V) Range:	3:1	to	3:1				
Approx. Waterside Slope (H:V) Range:	1.5:1	to	3:1				
Waterside Constraint(s): Waterside toe of slope at the waterway							
Landside Constraint(s): Existing seepage berm and agricultural land.							
Landside repairs associated with PL84-99: None							
Improvements associated with LSRP P1: Drained Seepage Berm							
Improvements associated with LSRP P2: None							
Proposed Improvements associated with LSRP P3: Chimney Drain							
<b>Generalized Subsurface Conditions</b>							
Levee Prism Soils: Silty SAND to Clayey SAND							
Landside Surface Layer: Lean CLAY, approx. 15 feet thick at toe of levee							
Soils below surface layer: Approx. 30 feet of interlayered Silty SAND, SAND and Silty CLAY, over 30 feet of Lean CLAY

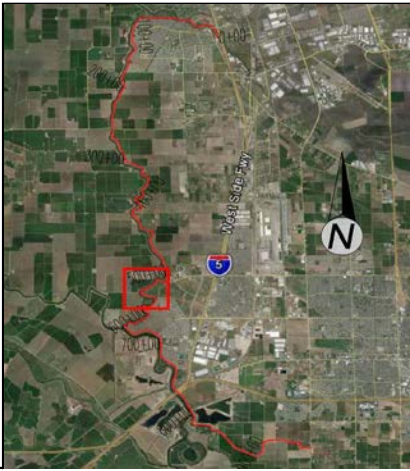
<b>REACH J3A - STA 544+33</b>							
<b>Based on our evaluation, this reach meets the ULDC Criteria.</b>							
<b>Seepage Evaluation Summary</b>				<b>Slope Stability Evaluation Summary</b>			
200-Year DWSEL, Under Seepage:	<b>Meets Criteria</b>			Steady State Seepage 200-Year DWSEL, LS:	<b>Meets Criteria</b>		
200-Year DWSEL, Through Seepage:	<b>Meets Criteria</b>			Steady State Seepage HTOL, LS:	<b>Meets Criteria</b>		
HTOL, Under Seepage:	<b>Meets Criteria</b>			Rapid Drawdown, WS:	<b>Meets Criteria</b>		
				Seismic Slope Stability, WS:	<b>Meets Criteria</b>		
				Seismic Slope Stability, LS:	<b>Meets Criteria</b>		
<b>Reach Description</b>				<b>Reach Overview</b>			
(Same cross section used for Reach J2)

Station Limits: 544+50 to 548+50							
Feature(s) at Upstream Station Limit: Southern end Phase 1 LSRP drained seepage berm - Reach J3A							
Feature(s) at Downstream Station Limit: Adjoining Phase 1 LSRP drained seepage berm - Reach J2

Approx. Crown Elevation Range (feet, NAVD88): 29 to 30							
Approx. Levee Height Range (feet): 18 to 19							
Approx. Crown Width Range (feet): 16 to 27							
Approx. Landside Slope (H:V) Range: 3:1 to 3:1							
Approx. Waterside Slope (H:V) Range: 1.5:1 to 3:1							
Waterside Constraint(s): Waterside toe of slope at the waterway							
Landside Constraint(s): Existing seepage berm and agricultural land.							
Landside repairs associated with PL84-99: None							
Improvements associated with LSRP P1: Drained Seepage Berm							
Improvements associated with LSRP P2: None							
Proposed Improvements associated with LSRP P3: Chimney Drain							
<b>Generalized Subsurface Conditions</b>							
Levee Prism Soils: Silty SAND to Clayey SAND							
Landside Surface Layer: Lean CLAY, approx. 15 feet thick at toe of levee							
Soils below surface layer: Approx. 30 feet of interlayered Silty SAND, SAND and Silty CLAY, over 30 feet of Lean CLAY

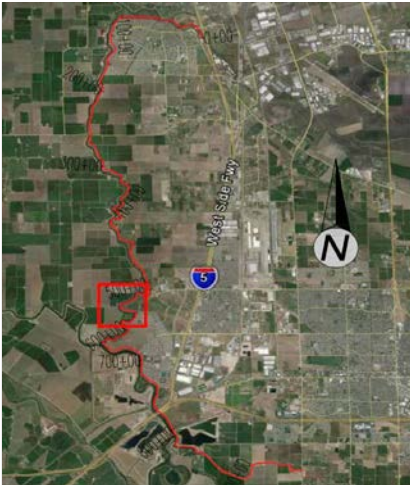
<b>REACH J3B - STA 553+71</b>							
Based on our evaluation, this reach meets the ULDC Criteria.							
<u>Seepage Evaluation Summary</u>				<u>Slope Stability Evaluation Summary</u>			
200-Year DWSEL, Under Seepage:		Meets Criteria		Steady State Seepage 200-Year DWSEL, LS:		Meets Criteria	
200-Year DWSEL, Through Seepage:		Meets Criteria		Steady State Seepage HTOL, LS:		Meets Criteria	
HTOL, Under Seepage:		Meets Criteria		Rapid Drawdown, WS:		Meets Criteria	
				Seismic Slope Stability, WS:		Meets Criteria	
				Seismic Slope Stability, LS:		Meets Criteria	
<u>Reach Description</u>				<u>Reach Overview</u>			
Station Limits: 548+50 to 555+70 Feature(s) at Upstream Station Limit: Northern end Phase 1 LSRP drained seepage berm - Reach J3C Feature(s) at Downstream Station Limit: Southern end Phase 1 LSRP drained seepage berm - Reach J3A Approx. Crown Elevation Range (feet, NAVD88): 29 to 31 Approx. Levee Height Range (feet): 15 to 18 Approx. Crown Width Range (feet): 18 to 20 Approx. Landside Slope (H:V) Range: 3:1 to 3:1 Approx. Waterside Slope (H:V) Range: 1.5:1 to 3:1 Waterside Constraint(s): Waterside toe of slope at the waterway - no waterside bench. Landside Constraint(s): Oak Trees Landside repairs associated with PL84-99: None definitively documented Improvements associated with LSRP P1: None Improvements associated with LSRP P2: None Proposed Improvements associated with LSRP P3: Drained seepage berm with chimney drain

<u>Generalized Subsurface Conditions</u>							
Levee Prism Soils: Sandy SILT to Silty SAND Landside Surface Layer: Silty SAND, approx. 3 feet thick at toe of levee Soils below surface layer: Approx. 15 feet of Silty SAND, over 10 feet of Lean CLAY, over interbedded Silty SAND, SAND and Lean CLAY							
<u>Historic Performance</u>							
Extensive seepage, landside boils and erosion were reported in ULE's 2014 SGDR Addendum.							
<u>Liquefiable Soils</u>							
Based on our liquefaction assessment, we identified potentially liquefiable soils within this Reach (Refer to Appendix E and Appendix F)							
<u>Seepage Analysis Results</u>							
Station	Water Surface	Figure	Exit Gradient**			Through Seepage	Breakout Height (ft)*
			Levee Toe	Toe of Berm	Field		
<b>553+71</b>	200-Year	E-38-B	No Positive Gradient	0.46	---	No	n/a
	HTOL	E-38-C	No Positive Gradient	0.50	---	n/a	n/a
*Vertical distance from the toe of the levee (ground surface) to where the phreatic surface is calculated to daylight on the levee slope. Through seepage under HTOL conditions are not part of this evaluation. **Exit Gradient includes 3D effects

<u>Slope Stability Analysis Results</u>							
Station	Case Analyzed	Water Surface (ft)	Figure	Factor of Safety (Circular)		Factor of Safety (Non-Circular)	
				Waterside	Landside	Waterside	Landside
<b>553+71</b>	SS - 200yr	24.5	E-38-D	---	2.1	n/a	n/a
	SS - HTOL	26.0	E-38-E	---	2.1	n/a	n/a
	RDD	15.5	E-38-D	1.6	---	n/a	n/a
	PS	5.3	E-38-F	1.1	1.5	n/a	n/a
	Post-EQ	5.3	E-38-G/H	1.3	1.9	1.3	3.0

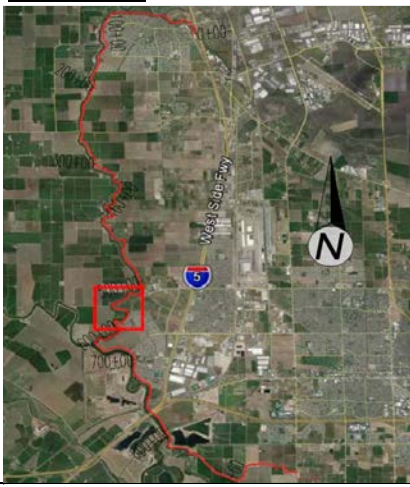
<b>REACH J3C - STA 557+50</b>							
<b>Based on our evaluation, this reach meets the ULDC Criteria.</b>							
<b>Seepage Evaluation Summary</b>				<b>Slope Stability Evaluation Summary</b>			
200-Year DWSEL, Under Seepage:		<b>Meets Criteria</b>		Steady State Seepage 200-Year DWSEL, LS:		<b>Meets Criteria</b>	
200-Year DWSEL, Through Seepage:		<b>Meets Criteria</b>		Steady State Seepage HTOL, LS:		<b>Meets Criteria</b>	
HTOL, Under Seepage:		<b>Meets Criteria</b>		Rapid Drawdown, WS:		<b>Meets Criteria</b>	
				Seismic Slope Stability, WS:		<b>Meets Criteria</b>	
				Seismic Slope Stability, LS:		<b>Meets Criteria</b>	
<b>Reach Description</b>				<b>Reach Overview</b>			
Station Limits: 555+70 to 569+50 Feature(s) at Upstream Station Limit: Southern end of Phase 1 LSRP drained seepage berm (at oak trees) Feature(s) at Downstream Station Limit: Northern end of Phase 1 LSRP drained seepage berm (at oak trees) Approx. Crown Elevation Range (feet, NAVD88): 29 to 30 Approx. Levee Height Range (feet): 18 to 19 Approx. Crown Width Range (feet): 16 to 27 Approx. Landside Slope (H:V) Range: 3:1 to 3:1 Approx. Waterside Slope (H:V) Range: 1.5:1 to 3:1 Waterside Constraint(s): Waterside bench from STA 565+00 to 569+50 Landside Constraint(s): None - agricultural land Landside repairs associated with PL84-99: Yes, berm constructed from STA 555+70 to 564+00 Improvements associated with LSRP P1: Drained Seepage Berm Improvements associated with LSRP P2: None Proposed Improvements associated with LSRP P3: Chimney Drain

<b>Generalized Subsurface Conditions</b>							
Levee Prism Soils: Clayey SILT to SAND Landside Surface Layer: Silty SAND, approx. 2 feet thick at toe of levee Soils below surface layer: Approx. 21 feet of Lean CLAY, over interbedded layers of Silty SAND, Lean CLAY and SAND							
<b>Historic Performance</b>							
Extensive seepage and landside boils were reported in ULE's 2014 SGDR Addendum. An approximate 400 foot wide levee breach was reported between STA 560+00 to 564+00 associated with the 1950 flood event. Waterside erosion was reported at two locations during the 1997 event.							
<b>Liquefiable Soils</b>							
Based on our liquefaction assessment, we are not considering liquefiable soils in our slope stability analyses.							
<b>Seepage Analysis Results</b>							
Station	Water Surface	Figure	Exit Gradient**			Through Seepage	Breakout Height (ft)*
			Levee Toe	Toe of Berm	Field		
<b>557+50</b>	200-Year	E-39-B	No Positive Gradient	0.09	---	No	n/a

HTOL	E-39-C	No Positive Gradient	0.11	---	n/a	n/a
*Vertical distance from the toe of the levee (ground surface) to where the phreatic surface is calculated to day light on the levee slope. Through seepage under HTOL conditions are not part of this evaluation. **Exit Gradient includes 3D effects							
<b>Slope Stability Analysis Results</b>							
Station	Case Analyzed	Water Surface (ft)	Figure	Factor of Safety (Circular)		Factor of Safety (Non-Circular)	
				Waterside	Landside	Waterside	Landside
<b>557+50</b>	SS - 200yr	24.6	E-39-D	---	2.1	n/a	n/a
	SS - HTOL	26.0	E-39-E	---	2.2	n/a	n/a
	RDD	15.6	E-39-D	1.6	---	n/a	n/a
	PS	5.3	E-39-F	1.1	1.4	n/a	n/a
	Post-EQ	n/a	n/a	n/a	n/a	n/a	n/a

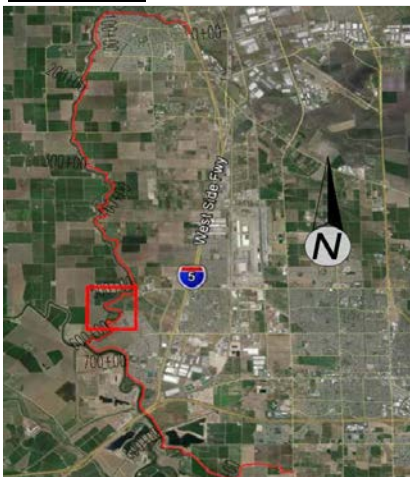
<b>REACH J3C - STA 564+00</b>							
<b>Based on our evaluation, this reach meets the ULDC Criteria.</b>							
<b>Seepage Evaluation Summary</b>				<b>Slope Stability Evaluation Summary</b>			
200-Year DWSEL, Under Seepage:		<b>Meets Criteria</b>		Steady State Seepage 200-Year DWSEL, LS:		<b>Meets Criteria</b>	
200-Year DWSEL, Through Seepage:		<b>Meets Criteria</b>		Steady State Seepage HTOL, LS:		<b>Meets Criteria</b>	
HTOL, Under Seepage:		<b>Meets Criteria</b>		Rapid Drawdown, WS:		<b>Meets Criteria</b>	
				Seismic Slope Stability, WS:		<b>Meets Criteria</b>	
				Seismic Slope Stability, LS:		<b>Meets Criteria</b>	
<b>Reach Description</b>				<b>Reach Overview</b>			
Station Limits: 555+70 to 569+50 Feature(s) at Upstream Station Limit: Southern end of Phase 1 LSRP drained seepage berm (at oak trees) Feature(s) at Downstream Station Limit: Northern end of Phase 1 LSRP drained seepage berm (at oak trees) Approx. Crown Elevation Range (feet, NAVD88): 29 to 30 Approx. Levee Height Range (feet): 18 to 19 Approx. Crown Width Range (feet): 16 to 27 Approx. Landside Slope (H:V) Range: 3:1 to 3:1 Approx. Waterside Slope (H:V) Range: 1.5:1 to 3:1 Waterside Constraint(s): Waterside bench from STA 565+00 to 569+50 Landside Constraint(s): None - agricultural land Landside repairs associated with PL84-99: Yes, berm constructed from STA 555+70 to 564+00 Improvements associated with LSRP P1: Drained Seepage Berm Improvements associated with LSRP P2: None Proposed Improvements associated with LSRP P3: Chimney Drain

<b>Generalized Subsurface Conditions</b>							
Levee Prism Soils: Clayey SILT to SAND Landside Surface Layer: Silty SAND, approx. 2 feet thick at toe of levee Soils below surface layer: Approx. 21 feet of Lean CLAY, over interbedded layers of Silty SAND, Lean CLAY and SAND							
<b>Historic Performance</b>							
Extensive seepage and landside boils were reported in ULE's 2014 SGDR Addendum. An approximate 400 foot wide levee breach was reported between STA 560+00 to 564+00 associated with the 1950 flood event. Waterside erosion was reported at two locations during the 1997 event.							
<b>Liquefiable Soils</b>							
Based on our liquefaction assessment, we are not considering liquefiable soils in our slope stability analyses.							
<b>Seepage Analysis Results</b>							
Station	Water Surface	Figure	Exit Gradient**			Through Seepage	Breakout Height (ft)*
			Levee Toe	Toe of Berm	Field		
<b>564+00</b>	200-Year	E-40-B	No Positive Gradient	0.32	---	No	n/a

HTOL	E-40-C	No Positive Gradient	0.36	---	n/a	n/a
*Vertical distance from the toe of the levee (ground surface) to where the phreatic surface is calculated to daylight on the levee slope. Through seepage under HTOL conditions are not part of this evaluation. **Exit Gradient includes 3D effects							
<b>Slope Stability Analysis Results</b>							
Station	Case Analyzed	Water Surface (ft)	Figure	Factor of Safety (Circular)		Factor of Safety (Non-Circular)	
				Waterside	Landside	Waterside	Landside
<b>564+00</b>	SS - 200yr	24.7	E-40-D	---	2.1	n/a	n/a
	SS - HTOL	26.2	E-40-E	---	2.1	n/a	n/a
	RDD	15.6	E-40-D	1.5	---	n/a	n/a
	PS	5.3	E-40-F	1.3	1.6	n/a	n/a
	Post-EQ	n/a	n/a	n/a	n/a	n/a	n/a

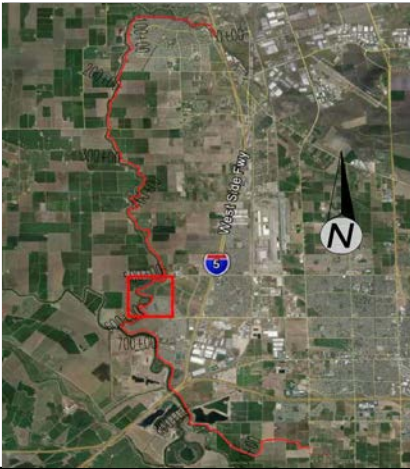
<b>REACH J4A - STA 573+10</b>							
<b>Based on our evaluation, this reach meets the ULDC Criteria.</b>							
<b>Seepage Evaluation Summary</b>				<b>Slope Stability Evaluation Summary</b>			
200-Year DWSEL, Under Seepage:	<b>Meets Criteria</b>			Steady State Seepage 200-Year DWSEL, LS:	<b>Meets Criteria</b>		
200-Year DWSEL, Through Seepage:	<b>Meets Criteria</b>			Steady State Seepage HTOL, LS:	<b>Meets Criteria</b>		
HTOL, Under Seepage:	<b>Meets Criteria</b>			Rapid Drawdown, WS:	<b>Meets Criteria</b>		
				Seismic Slope Stability, WS:	<b>Meets Criteria</b>		
				Seismic Slope Stability, LS:	<b>Meets Criteria</b>		
<b>Reach Description</b>				<b>Reach Overview</b>			
Station Limits: 569+50 to 574+50 Feature(s) at Upstream Station Limit: Levee access ramp, Begin north end of Phase II landside berm/trench for J4B Feature(s) at Downstream Station Limit: Southern end of Phase I LSRP drained seepage berm (at oak trees) Approx. Crown Elevation Range (feet, NAVD88): 29.5 to 30.5 Approx. Levee Height Range (feet): 15 to 17 Approx. Crown Width Range (feet): 40 to 42 Approx. Landside Slope (H:V) Range: 3:1 to 3:1 Approx. Waterside Slope (H:V) Range: 2:1 to 2:1 Waterside Constraint(s): Approx. 40 ft wide waterside bench at downstream end Landside Constraint(s): Oak trees Landside repairs associated with PL84-99: None Improvements associated with LSRP P1: None Improvements associated with LSRP P2: None Proposed Improvements associated with LSRP P3: Drained seepage berm with chimney

<b>Generalized Subsurface Conditions</b>							
Levee Prism Soils: Silty SAND to Silty CLAY Landside Surface Layer: Lean CLAY, approx. 24 feet thick at toe of levee Soils below surface layer: Approx. 4 feet of Silty SAND, over 12 feet of Lean CLAY, over 32 feet of SAND, over 28 feet of Lean CLAY							
<b>Historic Performance</b>							
Seepage and landside boils during the 1986 and 1997 flood events were reported in ULE's 2014 SGDR Addendum							
<b>Liquefiable Soils</b>							
Based on our liquefaction assessment, we are not considering liquefiable soils in our slope stability analyses.							
<b>Seepage Analysis Results</b>							
Station	Water Surface	Figure	Exit Gradient			Through Seepage	Breakout Height (ft)*
			Levee Toe	Toe of Berm	Field		
573+10	200-Year	E-41-B	0.09	0.34	---	No	n/a
	HTOL	E-41-C	0.13	0.39	---	n/a	n/a
*Vertical distance from the toe of the levee (ground surface) to where the phreatic surface is calculated to daylight on the levee slope. Through seepage under HTOL conditions are not part of this evaluation.

<b>Slope Stability Analysis Results</b>							
Station	Case Analyzed	Water Surface (ft)	Figure	Factor of Safety (Circular)		Factor of Safety (Non-Circular)	
				Waterside	Landside	Waterside	Landside
573+10	SS - 200yr	24.9	E-41-D	---	2.3	n/a	n/a
	SS - HTOL	26.5	E-41-E	---	2.3	n/a	n/a
	RDD	15.8	E-41-D	1.5	---	n/a	n/a
	PS	5.3	E-41-F	1.2	1.8	n/a	n/a
	Post-EQ	n/a	n/a	n/a	n/a	n/a	n/a

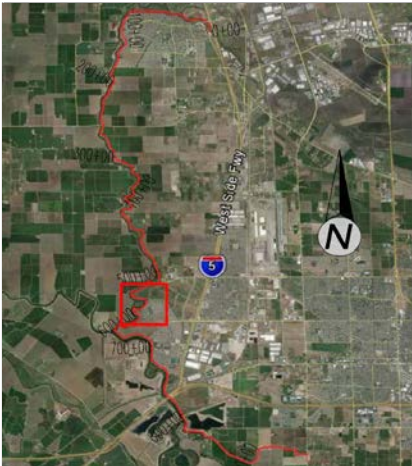
## 10.42 PROJECT REACH J4B, STATION 579+70

<b>REACH J4B - STA 579+70</b>							
<b>Based on our evaluation, this reach meets the ULDC Criteria.</b>							
<b>Seepage Evaluation Summary</b>				<b>Slope Stability Evaluation Summary</b>			
200-Year DWSEL, Under Seepage:		<b>Meets Criteria</b>		Steady State Seepage 200-Year DWSEL, LS:		<b>Meets Criteria</b>	
200-Year DWSEL, Through Seepage:		<b>Meets Criteria</b>		Steady State Seepage HTOL, LS:		<b>Meets Criteria</b>	
HTOL, Under Seepage:		<b>Meets Criteria</b>		Rapid Drawdown, WS:		<b>Meets Criteria</b>	
				Seismic Slope Stability, WS:		<b>Meets Criteria</b>	
				Seismic Slope Stability, LS:		<b>Meets Criteria</b>	
<b>Reach Description</b>				<b>Reach Overview</b>			
Station Limits: 574+50 to 585+50 Feature(s) at Upstream Station Limit: Landside park/begin waterside bench  Feature(s) at Downstream Station Limit: Levee access ramp, Begin north end of Phase II landside berm/trench for J4B Approx. Crown Elevation Range (feet, NAVD88): 30 to 30.5 Approx. Levee Height Range (feet): 17 to 22 Approx. Crown Width Range (feet): 26 to 32 Approx. Landside Slope (H:V) Range: 2.1:1 to 3:1 Approx. Waterside Slope (H:V) Range: 1.8:1 to 2.8:1 Waterside Constraint(s): None Landside Constraint(s): Lathrop Road and residential improvements Landside repairs associated with PL84-99: None Improvements associated with LSRP P1: None Improvements associated with LSRP P2: Drainage trench, drained seepage berm, Proposed Improvements associated with LSRP P3: None

<b>Generalized Subsurface Conditions</b>							
Levee Prism Soils: SILT to Silty SAND Landside Surface Layer: Lean CLAY and SILT, approx. 15 feet thick at toe of seepage berm Soils below surface layer: Interbedded layers of Silty SAND and Lean CLAY							
<b>Historic Performance</b>							
No events were reported in ULE's 2014 SGDR Addendum.							
<b>Liquefiable Soils</b>							
Based on our liquefaction assessment, we are not considering liquefiable soils in our slope stability analyses							
<b>Seepage Analysis Results</b>							
Station	Water Surface	Figure	Exit Gradient			Through Seepage	Breakout Height (ft)*
			Levee Toe	Toe of Berm	Field		
579+70	200-Year	E-42-B	No Positive Gradient	0.30	---	No	n/a
	HTOL	E-42-C	No Positive Gradient	0.34	---	n/a	n/a
*Vertical distance from the toe of the levee (ground surface) to where the phreatic surface is calculated to daylight on the levee slope. Through seepage under HTOL conditions are not part of this evaluation.

<b>Slope Stability Analysis Results</b>							
Station	Case Analyzed	Water Surface	Figure	Factor of Safety (Circular)		Factor of Safety (Non-Circular)	
				Waterside	Landside	Waterside	Landside
579+70	SS - 200yr	25.0	E-42-D	---	2.2	n/a	n/a
	SS - HTOL	26.6	E-42-E	---	2.1	n/a	n/a
	RDD	15.9	E-42-D	1.7	---	n/a	n/a
	PS	5.3	E-42-F	1.2	1.5	n/a	n/a
	Post-EQ	n/a	n/a	n/a	n/a	n/a	n/a

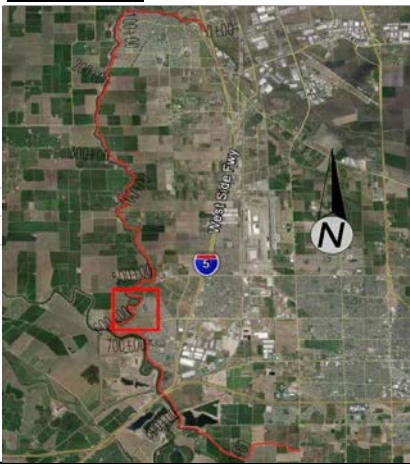
**10.43 PROJECT REACH K, STATION 17+00**

<b>Reach K - STA 017+00 {600+00}</b>							
<b>Based on our evaluation, this reach meets the ULDC Criteria.</b>							
<b>Seepage Evaluation Summary</b>				<b>Slope Stability Evaluation Summary</b>			
200-Year DWSEL, Under Seepage:		<b>Meets Criteria</b>		Steady State Seepage 200-Year DWSEL, LS:		<b>Meets Criteria</b>	
200-Year DWSEL, Through Seepage:		<b>Meets Criteria</b>		Steady State Seepage HTOL, LS:		<b>Meets Criteria</b>	
HTOL, Under Seepage:		<b>Meets Criteria</b>		Rapid Drawdown, WS:		<b>Meets Criteria</b>	
				Siesmic Slope Stability, WS:		<b>Meets Criteria</b>	
				Seismic Slope Stability, LS:		<b>Meets Criteria</b>	
<b>Reach Description</b>				<b>Reach Overview</b>			
Station Limits: 585+50 to 608+00  Feature(s) at Upstream Station Limit: Approx. 400 ft west of Old Wharf Court Feature(s) at Downstream Station Limit: Seepage berm, drainage trench, and chimney drain, Approx. 200 ft northwest Approx. Crown Elevation Range (feet, NAVD88): 30 to 30.5 Approx. Levee Height Range (feet): 16 to 18 Approx. Crown Width Range (feet): 20 to 20 Approx. Landside Slope (H:V) Range: 3:1 to 3:1 Approx. Waterside Slope (H:V) Range: 3:1 to 3:1 Waterside Constraint(s): Agricultural land between existing levee and setback levee Landside Constraint(s): None - agricultural land. Landside repairs associated with PL84-99: Drained seepage berm from STA 591+00 Improvements associated with LSRP P1: None Improvements associated with LSRP P2: None Proposed Improvements associated with LSRP P3: Setback levee with cutoff wall

<b>Generalized Subsurface Conditions</b> Levee Prism Soils: Engineered Levee Fill Landside Surface Layer: Lean CLAY at setback levee toe, approx. 2 feet thick Soils below surface layer: Clayey SAND over Lean CLAY and Poorly Graded SAND with SILT							
<b>Historic Performance</b> Heavy seepage and landside boils adjacent to existing levee during 1997 flood event were reported in ULE's 2014 SGDR Addendum.							
<b>Liquefiable Soils</b> Based on our liquefaction assessment, we are not considering liquefiable soils in our slope stability analyses.							
<b>Seepage Analysis Results</b>							
Station	Water Surface	Figure	Exit Gradient			Through Seepage	Breakout Height (ft)*
			Levee Toe	Toe of Berm	Field		
017+00	200-Year	E-43-B	0.30	---	---	Yes**	1.5
600+00	HTOL	E-43-C	0.35	---	---	n/a	n/a
*Vertical distance from the toe of the levee (ground surface) to where the phreatic surface is calculated to daylight on the levee slope. Through seepage under HTOL conditions are not part of this evaluation. **Exits onto engineered fine grained setback levee fill slope, therefore we report "meets criteria" for through seepage.

<b>Slope Stability Analysis Results</b>							
Station	Case Analyzed	Water Surface (ft)	Figure	Factor of Safety (Circular)		Factor of Safety (Non-Circular)	
				Waterside	Landside	Waterside	Landside
017+00 {	SS - 200yr	25.1	E-43-D	---	1.8	n/a	n/a
	SS - HTOL	26.7	E-43-E	---	1.7	n/a	n/a
	RDD	15.9	E-43-D	2.1	---	n/a	n/a
	PS	5.3	E-43-F	1.8	1.8	n/a	n/a
	Post-EQ	n/a	n/a	n/a	n/a	n/a	n/a

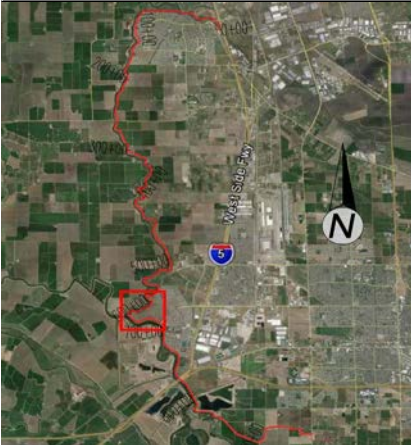
### 10.46 PROJECT REACH L1, STATION 631+50

<b>REACH L1 - STA 631+50</b>							
<b>Based on our evaluation, this reach meets the ULDC Criteria.</b>							
<b>Seepage Evaluation Summary</b>				<b>Slope Stability Evaluation Summary</b>			
200-Year DWSEL, Under Seepage:		<b>Meets Criteria</b>		Steady State Seepage 200-Year DWSEL, LS:		<b>Meets Criteria</b>	
200-Year DWSEL, Through Seepage:		<b>Meets Criteria</b>		Steady State Seepage HTOL, LS:		<b>Meets Criteria</b>	
HTOL, Under Seepage:		<b>Meets Criteria</b>		Rapid Drawdown, WS:		<b>Meets Criteria</b>	
				Seismic Slope Stability, WS:		<b>Meets Criteria</b>	
				Seismic Slope Stability, LS:		<b>Meets Criteria</b>	
<b>Reach Description</b>				<b>Reach Overview</b>			
Station Limits: 608+00 to 655+00 Feature(s) at Upstream Station Limit: Agricultural land Feature(s) at Downstream Station Limit: Transition to setback levee (Reach K) Approx. Crown Elevation Range (feet, NAVD88): 30 to 31.5 Approx. Levee Height Range (feet): 15.5 to 24.5 Approx. Crown Width Range (feet): 14 to 67 Approx. Landside Slope (H:V) Range: 1.9:1 to 3.6:1 Approx. Waterside Slope (H:V) Range: 1.2:1 to 5:1 Waterside Constraint(s): Waterside bench from approximately STA 625+00 to 636+00 Landside Constraint(s): None - agricultural land Landside repairs associated with PL84-99: Yes. Berms at STA 610+50 to 619+50 and 640+00 to 650+00. Improvements associated with LSRP P1: None Improvements associated with LSRP P2: None Proposed Improvements associated with LSRP P3: Cutoff Wall

<b>Generalized Subsurface Conditions</b>							
Levee Prism Soils: 15 to 20 feet of Silty SAND, Lean Clay and Sandy SILT Landside Surface Layer: Lean CLAY to Clayey SILT, approx. 6-12 feet thick at toe of levee Soils below surface layer: Approx. 35-40 feet of SAND to Silty Sand (w/occasional clay lenses), over Lean CLAY							
<b>Historic Performance</b>							
Extensive seepage and landside boils (1986 & 1997), a waterside slide (1997 - STA 646+00) and waterside scour (1997, 2006) were reported in ULE's 2014 SGDR Addendum.							
<b>Liquefiable Soils</b>							
Based on our liquefaction assessment, we identified potentially liquefiable soils within this Reach (Refer to Appendix E and Appendix F)							
<b>Seepage Analysis Results</b>							
Station	Water Surface	Figure	Exit Gradient**			Through Seepage	Breakout Height (ft)*
			Levee Toe	Toe of Berm	Field		
<b>631+50</b>	200-Year	E-46-B	0.17	---	0.21	No	n/a

HTOL	E-46-C	0.19	---	0.22	n/a	n/a
*Vertical distance from the toe of the levee (ground surface) to where the phreatic surface is calculated to daylight on the levee slope. Through seepage under HTOL conditions are not part of this evaluation. **Exit Gradient includes 3D effects							
<b>Slope Stability Analysis Results</b>							
Station	Case Analyzed	Water Surface	Figure	Factor of Safety (Circular)		Factor of Safety (Non-Circular)	
				Waterside	Landside	Waterside	Landside
<b>631+50</b>	SS - 200yr	25.6	E-46-D/E	---	1.8	---	1.8
	SS - HTOL	27.4	E-46-F	---	1.7	---	1.8
	RDD	16.2	E-46-D/E	1.9	---	2.2	---
	PS	5.3	E-46-G/H	1.5	1.3	1.6	1.5
	Post-EQ	5.3	E-46-I/J	1.2	1.7	1.2	2.0

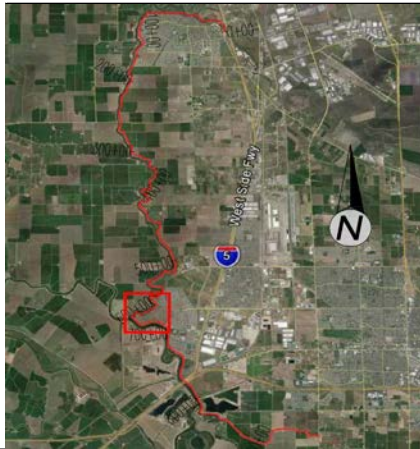
### 10.47 PROJECT REACH L1, STATION 644+00

<b>REACH L1 - STA 644+00</b>							
<b>Based on our evaluation, this reach meets the ULDC Criteria.</b>							
<b>Seepage Evaluation Summary</b>				<b>Slope Stability Evaluation Summary</b>			
200-Year DWSEL, Under Seepage:		<b>Meets Criteria</b>		Steady State Seepage 200-Year DWSEL, LS:		<b>Meets Criteria</b>	
200-Year DWSEL, Through Seepage:		<b>Meets Criteria</b>		Steady State Seepage HTOL, LS:		<b>Meets Criteria</b>	
HTOL, Under Seepage:		<b>Meets Criteria</b>		Rapid Drawdown, WS:		<b>Meets Criteria</b>	
				Seismic Slope Stability, WS:		<b>Meets Criteria</b>	
				Seismic Slope Stability, LS:		<b>Meets Criteria</b>	
<b>Reach Description</b>				<b>Reach Overview</b>			
Station Limits: 608+00 to 655+00 Feature(s) at Upstream Station Limit: Agricultural land Feature(s) at Downstream Station Limit: Transition to setback levee (Reach K) Approx. Crown Elevation Range (feet, NAVD88): 30 to 31.5 Approx. Levee Height Range (feet): 15.5 to 24.5 Approx. Crown Width Range (feet): 14 to 67 Approx. Landside Slope (H:V) Range: 1.9:1 to 3.6:1 Approx. Waterside Slope (H:V) Range: 1.2:1 to 5:1 Waterside Constraint(s): Waterside bench from approximately STA 625+00 to 636+00 Landside Constraint(s): None - agricultural land Landside repairs associated with PL84-99: Yes. Berms at STA 610+50 to 619+50 and 640+00 to 650+00. Improvements associated with LSRP P1: None Improvements associated with LSRP P2: None Proposed Improvements associated with LSRP P3: Cutoff Wall

<b>Generalized Subsurface Conditions</b>							
Levee Prism Soils: 15 to 20 feet of Silty SAND, Lean Clay and Sandy SILT Landside Surface Layer: Lean CLAY to Clayey SILT, approx. 6-12 feet thick at toe of levee Soils below surface layer: Approx. 35-40 feet of SAND to Silty Sand (w/occasional clay lenses), over Lean CLAY							
<b>Historic Performance</b>							
Extensive seepage and landside boils (1986 & 1997), a waterside slide (1997 - STA 646+00) and waterside scour (1997, 2006) were reported in ULE's 2014 SGDR Addendum.							
<b>Liquefiable Soils</b>							
Based on our liquefaction assessment, we identified potentially liquefiable soils within this Reach (Refer to Appendix E and Appendix F)							
<b>Seepage Analysis Results</b>							
Station	Water Surface	Figure	Exit Gradient			Through Seepage	Breakout Height (ft)*
			Levee Toe	Toe of Berm	Field		
<b>644+00</b>	200-Year	E-47-B	No Positive Gradient	---	0.01	No	n/a

HTOL	E-47-C	No Positive Gradient	---	0.02	n/a	n/a
*Vertical distance from the toe of the levee (ground surface) to where the phreatic surface is calculated to daylight on the levee slope. Through seepage under HTOL conditions are not part of this evaluation.							
<b>Slope Stability Analysis Results</b>							
Station	Case Analyzed	Water Surface	Figure	Factor of Safety (Circular)		Factor of Safety (Non-Circular)	
				Waterside	Landside	Waterside	Landside
<b>644+00</b>	SS - 200yr	25.8	E-47-D/E	---	3.1	---	3.4
	SS - HTOL	27.6	E-47-F	---	3.1	---	3.3
	RDD	16.3	E-47-D/E	2.7	---	2.4	---
	PS	5.3	E-47-G/H	1.6	2.1	1.7	2.4
	Post-EQ	5.3	E-47-I/J	1.8	3.1	1.7	5.3

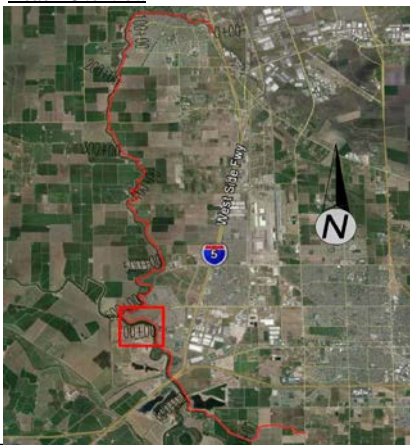
### 10.48 PROJECT REACH L2, STATION 658+00

<b>REACH L2 - STA 658+00</b>							
<b>Based on our evaluation, this reach meets the ULDC Criteria.</b>							
<b>Seepage Evaluation Summary</b>				<b>Slope Stability Evaluation Summary</b>			
200-Year DWSEL, Under Seepage:		<b>Meets Criteria</b>		Steady State Seepage 200-Year DWSEL, LS:		<b>Meets Criteria</b>	
200-Year DWSEL, Through Seepage:		<b>Meets Criteria</b>		Steady State Seepage HTOL, LS:		<b>Meets Criteria</b>	
HTOL, Under Seepage:		<b>Meets Criteria</b>		Rapid Drawdown, WS:		<b>Meets Criteria</b>	
				Seismic Slope Stability, WS:		<b>Meets Criteria</b>	
				Seismic Slope Stability, LS:		<b>Meets Criteria</b>	
<b>Reach Description</b>				<b>Reach Overview</b>			
Station Limits: 655+00 to 703+00 Feature(s) at Upstream Station Limit: Transition to Phase II Seepage Berm Feature(s) at Downstream Station Limit: Agricultural land Approx. Crown Elevation Range (feet, NAVD88): 31 to 32 Approx. Levee Height Range (feet): 13 to 19 Approx. Crown Width Range (feet): 13 to 35 Approx. Landside Slope (H:V) Range: 2:1 to 3:1 Approx. Waterside Slope (H:V) Range: 1.5:1 to 3.2:1 Waterside Constraint(s): River Islands Parkway Bridge (Approx. STA 689+00) Landside Constraint(s): Landside improvements (residential, approach fills, etc.) between approx. Waterside repairs associated with PL84-99: Riprap waterside (2006) Improvements associated with LSRP P1: None Improvements associated with LSRP P2: None Proposed Improvements associated with LSRP P3: Cutoff Wall

<b>Generalized Subsurface Conditions</b>							
Levee Prism Soils: Silty SAND to SAND Landside Surface Layer: Lean CLAY, approx. 5 to 10 feet thick at toe of levee Soils below surface layer: Approx. 15 to 20 feet of Silty SAND, over 25 to 30 feet of Poorly Graded SAND							
<b>Historic Performance</b>							
Seepage and landside boils (STA 668+00 to 669+00) during 1997 flood event and waterside erosion (STA 699+71 to 700+51) during 2006 flood event were reported in ULE's 2014 SGDR Addendum.							
<b>Liquefiable Soils</b>							
Based on our liquefaction assessment, we are not considering liquefiable soils in our slope stability analysis in the vicinity of 658+00. Refer to the tables for 684+50 and 700+00 for areas of Reach L2, where our liquefaction assessment indicates potentially liquefiable soils exist.							
<b>Seepage Analysis Results</b>							
Station	Water Surface	Figure	Exit Gradient**			Through Seepage	Breakout Height (ft)*

Levee Toe	Toe of Berm	Field		
<b>658+00</b>	200-Year	E-48-B	0.11	---	---	No	n/a
	HTOL	E-48-C	0.12	---	---	n/a	n/a
*Vertical distance from the toe of the levee (ground surface) to where the phreatic surface is calculated to daylight on the levee slope. Through seepage under HTOL conditions are not part of this evaluation. **Exit Gradient includes 3D effects							
<b>Slope Stability Analysis Results</b>							
Station	Case Analyzed	Water Surface (ft)	Figure	Factor of Safety (Circular)		Factor of Safety (Non-Circular)	
				Waterside	Landside	Waterside	Landside
<b>658+00</b>	SS - 200yr	25.8	E-48-D/E	---	1.5	---	1.7
	SS - HTOL	27.6	E-48-F	---	1.5	---	1.6
	RDD	16.1	E-48-D/E	1.7	---	1.7	---
	PS	5.3	E-48-G/H	1.3	1.2	1.3	1.4
	Post-EQ	n/a	n/a	n/a	n/a	n/a	n/a

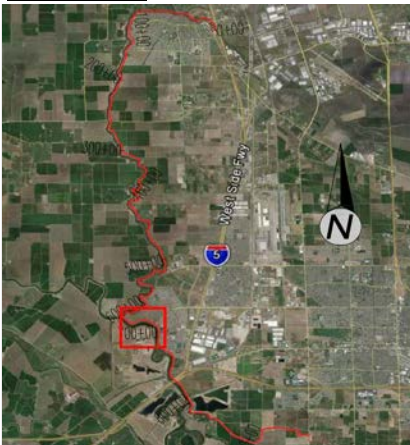
### 10.49 PROJECT REACH L2, STATION 671+00

<b>REACH L2 - STA 671+00</b>								
<b>Based on our evaluation, this reach meets the ULDC Criteria.</b>								
<b>Seepage Evaluation Summary</b>			<b>Slope Stability Evaluation Summary</b>					
200-Year DWSEL, Under Seepage:	<b>Meets Criteria</b>		Steady State Seepage 200-Year DWSEL, LS:	<b>Meets Criteria</b>				
200-Year DWSEL, Through Seepage:	<b>Meets Criteria</b>		Steady State Seepage HTOL, LS:	<b>Meets Criteria</b>				
HTOL, Under Seepage:	<b>Meets Criteria</b>		Rapid Drawdown, WS:	<b>Meets Criteria</b>				
			Seismic Slope Stability, WS:	<b>Meets Criteria</b>				
			Seismic Slope Stability, LS:	<b>Meets Criteria</b>				
<b>Reach Description</b>			<b>Reach Overview</b>					
Station Limits: 655+00 to 703+00 Feature(s) at Upstream Station Limit: Transition to Phase II Seepage Berm Feature(s) at Downstream Station Limit: Agricultural land Approx. Crown Elevation Range (feet, NAVD88): 31 to 32 Approx. Levee Height Range (feet): 13 to 19 Approx. Crown Width Range (feet): 13 to 35 Approx. Landside Slope (H:V) Range: 2:1 to 3:1 Approx. Waterside Slope (H:V) Range: 1.5:1 to 3.2:1 Waterside Constraint(s): River Islands Parkway Bridge (Approx. STA 689+00) Landside Constraint(s): Landside improvements (residential, approach fills, etc.) between approx. Waterside repairs associated with PL84-99: Riprap waterside (2006) Improvements associated with LSRP P1: None Improvements associated with LSRP P2: None Proposed Improvements associated with LSRP P3: Cutoff Wall

<b>Generalized Subsurface Conditions</b>								
Levee Prism Soils: Silty SAND to SAND Landside Surface Layer: Lean CLAY, approx. 5 to 10 feet thick at toe of levee Soils below surface layer: Approx. 15 to 20 feet of Silty SAND, over 25 to 30 feet of Poorly Graded SAND								
<b>Historic Performance</b>								
Seepage and landside boils (STA 668+00 to 669+00) during 1997 flood event and waterside erosion (STA 699+71 to 700+51) during 2006 flood event were reported in ULE's 2014 SGDR Addendum.								
<b>Liquefiable Soils</b>								
Based on our liquefaction assessment, we are not considering liquefiable soils in our slope stability analysis in the vicinity of 671+00. Refer to the tables for 684+50 and 700+00 for areas of Reach L2, where our liquefaction assessment indicates potentially liquefiable soils exist.								
<b>Seepage Analysis Results</b>								
Station	Water Surface	Figure	Exit Gradient			Through Seepage	Breakout Height (ft)*

Levee Toe	Toe of Berm	Field			
<b>671+00</b>	200-Year	E-49-B	0.02	---	0.05	No	n/a	
	HTOL	E-49-C	0.04	---	0.05	n/a	n/a	
*Vertical distance from the toe of the levee (ground surface) to where the phreatic surface is calculated to daylight on the levee slope. Through seepage under HTOL conditions are not part of this evaluation.								
<b>Slope Stability Analysis Results</b>								
Station	Case Analyzed	Water Surface	Figure	Factor of Safety (Circular)		Factor of Safety (Non-Circular)		
				Waterside	Landside	Waterside	Landside	
<b>671+00</b>	SS - 200yr	26.2	E-49-D/E	---	1.5	---	1.6	
	SS - HTOL	28.1	E-49-F	---	1.5	---	1.7	
	RDD	16.4	E-49-D/E	2.2	---	2.3	---	
	PS	5.3	E-49-G/H	1.7	1.2	1.8	1.4	
	Post-EQ	n/a	n/a	n/a	n/a	n/a	n/a

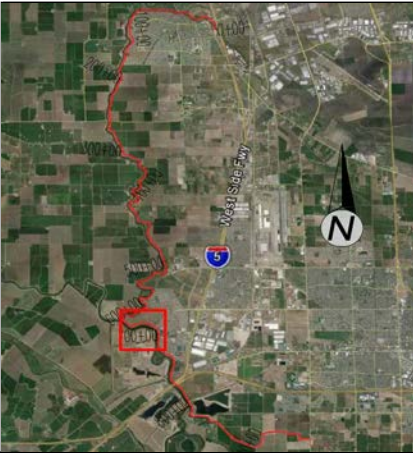
## 10.50 PROJECT REACH L2, STATION 684+50

<b>REACH L2 - STA 684+50</b>							
<b>Based on our evaluation, this reach meets the ULDC Criteria.</b>							
<b>Seepage Evaluation Summary</b>				<b>Slope Stability Evaluation Summary</b>			
200-Year DWSEL, Under Seepage:		<b>Meets Criteria</b>		Steady State Seepage 200-Year DWSEL, LS:		<b>Meets Criteria</b>	
200-Year DWSEL, Through Seepage:		<b>Meets Criteria</b>		Steady State Seepage HTOL, LS:		<b>Meets Criteria</b>	
HTOL, Under Seepage:		<b>Meets Criteria</b>		Rapid Drawdown, WS:		<b>Meets Criteria</b>	
				Seismic Slope Stability, WS:		<b>Meets Criteria</b>	
				Seismic Slope Stability, LS:		<b>Meets Criteria</b>	
<b>Reach Description</b>				<b>Reach Overview</b>			
Station Limits: 655+00 to 703+00 Feature(s) at Upstream Station Limit: Transition to Phase II Seepage Berm Feature(s) at Downstream Station Limit: Agricultural land Approx. Crown Elevation Range (feet, NAVD88): 31 to 32 Approx. Levee Height Range (feet): 13 to 19 Approx. Crown Width Range (feet): 13 to 35 Approx. Landside Slope (H:V) Range: 2:1 to 3:1 Approx. Waterside Slope (H:V) Range: 1.5:1 to 3.2:1 Waterside Constraint(s): River Islands Parkway Bridge (Approx. STA 689+00) Landside Constraint(s): Landside improvements (residential, approach fills, etc.) between approx STA Waterside repairs associated with PL84-99: Riprap waterside (2006) Improvements associated with LSRP P1: None Improvements associated with LSRP P2: None Proposed Improvements associated with LSRP P3: Cutoff Wall

Generalized Subsurface Conditions Levee Prism Soils: Silty SAND to SAND Landside Surface Layer: Lean CLAY, approx. 5 to 10 feet thick at toe of levee Soils below surface layer: Approx. 15 to 20 feet of Silty SAND, over 25 to 30 feet of Poorly Graded SAND							
<b>Historic Performance</b> Seepage and landside boils (STA 668+00 to 669+00) during 1997 flood event and waterside erosion (STA 699+71 to 700+51) during 2006 flood event were reported in ULE's 2014 SGDR Addendum.							
<b>Liquefiable Soils</b> Based on our liquefaction assessment, we identified potentially liquefiable soils within this Reach (Refer to Appendix E and Appendix F)							
<b>Seepage Analysis Results</b>							
Station	Water Surface	Figure	Exit Gradient			Through Seepage	Breakout Height (ft)*
			Levee Toe	Toe of Berm	Field		
684+50	200-Year	E-50-B	No Positive Gradient	---	0.59	No	n/a
	HTOL	E-50-C	No Positive Gradient	---	0.62	n/a	n/a

*Vertical distance from the toe of the levee (ground surface) to where the phreatic surface is calculated to daylight on the levee slope. Through seepage under HTOL conditions are not part of this evaluation.							
<b>Slope Stability Analysis Results</b>							
Station	Case Analyzed	Water Surface	Figure	Factor of Safety (Circular)		Factor of Safety (Non-Circular)	
				Waterside	Landside	Waterside	Landside
684+50	SS - 200yr	26.4	E-50-D/E	---	1.9	---	2.2
	SS - HTOL	28.5	E-50-F	---	1.9	---	2.2
	RDD	16.6	E-50-D/E	2.3	---	2.4	---
	PS	5.4	E-50-G/H	1.7	1.5	1.8	1.6
	Post-EQ	5.4	E-50 - I/J	2.2	2.0	2.0	3.7

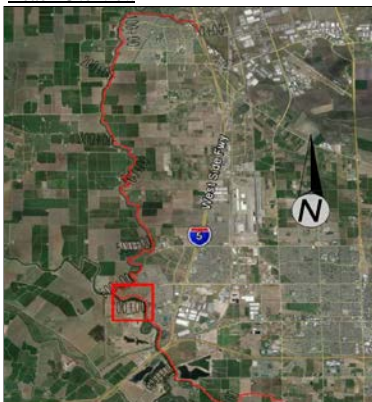
## 10.51 PROJECT REACH L2, STATION 700+00

<b>REACH L2 - STA 700+00</b>							
<b>Based on our evaluation, this reach meets the ULDC Criteria. Seismic deformations are not anticipated to degrade below 10-Year WSE+3 feet.</b>							
<b>Seepage Evaluation Summary</b>				<b>Slope Stability Evaluation Summary</b>			
200-Year DWSEL, Under Seepage:		<b>Meets Criteria</b>		Steady State Seepage 200-Year DWSEL, LS:		<b>Meets Criteria</b>	
200-Year DWSEL, Through Seepage:		<b>Meets Criteria</b>		Steady State Seepage HTOL, LS:		<b>Meets Criteria</b>	
HTOL, Under Seepage:		<b>Meets Criteria</b>		Rapid Drawdown, WS:		<b>Meets Criteria</b>	
				Seismic Slope Stability, WS:		<b>Fails Criteria</b>	
				Seismic Slope Stability, LS:		<b>Meets Criteria</b>	
<b>Reach Description</b>				<b>Reach Overview</b>			
Station Limits: 655+00 to 703+00 Feature(s) at Upstream Station Limit: Transition to Phase II Seepage Berm Feature(s) at Downstream Station Limit: Agricultural land Approx. Crown Elevation Range (feet, NAVD88): 31 to 32 Approx. Levee Height Range (feet): 13 to 19 Approx. Crown Width Range (feet): 13 to 35 Approx. Landside Slope (H:V) Range: 2:1 to 3:1 Approx. Waterside Slope (H:V) Range: 1.5:1 to 3.2:1 Waterside Constraint(s): River Islands Parkway Bridge (Approx. STA 689+00) Landside Constraint(s): Landside improvements (residential, approach fills, etc.) between approx. Waterside repairs associated with PL84-99: Riprap waterside (2006) Improvements associated with LSRP P1: None Improvements associated with LSRP P2: None Proposed Improvements associated with LSRP P3: Cutoff Wall

Generalized Subsurface Conditions Levee Prism Soils: Silty SAND to SAND Landside Surface Layer: Lean CLAY, approx 5 to 10 feet thick at toe of levee Soils below surface layer: Approx. 15 to 20 feet of Silty SAND, over 25 to 30 feet of Poorly Graded SAND							
<b>Historic Performance</b> Seepage and landside boils (STA 668+00 to 669+00) during 1997 flood event and waterside erosion (STA 699+71 to 700+51) during 2006 flood event were reported in ULEs 2014 SGDR Addendum.							
<b>Liquefiable Soils</b> Based on our liquefaction assessment, we identified potentially liquefiable soils within this Reach (Refer to Appendix E and Appendix F)							
<b>Seepage Analysis Results</b>							
Station	Water Surface	Figure	Exit Gradient			Through Seepage	Breakout Height (ft)*
			Levee Toe	Toe of Berm	Field		
700+00	200-Year	E-51-B	No Positive Gradient	---	0.12	No	n/a
	HTOL	E-51-C	No Positive Gradient	---	0.13	n/a	n/a

*Vertical distance from the toe of the levee (ground surface) to where the phreatic surface is calculated to day light on the levee slope. Through seepage under HTOL conditions are not part of this evaluation.							
<b>Slope Stability Analysis Results</b>							
Station	Case Analyzed	Water Surface (ft)	Figure	Factor of Safety (Circular)		Factor of Safety (Non-Circular)	
				Waterside	Landside	Waterside	Landside
700+00	SS - 200yr	26.7	E-51-D/E	---	2.3	---	2.5
	SS - HTOL	28.8	E-51-F	---	2.2	---	2.5
	RDD	16.9	E-51-D/E	1.6	---	1.6	---
	PS	5.4	E-51-G/H	1.4	1.7	1.4	1.8
	Post-EQ	5.4	E-51-I/J	1.0	2.3	0.9	3.0
<b>Post 200-Year Seismic Event Restoration Estimates</b>							
Reach	Damage Length (feet)	Estimated Lateral Movement (feet)	Estimated Vertical Movement (feet)	Fill Volume (10 year WSE+3 feet Freeboard) (cubic yards)	Fill Volume (Fully Restored Levee Geometry) (cubic yards)		
C3A	2,000	7	5	No Fill Anticipated	2,600

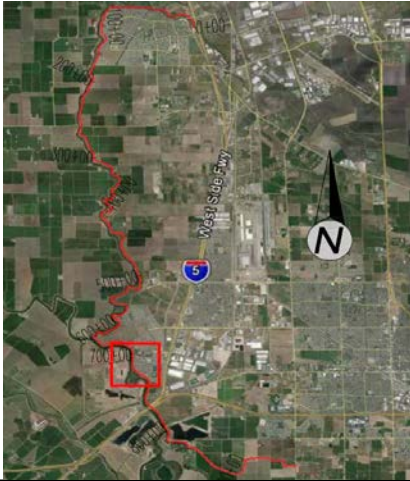
## 10.52 PROJECT REACH M1, STATION 704+92

<b>REACH M1 - STA 704+92</b>							
<b>Based on our evaluation, this reach meets ULDC criteria.</b>							
<b>Seepage Evaluation Summary</b>				<b>Slope Stability Evaluation Summary</b>			
200-Year DWSEL, Under Seepage:		<b>Meets Criteria</b>		Steady State Seepage 200-Year DWSEL, LS:		<b>Meets Criteria</b>	
200-Year DWSEL, Through Seepage:		<b>Meets Criteria</b>		Steady State Seepage HTOL, LS:		<b>Meets Criteria</b>	
HTOL, Under Seepage:		<b>Meets Criteria</b>		Rapid Drawdown, WS:		<b>Meets Criteria</b>	
				Seismic Slope Stability, WS:		<b>Meets Criteria</b>	
				Seismic Slope Stability, LS:		<b>Meets Criteria</b>	
<b>Reach Description</b>				<b>Reach Overview</b>			
Station Limits: 703+00 to 724+50 Feature(s) at Upstream Station Limit: Levee access ramp, transition to Element VI.a.3 seepage berm (Phase II) Feature(s) at Downstream Station Limit: Transition between Phase II berm and Phase II cutoff wall Approx. Crown Elevation Range (feet, NAVD88): 31.5 to 32.5 Approx. Levee Height Range (feet): 14 to 18 Approx. Crown Width Range (feet): 23 to 60 Approx. Landside Slope (H:V) Range: 3:1 to 5:1 Approx. Waterside Slope (H:V) Range: 1.3:1 to 3.2:1 Waterside Constraint(s): Waterside bench between STA 717+00 Landside Constraint(s): Phase II berm and residential development Landside repairs associated with PL84-99: Yes, berms at STA 710+00 to 713+00 and 722+00 to 724+50. Improvements associated with LSRP P1: None Improvements associated with LSRP P2: Drained seepage berm Proposed Improvements associated with LSRP P3: None

<b>Generalized Subsurface Conditions</b>							
Levee Prism Soils: Lean CLAY and Poorly Graded SAND							
Landside Surface Layer: Lean CLAY, approx. 10 feet thick at toe of levee							
Soils below surface layer: Approx. 10 to 25 feet of Silty SAND to SAND, over 20 feet of Lean CLAY							
<b>Historic Performance</b>							
Seepage and landside boils were reported in ULE's 2014 SGDR Addendum.							
<b>Liquefiable Soils</b>							
Based on our liquefaction assessment, we identified potentially liquefiable soils within this Reach (Refer to Appendix E and Appendix F)							
<b>Seepage Analysis Results</b>							
Station	Water Surface	Figure	Exit Gradient			Through Seepage	Breakout Height (ft)*
			Levee Toe	Toe of Berm	Field		
704+92	200-Year	E-52-B	No Positive Gradient	0.21	0.71	No	n/a
	HTOL	E-52-C	No Positive Gradient	0.27	0.80	n/a	n/a
*Vertical distance from the toe of the levee (ground surface) to where the phreatic surface is calculated to daylight on the levee slope. Through seepage under HTOL conditions are not part of this evaluation.

<b>Slope Stability Analysis Results</b>							
Station	Case Analyzed	Water Surface (ft)	Figure	Factor of Safety (Circular)		Factor of Safety (Non-Circular)	
				Waterside	Landside	Waterside	Landside
704+92	SS - 200yr	26.8	E-52-D	---	1.8	n/a	n/a
	SS - HTOL	28.9	E-52-E	---	1.8	n/a	n/a
	RDD	17.0	E-52-D	2.1	---	n/a	n/a
	PS	5.4	E-52-F	1.5	1.4	n/a	n/a
	Post-EQ	5.4	E-52-G/H	1.2	1.8	1.3	3.3

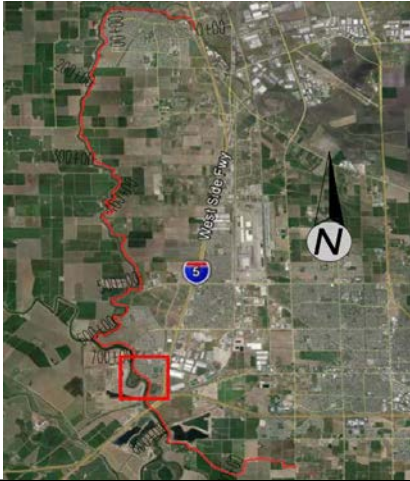
### 10.53 PROJECT REACH M2A, STATION 734+45

<b>REACH M2A - STA 734+45</b>							
<b>Based on our evaluation, this reach meets the ULDC Criteria.</b>							
<b>Seepage Evaluation Summary</b>				<b>Slope Stability Evaluation Summary</b>			
200-Year DWSEL, Under Seepage:		<b>Meets Criteria</b>		Steady State Seepage 200-Year DWSEL, LS:		<b>Meets Criteria</b>	
200-Year DWSEL, Through Seepage:		<b>Meets Criteria</b>		Steady State Seepage HTOL, LS:		<b>Meets Criteria</b>	
HTOL, Under Seepage:		<b>Meets Criteria</b>		Rapid Drawdown, WS:		<b>Meets Criteria</b>	
				Seismic Slope Stability, WS:		<b>Meets Criteria</b>	
				Seismic Slope Stability, LS:		<b>Meets Criteria</b>	
<b>Reach Description</b>				<b>Reach Overview</b>			
Station Limits: 724+50 to 741+30 Feature(s) at Upstream Station Limit: Begin Phase I drained seepage berm for Reach M2B, Sadler Oak Rd, end Feature(s) at Downstream Station Limit: Levee access ramp, transition to Element VI.a.2 seepage berm (Phase II) Approx. Crown Elevation Range (feet, NAVD88): 32 to 33 Approx. Levee Height Range (feet): 16.5 to 19 Approx. Crown Width Range (feet): 30 to 50 Approx. Landside Slope (H:V) Range: 3:1 to 3:1 Approx. Waterside Slope (H:V) Range: 1.6:1 to 4:1 Waterside Constraint(s): Waterside bench between STA 725+50 to 728+00 Landside Constraint(s): Phase II berm and residential improvements Landside repairs associated with PL84-99: Yes, berm along entire reach Improvements associated with LSRP P1: None Improvements associated with LSRP P2: Drained Seepage Berm Proposed Improvements associated with LSRP P3: None

<b>Generalized Subsurface Conditions</b>							
Levee Prism Soils: Silty SAND to Clayey SAND Landside Surface Layer: Lean CLAY, approx. 20 feet thick at toe of levee Soils below surface layer: Approx. 60 feet of Silty SAND to SAND, over Lean CLAY							
<b>Historic Performance</b>							
Seepage and flooded field conditions (STA 728+30 to 732+00) during 1997 flood event and waterside erosion (STA 737+55 to 739+45) during the 2006 flood event were reported in ULE's 2014 SGDR Addendum.							
<b>Liquefiable Soils</b>							
Based on our liquefaction assessment, we identified potentially liquefiable soils within this Reach (Refer to Appendix E and Appendix F)							
<b>Seepage Analysis Results</b>							
Station	Water Surface	Figure	Exit Gradient			Through Seepage	Breakout Height (ft)*
			Levee Toe	Toe of Berm	Field		
734+45	200-Year	E-53-B	0.07	0.51	0.67	No	n/a
	HTOL	E-53-C	0.16	0.62	0.79	n/a	n/a
*Vertical distance from the toe of the levee (ground surface) to where the phreatic surface is calculated to daylight on the levee slope. Through seepage under HTOL conditions are not part of this evaluation.

<b>Slope Stability Analysis Results</b>							
Station	Case Analyzed	Water Surface	Figure	Factor of Safety (Circular)		Factor of Safety (Non-Circular)	
				Waterside	Landside	Waterside	Landside
734+45	SS - 200yr	27.9	E-53-D	---	2.2	n/a	n/a
	SS - HTOL	30.4	E-53-E	---	2.0	n/a	n/a
	RDD	18.0	E-53-D	1.7	---	n/a	n/a
	PS	5.5	E-53-F	1.3	1.7	n/a	n/a
	Post-EQ	5.5	E-53-G/H	1.5	2.2	1.7	3.4

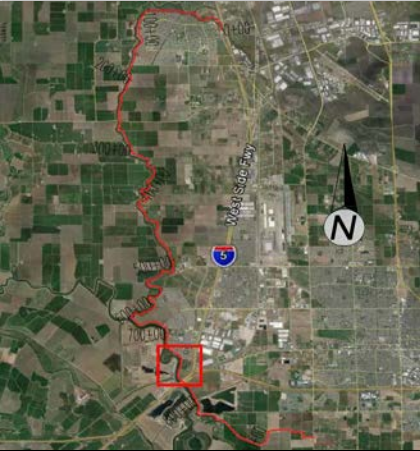
**10.54 PROJECT REACH M2B, STATION 744+73**

<b>REACH M2B - STA 744+73</b>							
<b>Based on our evaluation, this reach meets the ULDC Criteria.</b>							
<b>Seepage Evaluation Summary</b>				<b>Slope Stability Evaluation Summary</b>			
200-Year DWSEL, Under Seepage:		<b>Meets Criteria</b>		Steady State Seepage 200-Year DWSEL, LS:		<b>Meets Criteria</b>	
200-Year DWSEL, Through Seepage:		<b>Meets Criteria</b>		Steady State Seepage HTOL, LS:		<b>Meets Criteria</b>	
HTOL, Under Seepage:		<b>Meets Criteria</b>		Rapid Drawdown, WS:		<b>Meets Criteria</b>	
				Seismic Slope Stability, WS:		<b>Meets Criteria</b>	
				Seismic Slope Stability, LS:		<b>Meets Criteria</b>	
<b>Reach Description</b>				<b>Reach Overview</b>			
Station Limits: 741+30 to 760+50 Feature(s) at Upstream Station Limit: End of Phase 1 drained seepage berm Feature(s) at Downstream Station Limit: Beginning of Phase 1 drained seepage berm, Sadler Oak Rd, residential Approx. Crown Elevation Range (feet, NAVD88): 33 to 34 Approx. Levee Height Range (feet): 15 to 16.5 Approx. Crown Width Range (feet): 15 to 30 Approx. Landside Slope (H:V) Range: 1.8:1 to 2.8:1 Approx. Waterside Slope (H:V) Range: 1.8:1 to 3.1:1 Waterside Constraint(s): Waterside toe of slope at the waterway - no waterside bench. Landside Constraint(s): None - agricultural land Landside repairs associated with PL84-99: Yes - drained berms constructed Improvements associated with LSRP P1: Drained Seepage Berm Improvements associated with LSRP P2: None Proposed Improvements associated with LSRP P3: Cutoff wall

<b>Generalized Subsurface Conditions</b>							
Levee Prism Soils: Silty SAND to Lean CLAY Landside Surface Layer: Lean CLAY to SILT, approx. 6 to 12 feet thick at toe of levee Soils below surface layer: Approx. 40-feet of Silty SAND to SAND (with occasional interbedded SILT/CLAY layers), over Lean to Sandy CLAY.							
<b>Historic Performance</b>							
Seepage and landside boils during 1997 flood event were reported in ULE's 2014 SGDR Addendum.							
<b>Liquefiable Soils</b>							
Based on our liquefaction assessment, we are not considering liquefiable soils in our slope stability analyses.							
<b>Seepage Analysis Results</b>							
Station	Water Surface	Figure	Exit Gradient			Through Seepage	Breakout Height (ft)*
			Levee Toe	Toe of Berm	Field		
<b>744+73</b>	200-Year	E-54-B	No Positive Gradient	0.09	---	No	n/a
	HTOL	E-54-C	No Positive Gradient	0.11	---	n/a	n/a
*Vertical distance from the toe of the levee (ground surface) to where the phreatic surface is calculated to daylight on the levee slope. Through seepage under HTOL conditions are not part of this evaluation.

<b>Slope Stability Analysis Results</b>							
Station	Case Analyzed	Water Surface (ft)	Figure	Factor of Safety (Circular)		Factor of Safety (Non-Circular)	
				Waterside	Landside	Waterside	Landside
<b>744+73</b>	SS - 200yr	28.0	E-54-D/E	---	1.9	---	2.1
	SS - HTOL	30.6	E-54-F	---	1.9	---	2.1
	RDD	18.0	E-54-D/E	2.0	---	2.1	---
	PS	5.5	E-54-G/H	1.7	1.5	1.7	1.8
	Post-EQ	n/a	n/a	n/a	n/a	n/a	n/a

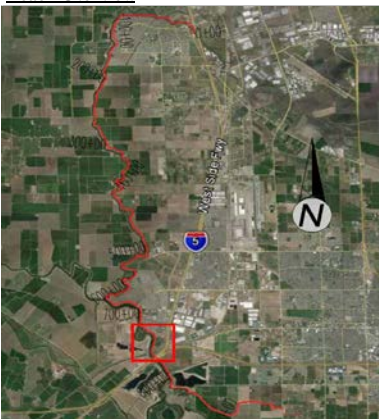
### 10.55 PROJECT REACH M2B, STATION 755+00

<b>REACH M2B - STA 755+00</b>							
<b>Based on our evaluation, this reach meets the ULDC Criteria. Seismic deformations are not anticipated to degrade below 10-Year WSE + 3 feet.</b>							
<b>Seepage Evaluation Summary</b>				<b>Slope Stability Evaluation Summary</b>			
200-Year DWSEL, Under Seepage:		<b>Meets Criteria</b>		Steady State Seepage 200-Year DWSEL, LS:		<b>Meets Criteria</b>	
200-Year DWSEL, Through Seepage:		<b>Meets Criteria</b>		Steady State Seepage HTOL, LS:		<b>Meets Criteria</b>	
HTOL, Under Seepage:		<b>Meets Criteria</b>		Rapid Drawdown, WS:		<b>Meets Criteria</b>	
				Seismic Slope Stability, WS:		<b>Fails Criteria</b>	
				Seismic Slope Stability, LS:		<b>Meets Criteria</b>	
<b>Reach Description</b>				<b>Reach Overview</b>			
Station Limits: 741+30 to 760+50 Feature(s) at Upstream Station Limit: End of Phase 1 drained seepage berm Feature(s) at Downstream Station Limit: Beginning of Phase 1 drained seepage berm, Sadler Oak Rd, residential Approx. Crown Elevation Range (feet, NAVD88): 32.5 to 34 Approx. Levee Height Range (feet): 15 to 16.5 Approx. Crown Width Range (feet): 15 to 30 Approx. Landside Slope (H:V) Range: 1.8:1 to 2.8:1 Approx. Waterside Slope (H:V) Range: 1.8:1 to 3.1:1 Waterside Constraint(s): Waterside toe of slope at the waterway - no waterside bench. Landside Constraint(s): None - agricultural land Landside repairs associated with PL84-99: Yes - drained berms constructed Improvements associated with LSRP P1: Drained Seepage Berm Improvements associated with LSRP P2: None Proposed Improvements associated with LSRP P3: Cutoff wall

<b>Generalized Subsurface Conditions</b> Levee Prism Soils: Silty SAND to Lean CLAY Landside Surface Layer: Lean CLAY to SILT, approx. 6 to 12 feet thick at toe of levee Soils below surface layer: Approx. 40 feet of Silty SAND to SAND (with occasional interbedded SILT/CLAY layers), over Lean to Sandy CLAY.							
<b>Historic Performance</b>							
Seepage and landside boils during 1997 flood event were reported in ULE's 2014 SGDR Addendum.							
<b>Liquefiable Soils</b>							
Based on our liquefaction assessment, we identified potentially liquefiable soils within this Reach (Refer to Appendix E and Appendix F)							
<b>Seepage Analysis Results</b>							
Station	Water Surface	Figure	Exit Gradient			Through Seepage	Breakout Height (ft)*
			Levee Toe	Toe of Berm	Field		
755+00	200-Year	E-55-B	No Positive Gradient	0.09	---	No	n/a
	HTOL	E-55-C	No Positive Gradient	0.12	---	n/a	n/a
*Vertical distance from the toe of the levee (ground surface) to where the phreatic surface is calculated to daylight on the levee slope. Through seepage under HTOL conditions are not part of this evaluation.

<b>Slope Stability Analysis Results</b>							
Station	Case Analyzed	Water Surface	Figure	Factor of Safety (Circular)		Factor of Safety (Non-Circular)	
				Waterside	Landside	Waterside	Landside
755+00	SS - 200yr	28.0	E-55-D/E	---	2.0	---	2.1
	SS - HTOL	30.6	E-55-F	---	2.0	---	2.3
	RDD	18.0	E-55-D/E	1.3	---	1.4	---
	PS	5.4	E-55-G/H	1.1	1.6	1.2	1.6
	Post-EQ	5.4	E-55-I/J	0.6	2.0	0.4	2.4
<b>Post 200-Year Seismic Event Restoration Estimates</b>							
Reach	Damage Length (feet)	Estimated Lateral Movement (feet)	Estimated Vertical Movement (feet)	Fill Volume (10 year WSE+3 feet Freeboard) (cubic yards)	Fill Volume (Fully Restored Levee Geometry) (cubic yards)		
M2B	1,350	7.5	5.5	No Fill Anticipated	2,100

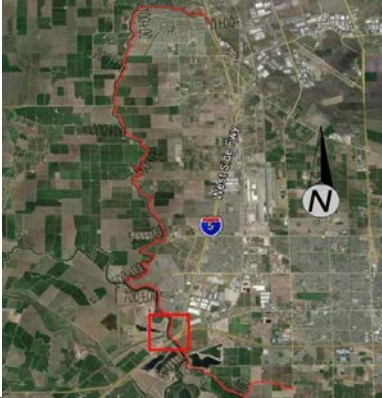
### 10.56 PROJECT REACH M3A, STATION 761+00

<b>REACH M3A - STA 761+00</b>							
<b>Based on our evaluation, this reach meets the ULDC Criteria. An Operations and Maintenance plan should be implemented for seismic deformations following the 200-year event.</b>							
<b>Seepage Evaluation Summary</b>				<b>Slope Stability Evaluation Summary</b>			
200-Year DWSEL, Under Seepage:		<b>Meets Criteria</b>		Steady State Seepage 200-Year DWSEL, LS:		<b>Meets Criteria</b>	
200-Year DWSEL, Through Seepage:		<b>Meets Criteria</b>		Steady State Seepage HTOL, LS:		<b>Meets Criteria</b>	
HTOL, Under Seepage:		<b>Meets Criteria</b>		Rapid Drawdown, WS:		<b>Meets Criteria</b>	
				Seismic Slope Stability, WS:		<b>Fails Criteria</b>	
				Seismic Slope Stability, LS:		<b>Meets Criteria</b>	
<b>Reach Description</b>				<b>Reach Overview</b>			
Station Limits: 760+50 to 763+00 Feature(s) at Upstream Station Limit: Railroad bridge approach fill Feature(s) at Downstream Station Limit: End of Phase 1 drained seepage berm Approx. Crown Elevation Range (feet, NAVD88): 32 to 33 Approx. Levee Height Range (feet): 13 to 14 Approx. Crown Width Range (feet): 20 to 30 Approx. Landside Slope (H:V) Range: 2.5:1 to 3:1 Approx. Waterside Slope (H:V) Range: 3:1 to 3.5:1 Waterside Constraint(s): Waterside toe of slope at the waterway - no waterside bench. Railroad bridge Landside Constraint(s): None - agricultural land Landside repairs associated with PL84-99: None Improvements associated with LSRP P1: None Improvements associated with LSRP P2: None Proposed Improvements associated with LSRP P3: Cutoff wall

<b>Generalized Subsurface Conditions</b>							
Levee Prism Soils: Poorly graded SAND to Silty SAND Landside Surface Layer: Lean CLAY, approx. 7 feet thick at toe of levee Soils below surface layer: Approx. 45 feet of SAND, over 30 feet of Lean CLAY							
<b>Historic Performance</b>							
Seepage and landside boils (STA 762+00 to 764+00) during 1997 flood event were reported in ULE's 2014 SGDR Addendum.							
<b>Liquefiable Soils</b>							
Based on our liquefaction assessment, we identified potentially liquefiable soils within this Reach (Refer to Appendix E and Appendix F)							
<b>Seepage Analysis Results</b>							
Station	Water Surface	Figure	Exit Gradient			Through Seepage	Breakout Height (ft)*
			Levee Toe	Toe of Berm	Field		
761+00	200-Year	E-56-B	No Positive Gradient	---	0.12	No	n/a
	HTOL	E-56-C	No Positive Gradient	---	0.14	n/a	n/a
*Vertical distance from the toe of the levee (ground surface) to where the phreatic surface is calculated to daylight on the levee slope. Through seepage under HTOL conditions are not part of this evaluation.

<b>Slope Stability Analysis Results</b>							
Station	Case Analyzed	Water Surface (ft)	Figure	Factor of Safety (Circular)		Factor of Safety (Non-Circular)	
				Waterside	Landside	Waterside	Landside
761+00	SS - 200yr	28.4	E-56-D/E	---	2.0	---	2.2
	SS - HTOL	31.0	E-56-F	---	2.0	---	2.3
	RDD	18.4	E-56-D/E	1.9	---	1.9	---
	PS	5.5	E-56-G/H	1.3	1.5	1.1	1.6
	Post-EQ	5.5	E-56-I/J	0.5	1.6	0.5	1.6
<b>Post 200-Year Seismic Event Restoration Estimates</b>							
Reach	Damage Length (feet)	Estimated Lateral Movement (feet)	Estimated Vertical Movement (feet)	Fill Volume (10 year WSE+3 feet Freeboard) (cubic yards)	Fill Volume (Fully Restored Levee Geometry) (cubic yards)		
M3A	250	23	16	1,500	3,400
