# URBAN LEVEE DESIGN CRITERIA EVALUATION

MOSSDALE TRACT  
RECLAMATION DISTRICT NO. 17  
SAN JOAQUIN COUNTY, CALIFORNIA

Subject: Mossdale Tract  
Reclamation District No. 17  
San Joaquin County, California

## URBAN LEVEE DESIGN CRITERIA EVALUATION

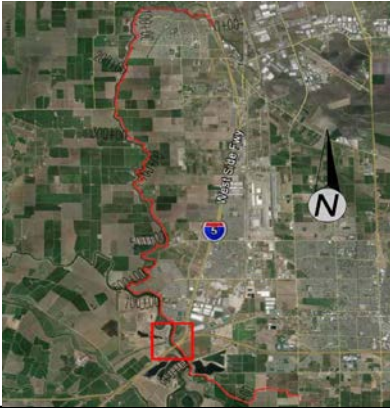
### 10.57 PROJECT REACH M3B, STATION 764+13

<b>REACH M3B - STA 764+13</b>							
<b>Based on our evaluation, this reach meets the ULDC criteria. Seismic deformations are not anticipated to degrade below 10-Year WSE + 3 feet.</b>							
<b>Seepage Evaluation Summary</b>				<b>Slope Stability Evaluation Summary</b>			
200-Year DWSEL, Under Seepage:		<b>Meets Criteria</b>		Steady State Seepage 200-Year DWSEL, LS:		<b>Meets Criteria</b>	
200-Year DWSEL, Through Seepage:		<b>Meets Criteria</b>		Steady State Seepage HTOL, LS:		<b>Meets Criteria</b>	
HTOL, Under Seepage:		<b>Meets Criteria</b>		Rapid Drawdown, WS:		<b>Meets Criteria</b>	
				Seismic Slope Stability, WS:		<b>Fails Criteria</b>	
				Seismic Slope Stability, LS:		<b>Meets Criteria</b>	
<b>Reach Description</b>				<b>Reach Overview</b>			
Station Limits: 763+00 to 768+00 Feature(s) at Upstream Station Limit: Manthey Road, I-5 approach fill/crossing Feature(s) at Downstream Station Limit: Railroad bridge approach fill Approx. Crown Elevation Range (feet, NAVD88): 32 to 33 Approx. Levee Height Range (feet): 12 to 17 Approx. Crown Width Range (feet): 20 to 33 Approx. Landside Slope (H:V) Range: 2:1 to 3:1 Approx. Waterside Slope (H:V) Range: 2:1 to 3:1 Waterside Constraint(s): Boat launch ramp, railroad bridge Landside Constraint(s): Mossdale County Park improvements Landside repairs associated with PL84-99: None Improvements associated with LSRP P1: None Improvements associated with LSRP P2: None Proposed Improvements associated with LSRP P3: Cutoff Wall/Drained Berm at RR Tracks

<b>Generalized Subsurface Conditions</b>							
Levee Prism Soils: Silty SAND to SAND Landside Surface Layer: Lean CLAY to Clayey SILT, approx. 3 to 13 feet thick at toe of levee Soils below surface layer: Approx. 40 to 50 feet of Silty SAND to SAND, over Lean CLAY							
<b>Historic Performance</b>							
Seepage and landside boils during 1997 flood event were reported in ULE's 2014 SGDR Addendum.							
<b>Liquefiable Soils</b>							
Based on our liquefaction assessment, we identified potentially liquefiable soils within this Reach (Refer to Appendix E and Appendix F)							
<b>Seepage Analysis Results</b>							
Station	Water Surface	Figure	Exit Gradient			Through Seepage	Breakout Height (ft)*
			Levee Toe	Toe of Berm	Field		
764+13	200-Year	E-57-B	No Positive Gradient	---	0.49	No	n/a
	HTOL	E-56-C	No Positive Gradient	---	0.52	n/a	n/a
*Vertical distance from the toe of the levee (ground surface) to where the phreatic surface is calculated to daylight on the levee slope. Through seepage under HTOL conditions are not part of this evaluation.

<b>Slope Stability Analysis Results</b>							
Station	Case Analyzed	Water Surface (ft)	Figure	Factor of Safety (Circular)		Factor of Safety (Non-Circular)	
				Waterside	Landside	Waterside	Landside
764+13	SS - 200yr	28.5	E-57-D/E	---	1.7	---	1.9
	SS - HTOL	31.2	E-57-F	---	1.7	---	1.9
	RDD	18.5	E-57-D/E	2.1	---	2.2	---
	PS	5.6	E-57-G/H	1.5	1.3	1.7	1.6
	Post-EQ	5.6	E-57-I/J	0.7	1.7	0.7	1.7
<b>Post 200-Year Seismic Event Restoration Estimates</b>							
Reach	Damage Length (feet)	Estimated Lateral Movement (feet)	Estimated Vertical Movement (feet)	Fill Volume (10 year WSE+3 feet Freeboard) (cubic yards)	Fill Volume (Fully Restored Levee Geometry) (cubic yards)		
M3B	500	9	6	No Fill Anticipated	1,000

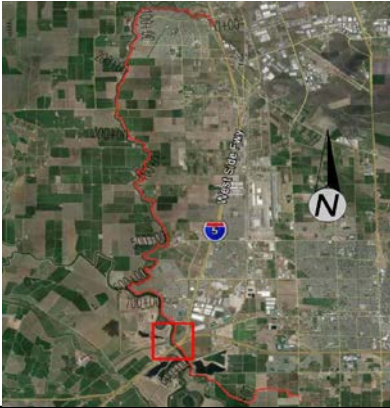
### 10.58 PROJECT REACH M3B, STATION 767+00

<b>REACH M3B - STA 767+00</b>							
<b>Based on our evaluation, this reach meets the ULDC criteria. Seismic deformations are not anticipated to degrade below 10-Year WSE + 3 feet.</b>							
<b>Seepage Evaluation Summary</b>				<b>Slope Stability Evaluation Summary</b>			
200-Year DWSEL, Under Seepage:		<b>Meets Criteria</b>		Steady State Seepage 200-Year DWSEL, LS:		<b>Meets Criteria</b>	
200-Year DWSEL, Through Seepage:		<b>Meets Criteria</b>		Steady State Seepage HTOL, LS:		<b>Meets Criteria</b>	
HTOL, Under Seepage:		<b>Meets Criteria</b>		Rapid Drawdown, WS:		<b>Meets Criteria</b>	
				Seismic Slope Stability, WS:		<b>Fails Criteria</b>	
				Seismic Slope Stability, LS:		<b>Meets Criteria</b>	
<b>Reach Description</b>				<b>Reach Overview</b>			
Station Limits: 763+00 to 768+00 Feature(s) at Upstream Station Limit: Manthey Road, I-5 approach fill/crossing Feature(s) at Downstream Station Limit: Railroad bridge approach fill Approx. Crown Elevation Range (feet, NAVD88): 32 to 33 Approx. Levee Height Range (feet): 12 to 17 Approx. Crown Width Range (feet): 20 to 33 Approx. Landside Slope (H:V) Range: 2:1 to 3:1 Approx. Waterside Slope (H:V) Range: 2:1 to 3:1 Waterside Constraint(s): Boat launch ramp, railroad bridge Landside Constraint(s): Mossdale County Park improvements Landside repairs associated with PL84-99: None Improvements associated with LSRP P1: None Improvements associated with LSRP P2: None Proposed Improvements associated with LSRP P3: Cutoff Wall/Drained Berm at RR Tracks

<b>Generalized Subsurface Conditions</b>							
Levee Prism Soils: Silty SAND to SAND Landside Surface Layer: Lean CLAY to Clayey SILT, approx. 3 to 13 feet thick at toe of levee Soils below surface layer: Approx. 40 to 50-feet of Silty SAND to SAND, over Lean CLAY							
<b>Historic Performance</b>							
Seepage and landside boils during 1997 flood event were reported in ULE's 2014 SGDR Addendum.							
<b>Liquefiable Soils</b>							
Based on our liquefaction assessment, we identified potentially liquefiable soils within this Reach (Refer to Appendix E and Appendix F)							
<b>Seepage Analysis Results</b>							
Station	Water Surface	Figure	Exit Gradient			Through Seepage	Breakout Height (ft)*
			Levee Toe	Toe of Berm	Field		
767+00	200-Year	E-58-B	No Positive Gradient	---	---	No	n/a
	HTOL	E-58-C	No Positive Gradient	---	---	n/a	n/a
*Vertical distance from the toe of the levee (ground surface) to where the phreatic surface is calculated to daylight on the levee slope. Through seepage under HTOL conditions are not part of this evaluation.

<b>Slope Stability Analysis Results</b>							
Station	Case Analyzed	Water Surface (ft)	Figure	Factor of Safety (Circular)		Factor of Safety (Non-Circular)	
				Waterside	Landside	Waterside	Landside
767+00	SS - 200yr	28.6	E-58-D/E	---	2.6	---	2.9
	SS - HTOL	31.3	E-58-F	---	2.6	---	2.6
	RDD	18.6	E-58-D/E	1.9	---	1.9	---
	PS	5.6	E-58-G/H	1.3	1.7	1.3	1.9
	Post-EQ	5.6	E-58-I/J	0.7	2.1	0.5	2.0
<b>Post 200-Year Seismic Event Restoration Estimates</b>							
Reach	Damage Length (feet)	Estimated Lateral Movement (feet)	Estimated Vertical Movement (feet)	Fill Volume (10 year WSE+3 feet Freeboard) (cubic yards)	Fill Volume (Fully Restored Levee Geometry) (cubic yards)		
M3B	500	9	6	No Fill Anticipated	1,000

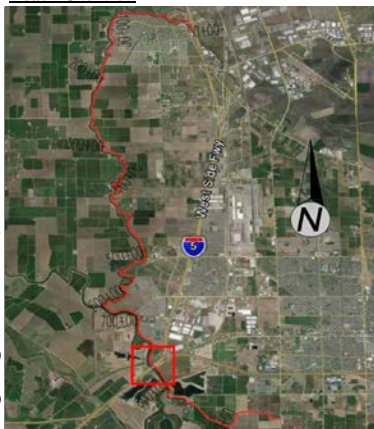
### 10.59 PROJECT REACH M3C, STATION 777+00

<b>REACH M3C - STA 777+00</b>							
<b>Based on our evaluation, this reach meets the ULDC Criteria. An Operations and Maintenance plan should be implemented for seismic deformations following the 200-year event.</b>							
<b>Seepage Evaluation Summary</b>				<b>Slope Stability Evaluation Summary</b>			
200-Year DWSEL, Under Seepage:		<b>Meets Criteria</b>		Steady State Seepage 200-Year DWSEL, LS:		<b>Meets Criteria</b>	
200-Year DWSEL, Through Seepage:		<b>Meets Criteria</b>		Steady State Seepage HTOL, LS:		<b>Meets Criteria</b>	
HTOL, Under Seepage:		<b>Meets Criteria</b>		Rapid Drawdown, WS:		<b>Meets Criteria</b>	
				Seismic Slope Stability, WS:		<b>Fails Criteria</b>	
				Seismic Slope Stability, LS:		<b>Meets Criteria</b>	
<b>Reach Description</b>				<b>Reach Overview</b>			
Station Limits: 775+00 to 781+00 Feature(s) at Upstream Station Limit: Landside berm/agricultural areas Feature(s) at Downstream Station Limit: I-5 Bridge Crossing Approach Approx. Crown Elevation Range (feet, NAVD88): 32 1/2 to 34.5 Approx. Levee Height Range (feet): 11 to 17 Approx. Crown Width Range (feet): 25 to 40 Approx. Landside Slope (H:V) Range: 3:1 to 3:1 Approx. Waterside Slope (H:V) Range: 2.5:1 to 3.5:1 Waterside Constraint(s): Waterside toe of slope at the waterway - isolated 35 foot wide waterside bench. Landside Constraint(s): Phase II berm and agricultural land Landside repairs associated with PL84-99: Yes - drained seepage berm Improvements associated with LSRP P1: None Improvements associated with LSRP P2: Drained Seepage Berm from STA 778+50 to 781+00 Proposed Improvements associated with LSRP P3: Drained Seepage Berm from STA 775+00 to 778+50

<b>Generalized Subsurface Conditions</b> Levee Prism Soils: Silty SAND to SAND Landside Surface Layer: SAND Soils below surface layer: Approx. 45 feet of SAND, over interlayered Lean CLAY and Clayey SAND							
<b>Historic Performance</b>							
Seepage and landside boils were reported in ULE's 2014 SGDR Addendum.							
<b>Liquefiable Soils</b>							
Based on our liquefaction assessment, we identified potentially liquefiable soils within this Reach (Refer to Appendix E and Appendix F)							
<b>Seepage Analysis Results</b>							
Station	Water Surface	Figure	Exit Gradient			Through Seepage	Breakout Height (ft)*
			Levee Toe	Toe of Berm	Field		
777+00	200-Year	E-59-B	0.01	0.09	---	No	n/a
	HTOL	E-59-C	0.01	0.10	---	n/a	n/a
*Vertical distance from the toe of the levee (ground surface) to where the phreatic surface is calculated to day light on the levee slope. Through seepage under HTOL conditions are not part of this evaluation.

<b>Slope Stability Analysis Results</b>							
Station	Case Analyzed	Water Surface	Figure	Factor of Safety (Circular)		Factor of Safety (Non-Circular)	
				Waterside	Landside	Waterside	Landside
777+00	SS - 200yr	28.9	E-59-D	---	2.4	n/a	n/a
	SS - HTOL	31.8	E-59-E	---	2.3	n/a	n/a
	RDD	18.9	E-59-D	2.0	---	n/a	n/a
	PS	5.8	E-59-F	1.4	1.7	n/a	n/a
	Post-EQ	5.8	E-59-G/H	0.5	2.3	0.5	2.1
<b>Post 200-Year Seismic Event Restoration Estimates</b>							
Reach	Damage Length (feet)	Estimated Lateral Movement (feet)	Estimated Vertical Movement (feet)	Fill Volume (10 year WSE+3 feet Freeboard) (cubic yards)	Fill Volume (Fully Restored Levee Geometry) (cubic yards)		
M3C	600	30	21	7,000	14,000

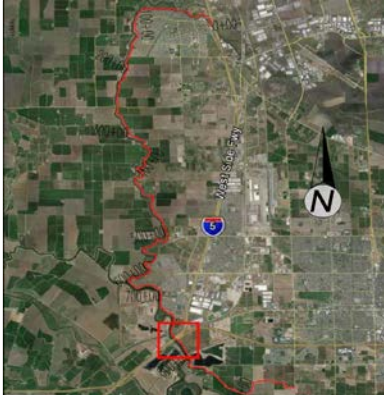
### 10.60 PROJECT REACH M4, STATION 795+87

<b>REACH M4 - STA 795+87</b>							
<b>Based on our evaluation, this reach meets the ULDC Criteria. Seismic deformations are not anticipated to degrade below 10-Year WSE + 3 feet.</b>							
<b>Seepage Evaluation Summary</b>				<b>Slope Stability Evaluation Summary</b>			
200-Year DWSEL, Under Seepage:		<b>Meets Criteria</b>		Steady State Seepage 200-Year DWSEL, LS:		<b>Meets Criteria</b>	
200-Year DWSEL, Through Seepage:		<b>Meets Criteria</b>		Steady State Seepage HTOL, LS:		<b>Meets Criteria</b>	
HTOL, Under Seepage:		<b>Meets Criteria</b>		Rapid Drawdown, WS:		<b>Meets Criteria</b>	
				Seismic Slope Stability, WS:		<b>Fails Criteria</b>	
				Seismic Slope Stability, LS:		<b>Meets Criteria</b>	
<b>Reach Description</b>				<b>Reach Overview</b>			
Station Limits: 781+00 to 799+50 Feature(s) at Upstream Station Limit: Railroad alignment/approach Feature(s) at Downstream Station Limit: Phase II Berm, agricultural land Approx. Crown Elevation Range (feet, NAVD88): 33 to 34 Approx. Levee Height Range (feet): 13 to 18 Approx. Crown Width Range (feet): 30 to 44 Approx. Landside Slope (H:V) Range: 3:1 to 3:1 Approx. Waterside Slope (H:V) Range: 2.5:1 to 3.3:1 Waterside Constraint(s): Waterside toe of slope at the waterway - no waterside bench. Landside Constraint(s): High tension power lines and ag land Landside repairs associated with PL84-99: Gravel berm at STA 788+00 to 799+50 Improvements associated with LSRP P1: None Improvements associated with LSRP P2: Drained Seepage Berm Proposed Improvements associated with LSRP P3: None

<b>Generalized Subsurface Conditions</b>							
Levee Prism Soils: Silty SAND and Lean CLAY							
Landside Surface Layer: Lean CLAY, approx. 15 feet thick at toe of levee							
Soils below surface layer: Approx. 40 feet of Silty SAND and SAND, over 10 feet of lean CLAY							
<b>Historic Performance</b>							
Seepage and landside boils were reported during the 1997 high-water event and minor wave wash erosion on waterside slope between Station 790+00 to 799+00 during 1998 high-water event in ULE's 2014 SGDR Addendum.							
<b>Liquefiable Soils</b>							
Based on our liquefaction assessment, we identified potentially liquefiable soils within this Reach (Refer to Appendix E and Appendix F)							
<b>Seepage Analysis Results</b>							
Station	Water Surface	Figure	Exit Gradient			Through Seepage	Breakout Height (ft)*
			Levee Toe	Toe of Berm	Field		
795+87	200-Year	E-60-B	0.03	0.58	---	No	n/a
	HTOL	E-60-C	0.13	0.71	---	n/a	n/a

*Vertical distance from the toe of the levee (ground surface) to where the phreatic surface is calculated to daylight on the levee slope. Through seepage under HTOL conditions are not part of this evaluation.							
<b>Slope Stability Analysis Results</b>							
Station	Case Analyzed	Water Surface	Figure	Factor of Safety (Circular)		Factor of Safety (Non-Circular)	
				Waterside	Landside	Waterside	Landside
795+87	SS - 200yr	29.0	E-60-D	---	1.9	n/a	n/a
	SS - HTOL	31.9	E-60-E	---	2.0	n/a	n/a
	RDD	19.0	E-60-D	1.9	---	n/a	n/a
	PS	6.0	E-60-F	1.6	1.5	n/a	n/a
	Post-EQ	6.0	E-60-G/H	0.8	2.0	0.9	2.9
<b>Post 200-Year Seismic Event Restoration Estimates</b>							
Reach	Damage Length (feet)	Estimated Lateral Movement (feet)	Estimated Vertical Movement (feet)	Fill Volume (10 year WSE+3 feet Freeboard) (cubic yards)	Fill Volume (Fully Restored Levee Geometry) (cubic yards)		
M4	1,850	3	2	No Fill Anticipated	450

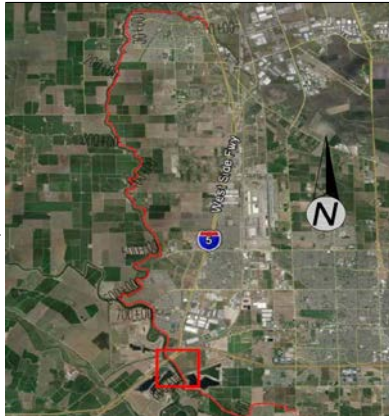
### 10.61 PROJECT REACH N1, STATION 804+50

<b>REACH N1 - STA 804+50</b>							
<b>Based on our evaluation, this reach meets the ULDC Criteria.</b>							
<b>Seepage Evaluation Summary</b>				<b>Slope Stability Evaluation Summary</b>			
200-Year DWSEL, Under Seepage:		<b>Meets Criteria</b>		Steady State Seepage 200-Year DWSEL, LS:		<b>Meets Criteria</b>	
200-Year DWSEL, Through Seepage:		<b>Meets Criteria</b>		Steady State Seepage HTOL, LS:		<b>Meets Criteria</b>	
HTOL, Under Seepage:		<b>Meets Criteria</b>		Rapid Drawdown, WS:		<b>Meets Criteria</b>	
				Seismic Slope Stability, WS:		<b>Meets Criteria</b>	
				Seismic Slope Stability, LS:		<b>Meets Criteria</b>	
<b>Reach Description</b>				<b>Reach Overview</b>			
Station Limits: 799+50 to 806+00 Feature(s) at Upstream Station Limit: LSRP Phase 3 Cutoff Wall Feature(s) at Downstream Station Limit: RR-X-ing Approx. Crown Elevation Range (feet, NAVD88): 34 to 35 Approx. Levee Height Range (feet): 9 to 12 Approx. Crown Width Range (feet): 50 to 50 Approx. Landside Slope (H:V) Range: 3:1 to 5:1 Approx. Waterside Slope (H:V) Range: 1.5:1 to 2:1 Waterside Constraint(s): Waterside toe of slope at the waterway - no waterside bench. Landside Constraint(s): Pond, RR X-ing Landside repairs associated with PL84-99: Gravel berm at STA 799+50 to 806+00 (excluding RR X-ing) Improvements associated with LSRP P1: None Improvements associated with LSRP P2: None Proposed Improvements associated with LSRP P3: None

<b>Generalized Subsurface Conditions</b>							
Levee Prism Soils: Silty SAND Landside Surface Layer: Lean CLAY, approx. 5 to 15 feet thick near toe of levee Soils below surface layer: Approx. 20 feet of lean CLAY, over 60 feet of Poorly Graded SAND							
<b>Historic Performance</b>							
Seepage and landside boils (sandbag rings) were reported in ULE's 2014 SGDR Addendum.							
<b>Liquefiable Soils</b>							
Based on our liquefaction assessment, we identified potentially liquefiable soils within this Reach (Refer to Appendix E and Appendix F)							
<b>Seepage Analysis Results</b>							
Station	Water Surface	Figure	Exit Gradient			Through Seepage	Breakout Height (ft)*
			Levee Toe	Toe of Berm	Field		
804+50	200-Year	E-61-B	No Positive Gradient	---	0.06	No	n/a
	HTOL	E-61-C	No Positive Gradient	---	0.08	n/a	n/a
*Vertical distance from the toe of the levee (ground surface) to where the phreatic surface is calculated to daylight on the levee slope. Through seepage under HTOL conditions are not part of this evaluation.

<b>Slope Stability Analysis Results</b>							
Station	Case Analyzed	Water Surface (ft)	Figure	Factor of Safety (Circular)		Factor of Safety (Non-Circular)	
				Waterside	Landside	Waterside	Landside
804+50	SS - 200yr	29.0	E-61-D	---	2.4	n/a	n/a
	SS - HTOL	32.0	E-61-E	---	2.2	n/a	n/a
	RDD	19.0	E-61-D	1.6	---	n/a	n/a
	PS	6.0	E-61-F	1.3	1.8	n/a	n/a
	Post-EQ	6.0	E-61-G/H	1.1	2.5	1.1	4.6
<b>Post 200-Year Seismic Event Restoration Estimates</b>							
Reach	Damage Length (feet)	Estimated Lateral Movement (feet)	Estimated Vertical Movement (feet)	Fill Volume (10 year WSE+3 feet Freeboard) (cubic yards)	Fill Volume (Fully Restored Levee Geometry) (cubic yards)		
N1	650	9	6	No Fill Anticipated	1,300

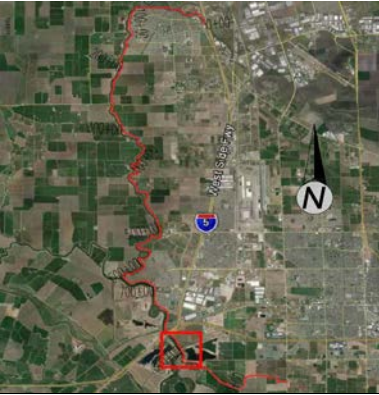
### 10.63 PROJECT REACH N2, STATION 820+69

<b>REACH N2 - STA 820+69</b>							
<b>Based on our evaluation, this reach meets the ULDC Criteria. An Operations and Maintenance plan should be implemented for seismic deformations following the 200-year event.</b>							
<b>Seepage Evaluation Summary</b>				<b>Slope Stability Evaluation Summary</b>			
200-Year DWSEL, Under Seepage:		<b>Meets Criteria</b>		Steady State Seepage 200-Year DWSEL, LS:		<b>Meets Criteria</b>	
200-Year DWSEL, Through Seepage:		<b>Meets Criteria</b>		Steady State Seepage HTOL, LS:		<b>Meets Criteria</b>	
HTOL, Under Seepage:		<b>Meets Criteria</b>		Rapid Drawdown, WS:		<b>Meets Criteria</b>	
				Seismic Slope Stability, WS:		<b>Fails Criteria</b>	
				Seismic Slope Stability, LS:		<b>Meets Criteria</b>	
<b>Reach Description</b>				<b>Reach Overview</b>			
Station Limits: 806+00 to 825+00 Feature(s) at Upstream Station Limit: Beginning of Phase II Seepage Berm Feature(s) at Downstream Station Limit: End of landside residential /RR Crossing Approx. Crown Elevation Range (feet, NAVD88): 34 to 35 Approx. Levee Height Range (feet): 12.5 to 20 Approx. Crown Width Range (feet): 12 to 18 Approx. Landside Slope (H:V) Range: 2.5:1 to 2.5:1 Approx. Waterside Slope (H:V) Range: 2:1 to 2.5:1 Waterside Constraint(s): Waterside toe of slope at the waterway - no waterside bench. Landside Constraint(s): Residential/Oakwood lake Landside repairs associated with PL84-99: None Improvements associated with LSRP P1: None Improvements associated with LSRP P2: None Proposed Improvements associated with LSRP P3: Fully Penetrating Cutoff Wall

<b>Generalized Subsurface Conditions</b>							
Levee Prism Soils: Clayey SAND to Lean CLAY Landside Surface Layer: Lean CLAY, approx. 13 feet thick at toe of levee Soils below surface layer: Approx. 40 feet of SAND, over 12 feet of Lean CLAY							
<b>Historic Performance</b>							
Seepage and landside boils during 1997 flood event were reported in ULE's 2014 SGDR Addendum. In the mid 2000's a 24 foot deep sheet pile wall was installed in levee crown between Station 822+00 to 825+50.							
<b>Liquefiable Soils</b>							
Based on our liquefaction assessment, we identified potentially liquefiable soils within this Reach (Refer to Appendix E and Appendix F)							
<b>Seepage Analysis Results</b>							
Station	Water Surface	Figure	Exit Gradient			Through Seepage	Breakout Height (ft)*
			Levee Toe	Toe of Berm	Field		
<b>820+69</b>	200-Year	E-63-B	No Positive Gradient	---	---	No	n/a
	HTOL	E-63-C	No Positive Gradient	---	---	n/a	n/a

*Vertical distance from the toe of the levee (ground surface) to where the phreatic surface is calculated to day light on the levee slope. Through seepage under HTOL conditions are not part of this evaluation.							
<b>Slope Stability Analysis Results</b>							
Station	Case Analyzed	Water Surface (ft)	Figure	Factor of Safety (Circular)		Factor of Safety (Non-Circular)	
				Waterside	Landside	Waterside	Landside
<b>820+69</b>	SS - 200yr	29.1	E-63-D/E	---	2.2	---	2.4
	SS - HTOL	32.0	E-63-F	---	2.2	---	2.4
	RDD	19.1	E-63-D/E	1.6	---	1.6	---
	PS	6.0	E-63-G/H	1.4	1.5	1.4	1.6
	Post-EQ	6.0	E-63-I/J	0.6	2.0	0.6	1.6
<b>Post 200-Year Seismic Event Restoration Estimates</b>							
Reach	Damage Length (feet)	Estimated Lateral Movement (feet)	Estimated Vertical Movement (feet)	Fill Volume (10 year WSE+3 feet Freeboard) (cubic yards)	Fill Volume (Fully Restored Levee Geometry) (cubic yards)		
<b>N2</b>	1,900	11	8	200	6,200

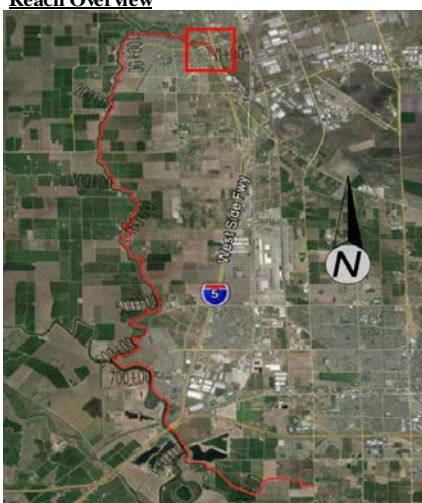
### 10.64 PROJECT REACH NPL, STATION -12+00

<b>REACH NPL - STA (-)12+00</b>							
<b>Based on our evaluation, this reach meets the ULDC Criteria.</b>							
<b>Seepage Evaluation Summary</b>				<b>Slope Stability Evaluation Summary</b>			
200-Year DWSEL, Under Seepage:		<b>Meets Criteria</b>		Steady State Seepage 200-Year DWSEL, LS:		<b>Meets Criteria</b>	
200-Year DWSEL, Through Seepage:		<b>Meets Criteria</b>		Steady State Seepage HTOL, LS:		<b>Meets Criteria</b>	
HTOL, Under Seepage:		<b>Meets Criteria</b>		Rapid Drawdown, WS:		<b>Meets Criteria</b>	
				Seismic Slope Stability, WS:		<b>Meets Criteria</b>	
				Seismic Slope Stability, LS:		<b>Meets Criteria</b>	
<b>Reach Description</b>				<b>Reach Overview</b>			
Station Limits: (-)35+00 to 00+00 Feature(s) at Upstream Station Limit: South Manthey Road/power lines Feature(s) at Downstream Station Limit: South Manthey Road (North) Approx. Crown Elevation Range (feet, NAVD88): 19 to 23 Approx. Levee Height Range (feet): 8 to 10.5 Approx. Crown Width Range (feet): 17 to 47 Approx. Landside Slope (H:V) Range: 2:1 to 4.5:1 Approx. Waterside Slope (H:V) Range: 1.7:1 to 3:1 Waterside Constraint(s): Overhead power lines, waterway near William Moss Blvd. Landside Constraint(s): STA -30+00 to -6+50 - agricultural land, STA 0+00 to -6+50 - residential development Landside repairs associated with PL84-99: None Improvements associated with LSRP P1: None Improvements associated with LSRP P2: None Proposed Improvements associated with LSRP P3: None

<b>Generalized Subsurface Conditions</b>							
Levee Prism Soils: Silty SAND Landside Surface Layer: Silty SAND, approx. 8 feet thick at levee toe Soils below surface layer: Interlayered SILT, Lean CLAY and SAND							
<b>Historic Performance</b>							
No recorded events in ULE's 2014 SGDR Addendum							
<b>Liquefiable Soils</b>							
Based on our liquefaction assessment, we are not considering liquefiable soils in our slope stability analyses.							
<b>Seepage Analysis Results</b>							
Station	Water Surface	Figure	Exit Gradient			Through Seepage	Breakout Height (ft)*
			Levee Toe	Toe of Berm	Field		
<b>825+86</b>	200-Year	E-1-B	No Positive Gradient	---	0.01	No	n/a
	HTOL	E-1-C	No Positive Gradient	---	0.04	n/a	n/a
*Vertical distance from the toe of the levee (ground surface) to where the phreatic surface is calculated to daylight on the levee slope. Through seepage under HTOL conditions are not part of this evaluation.

<b>Slope Stability Analysis Results</b>							
Station	Case Analyzed	Water Surface (ft)	Figure	Factor of Safety (Circular)		Factor of Safety (Non-Circular)	
				Waterside	Landside	Waterside	Landside
<b>-12+00</b>	SS - 200yr	14.5	E-1-D	---	3.2	n/a	n/a
	SS - HTOL	15.7	E-1-E	---	3.1	n/a	n/a
	RDD	10.8	E-1-D	1.6	---	n/a	n/a
	PS	2.9	E-1-F	1.3	2.6	n/a	n/a
	Post-EQ	n/a	n/a	n/a	n/a	n/a	n/a

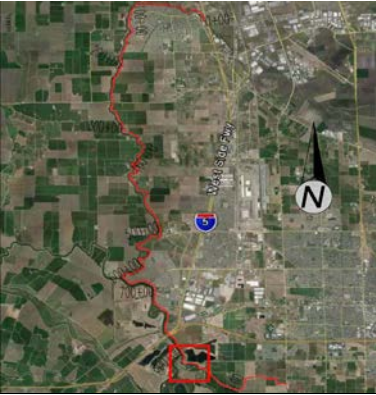
## 10.65 PROJECT REACH 01, STATION 825+86

<b>REACH 01 - STA 825+86</b>							
<b>Based on our evaluation, this reach meets the ULDC Criteria. An Operations and Maintenance plan should be implemented for seismic deformations following the 200-year event.</b>							
<b>Seepage Evaluation Summary</b>				<b>Slope Stability Evaluation Summary</b>			
200-Year DWSEL, Under Seepage:		<b>Meets Criteria</b>		Steady State Seepage 200-Year DWSEL, LS:		<b>Meets Criteria</b>	
200-Year DWSEL, Through Seepage:		<b>Meets Criteria</b>		Steady State Seepage HTOL, LS:		<b>Meets Criteria</b>	
HTOL, Under Seepage:		<b>Meets Criteria</b>		Rapid Drawdown, WS:		<b>Meets Criteria</b>	
				Seismic Slope Stability, WS:		<b>Fails Criteria</b>	
				Seismic Slope Stability, LS:		<b>Meets Criteria</b>	
<b>Reach Description</b>				<b>Reach Overview</b>			
Station Limits: 825+00 to 835+00 Feature(s) at Upstream Station Limit: Residential Lots and Street Feature(s) at Downstream Station Limit: Begin LSRP P2 Berm Approx. Crown Elevation Range (feet, NAVD88): 34 to 35 Approx. Levee Height Range (feet): 14.5 to 16.5 Approx. Crown Width Range (feet): 32 to 42 Approx. Landside Slope (H:V) Range: 3:1 to 3:1 Approx. Waterside Slope (H:V) Range: 1.7:1 to 2.3:1 Waterside Constraint(s): Waterside toe of slope at the waterway - no waterside bench. Landside Constraint(s): Seepage Berm and Residential Landside repairs associated with PL84-99: Berm Improvements associated with LSRP P1: None Improvements associated with LSRP P2: Drained Seepage Berm Proposed Improvements associated with LSRP P3: None

<b>Generalized Subsurface Conditions</b>							
Levee Prism Soils: Clayey SAND to SILT Landside Surface Layer: Lean CLAY, approx. 20 feet thick at levee toe, Approx. 4 feet of Silty SAND at Berm toe Soils below surface layer: Approx. 40 feet of silty SAND, over 12 feet of Lean CLAY							
<b>Historic Performance</b>							
Seepage, landside boils, and waterside wavewash erosion during 1997 flood event, along with longitudinal cracking in 1993 were reported in ULE's 2014 SGDR Addendum.							
<b>Liquefiable Soils</b>							
Based on our liquefaction assessment, we identified potentially liquefiable soils within this Reach (Refer to Appendix E and Appendix F)							
<b>Seepage Analysis Results</b>							
Station	Water Surface	Figure	Exit Gradient			Through Seepage	Breakout Height (ft)*
			Levee Toe	Toe of Berm	Field		
825+86	200-Year	E-64-B	No Positive Gradient	0.35	0.46	No	n/a
	HTOL	E-64-C	No Positive Gradient	0.47	0.59	n/a	n/a

*Vertical distance from the toe of the levee (ground surface) to where the phreatic surface is calculated to day light on the levee slope. Through seepage under HTOL conditions are not part of this evaluation.							
<b>Slope Stability Analysis Results</b>							
Station	Case Analyzed	Water Surface (ft)	Figure	Factor of Safety (Circular)		Factor of Safety (Non-Circular)	
				Waterside	Landside	Waterside	Landside
825+86	SS - 200yr	30	E-64-D	---	2.4	n/a	n/a
	SS - HTOL	32.6	E-64-E	---	2.1	n/a	n/a
	RDD	18.7	E-64-D	1.1	---	n/a	n/a
	PS	10.4	E-64-F	1.0	1.6	n/a	n/a
	Post-EQ	10.4	E-64-G/H	0.6	1.7	0.6	1.8
<b>Post 200-Year Seismic Event Restoration Estimates</b>							
Reach	Damage Length (feet)	Estimated Lateral Movement (feet)	Estimated Vertical Movement (feet)	Fill Volume (10 year WSE+3 feet Freeboard) (cubic yards)	Fill Volume (Fully Restored Levee Geometry) (cubic yards)		
01	745	14	10	1,500	3,900

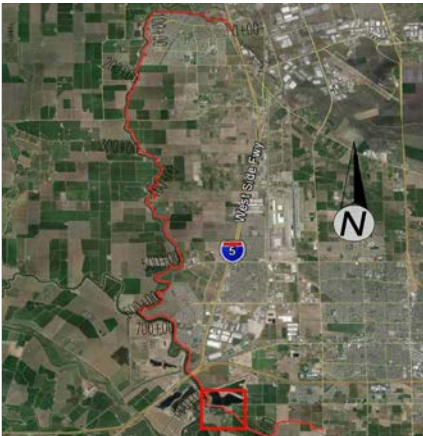
### 10.66 PROJECT REACH O2A, STATION 844+81

<b>REACH O2A - STA 844+81</b>							
<b>Based on our evaluation, this reach meets the ULDC Criteria.</b>							
<b>Seepage Evaluation Summary</b>				<b>Slope Stability Evaluation Summary</b>			
200-Year DWSEL, Under Seepage:		<b>Meets Criteria</b>		Steady State Seepage 200-Year DWSEL, LS:		<b>Meets Criteria</b>	
200-Year DWSEL, Through Seepage:		<b>Meets Criteria</b>		Steady State Seepage HTOL, LS:		<b>Meets Criteria</b>	
HTOL, Under Seepage:		<b>Meets Criteria</b>		Rapid Drawdown, WS:		<b>Meets Criteria</b>	
				Seismic Slope Stability, WS:		<b>Meets Criteria</b>	
				Seismic Slope Stability, LS:		<b>Meets Criteria</b>	
<b>Reach Description</b>				<b>Reach Overview</b>			
Station Limits: 835+00 to 849+65 Feature(s) at Upstream Station Limit: End of LSRP P2 berm, Start of LSRP P3 Feature(s) at Downstream Station Limit: LSRP P2 Berm continuation Approx. Crown Elevation Range (feet, NAVD88): 34 to 35 Approx. Levee Height Range (feet): 13.5 to 16 Approx. Crown Width Range (feet): 35 to 37 Approx. Landside Slope (H:V) Range: 3:1 to 3:1 Approx. Waterside Slope (H:V) Range: 1.9:1 to 3:1 Waterside Constraint(s): Waterside toe of slope at the waterway - no waterside bench. Landside Constraint(s): Graded residential lots and streets Landside repairs associated with PL84-99: None Improvements associated with LSRP P1: None Improvements associated with LSRP P2: Drained Seepage Berm w/chimney drain Proposed Improvements associated with LSRP P3: None

<b>Generalized Subsurface Conditions</b>							
Levee Prism Soils: Clayey SAND and Lean CLAY Landside Surface Layer: FAT CLAY, approx. 10 to 15 feet thick Soils below surface layer: Poorly Graded SAND							
<b>Historic Performance</b>							
Seepage, landside boils, and waterside wavewash erosion at Station 845+00 to 846+00 during 1997 flood event were reported in ULE's 2014 SGDR Addendum.							
<b>Liquefiable Soils</b>							
Based on our liquefaction assessment, we are not considering liquefiable soils in our slope stability analyses.							
<b>Seepage Analysis Results</b>							
Station	Water Surface	Figure	Exit Gradient			Through Seepage	Breakout Height (ft)*
			Levee Toe	Toe of Berm	Field		
<b>844+81</b>	200-Year	E-65-B	No Positive Gradient	No Positive Gradient	---	No	n/a
	HTOL	E-65-C	No Positive Gradient	No Positive Gradient	---	n/a	n/a
*Vertical distance from the toe of the levee (ground surface) to where the phreatic surface is calculated to daylight on the levee slope. Through seepage under HTOL conditions are not part of this evaluation.

<b>Slope Stability Analysis Results</b>							
Station	Case Analyzed	Water Surface (ft)	Figure	Factor of Safety (Circular)		Factor of Safety (Non-Circular)	
				Waterside	Landside	Waterside	Landside
<b>844+81</b>	SS - 200yr	29.7	E-65-D	---	2.1	n/a	n/a
	SS - HTOL	32.7	E-65-E	---	2.1	n/a	n/a
	RDD	18.8	E-65-D	1.6	---	n/a	n/a
	PS	10.4	E-65-F	1.0	1.6	n/a	n/a
	Post-EQ	n/a	n/a	n/a	n/a	n/a	n/a

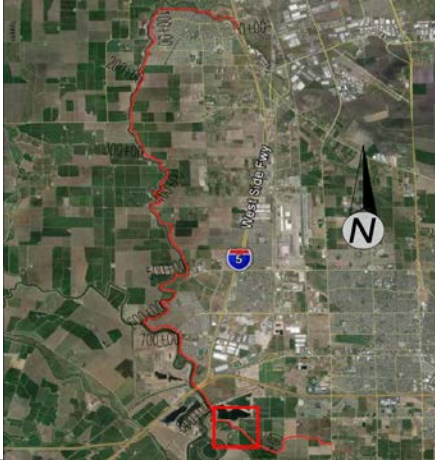
### 10.67 PROJECT REACH O2B, STATION 850+50

<b>REACH O2B - STA 850+50</b>							
<b>Based on our evaluation, this reach meets the ULDC Criteria.</b>							
<b>Seepage Evaluation Summary</b>				<b>Slope Stability Evaluation Summary</b>			
200-Year DWSEL, Under Seepage:		<b>Meets Criteria</b>		Steady State Seepage 200-Year DWSEL, LS:		<b>Meets Criteria</b>	
200-Year DWSEL, Through Seepage:		<b>Meets Criteria</b>		Steady State Seepage HTOL, LS:		<b>Meets Criteria</b>	
HTOL, Under Seepage:		<b>Meets Criteria</b>		Rapid Drawdown, WS:		<b>Meets Criteria</b>	
				Seismic Slope Stability, WS:		<b>Meets Criteria</b>	
				Seismic Slope Stability, LS:		<b>Meets Criteria</b>	
<b>Reach Description</b>				<b>Reach Overview</b>			
Station Limits: 849+65 to 853+50 Feature(s) at Upstream Station Limit: Approach fill for S. Williamson Road Feature(s) at Downstream Station Limit: Phase II Berm improvement transition Approx. Crown Elevation Range (feet, NAVD88): 34 to 35 Approx. Levee Height Range (feet): 13.5 to 16 Approx. Crown Width Range (feet): 12 to 12 Approx. Landside Slope (H:V) Range: 3:1 to 3:1 Approx. Waterside Slope (H:V) Range: 2:1 to 2:1 Waterside Constraint(s): Waterside bench/docks/pipe penetration Landside Constraint(s): Trees and residential lots, retaining walls Landside repairs associated with PL84-99: None Improvements associated with LSRP P1: None Improvements associated with LSRP P2: None Proposed Improvements associated with LSRP P3: Drained Seepage Berm w/chimney drain

<b>Generalized Subsurface Conditions</b>							
Levee Prism Soils: Silty SAND, SAND and SILT Landside Surface Layer: Lean CLAY and SILT, approx. 10-13 feet thick at toe of levee Soils below surface layer: Approx. 40 feet of SAND, over 15 feet of Lean CLAY							
<b>Historic Performance</b>							
No seepage or slope stability performance issues reported.							
<b>Liquefiable Soils</b>							
Based on our liquefaction assessment, we are not considering liquefiable soils in our slope stability analyses.							
<b>Seepage Analysis Results</b>							
Station	Water Surface	Figure	Exit Gradient			Through Seepage	Breakout Height (ft)*
			Levee Toe	Toe of Berm	Field		
<b>850+50</b>	200-Year	E-66-B	No Positive Gradient	0.19	---	No	n/a
	HTOL	E-66-C	No Positive Gradient	0.36	---	n/a	n/a
*Vertical distance from the toe of the levee (ground surface) to where the phreatic surface is calculated to daylight on the levee slope. Through seepage under HTOL conditions are not part of this evaluation.

<b>Slope Stability Analysis Results</b>							
Station	Case Analyzed	Water Surface (ft)	Figure	Factor of Safety (Circular)		Factor of Safety (Non-Circular)	
				Waterside	Landside	Waterside	Landside
<b>850+50</b>	SS - 200yr	29.8	E-66-D	---	2.4	n/a	n/a
	SS - HTOL	32.8	E-66-E	---	2.4	n/a	n/a
	RDD	18.9	E-66-D	1.7	---	n/a	n/a
	PS	10.4	E-66-F	1.5	1.7	n/a	n/a
	Post-EQ	n/a	n/a	n/a	n/a	n/a	n/a

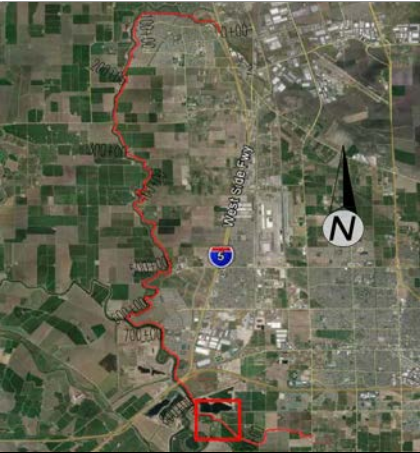
**10.68 PROJECT REACH O2B, STATION 851+20**

<b>REACH O2B - STA 851+20</b>							
<b>Based on our evaluation, this reach meets the ULDC Criteria.</b>							
Seepage Evaluation Summary				Slope Stability Evaluation Summary			
200-Year DWSEL, Under Seepage:		<b>Meets Criteria</b>		Steady State Seepage 200-Year DWSEL, LS:		<b>Meets Criteria</b>	
200-Year DWSEL, Through Seepage:		<b>Meets Criteria</b>		Steady State Seepage HTOL, LS:		<b>Meets Criteria</b>	
HTOL, Under Seepage:		<b>Meets Criteria</b>		Rapid Drawdown, WS:		<b>Meets Criteria</b>	
				Seismic Slope Stability, WS:		<b>Meets Criteria</b>	
				Seismic Slope Stability, LS:		<b>Meets Criteria</b>	
Reach Description				Reach Overview			
Station Limits: 849+65 to 853+50 Feature(s) at Upstream Station Limit: South Williamson Road Feature(s) at Downstream Station Limit: End of LSRP Phase 2 / Start of Phase 3 Approx. Crown Elevation Range (feet, NAVD88): 34 to 35 Approx. Levee Height Range (feet): 13.5 to 16 Approx. Crown Width Range (feet): 12 to 12 Approx. Landside Slope (H:V) Range: 3:1 to 3:1 Approx. Waterside Slope (H:V) Range: 2:1 to 2:1 Waterside Constraint(s): Waterside bench/docks/pipe penetration Landside Constraint(s): Trees and residential lots, retaining walls and Oakwood Shore lake 400 to 700 ft Landside repairs associated with PL84-99: None Improvements associated with LSRP P1: None Improvements associated with LSRP P2: None Proposed Improvements associated with LSRP P3: Drained Seepage Berm w/chimney drain

Generalized Subsurface Conditions							
Levee Prism Soils: Silty SAND, SAND and SILT Landside Surface Layer: Lean CLAY and SILT, approx. 10-13 feet thick at toe of levee Soils below surface layer: Approx. 40 feet of SAND, over 15 feet of Lean CLAY							
Historic Performance							
No seepage or slope stability performance issues reported.							
Liquefiable Soils							
Based on our liquefaction assessment, we are not considering liquefiable soils in our slope stability analyses.							
Seepage Analysis Results							
Station	Water Surface	Figure	Exit Gradient			Through Seepage	Breakout Height (ft)*
			Levee Toe	Toe of Berm	Field		
<b>851+20</b>	200-Year	E-67-B	No Positive Gradient	No Positive Gradient	---	No	n/a
	HTOL	E-67-C	No Positive Gradient	No Positive Gradient	---	n/a	n/a
*Vertical distance from the toe of the levee (ground surface) to where the phreatic surface is calculated to daylight on the levee slope. Through seepage under HTOL conditions are not part of this evaluation.

Slope Stability Analysis Results							
Station	Case Analyzed	Water Surface	Figure	Factor of Safety (Circular)		Factor of Safety (Non-Circular)	
				Waterside	Landside	Waterside	Landside
<b>851+20</b>	SS - 200yr	29.8	E-67-D	---	2.5	n/a	n/a
	SS - HTOL	32.8	E-67-E	---	2.5	n/a	n/a
	RDD	18.9	E-67-D	1.8	---	n/a	n/a
	PS	10.4	E-67-F	1.5	1.8	n/a	n/a
	Post-EQ	n/a	n/a	n/a	n/a	n/a	n/a

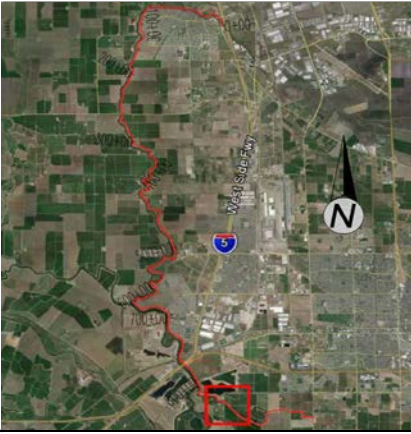
### 10.69 PROJECT REACH P1, STATION 866+50

<b>REACH P1 - STA 866+50</b>								
<b>Based on our evaluation, this reach meets the ULDC Criteria.</b>								
<b>Seepage Evaluation Summary</b>				<b>Slope Stability Evaluation Summary</b>				
200-Year DWSEL, Under Seepage:		<b>Meets Criteria</b>		Steady State Seepage 200-Year DWSEL, LS:		<b>Meets Criteria</b>		
200-Year DWSEL, Through Seepage:		<b>Meets Criteria</b>		Steady State Seepage HTOL, LS:		<b>Meets Criteria</b>		
HTOL, Under Seepage:		<b>Meets Criteria</b>		Rapid Drawdown, WS:		<b>Meets Criteria</b>		
				Seismic Slope Stability, WS:		<b>Meets Criteria</b>		
				Seismic Slope Stability, LS:		<b>Meets Criteria</b>		
<b>Reach Description</b>				<b>Reach Overview</b>				
Station Limits: 853+50 to 867+00

Feature(s) at Upstream Station Limit: Approx. 450 feet south of irrigation ditch								
Feature(s) at Downstream Station Limit: South Williamson Road								
Approx. Crown Elevation Range (feet, NAVD88):		34.5 to 35

Approx. Levee Height Range (feet):		11 to 15						
Approx. Crown Width Range (feet):		15 to 20						
Approx. Landside Slope (H:V) Range:		2.5:1 to 3.5:1						
Approx. Waterside Slope (H:V) Range:		2.5:1 to 3.5:1						
Waterside Constraint(s): Dryland levee								
Landside Constraint(s): Agricultural land								
Landside repairs associated with PL84-99: None								
Improvements associated with LSRP P1: None								
Improvements associated with LSRP P2: None								
Proposed Improvements associated with LSRP P3: None								
<b>Generalized Subsurface Conditions</b>								
Levee Prism Soils: Lean CLAY, SILT, Clayey SAND and Silty SAND								
Landside Surface Layer: SILT with sand, Sandy SILT and Lean CLAY								
Soils below surface layer: Silty SAND and Poorly Graded SAND with SILT								
<b>Historic Performance</b>								
According to the DWR Walthall Slough GER Draft 2, wave wash erosion was recorded between approximate Stations 1853+50 to 1858+30 during a high-water event caused by a breach of an upstream levee in 1996-1997. Some underseepage was observed by KSN somewhere along the dryland levee during the same 1996-1997 high-water event along the dryland levee, however the locations of underseepage are unknown.

<b>Liquefiable Soils</b>								
Based on our liquefaction assessment, we are not considering liquefiable soils in our slope stability analyses.								
<b>Seepage Analysis Results</b>								
Station	Water Surface	Figure	Exit Gradient			Through Seepage	Breakout Height (ft)*	
			Levee Toe	Toe of Berm	Field			
<b>866+50</b>	200-Year	E-68-B	0.34	---	---	Yes**	2.5	
	HTOL	E-68-C	0.44	---	---	n/a	n/a	
*Vertical distance from the toe of the levee (ground surface) to where the phreatic surface is calculated to daylight on the levee slope. Through seepage under HTOL conditions are not part of this evaluation.

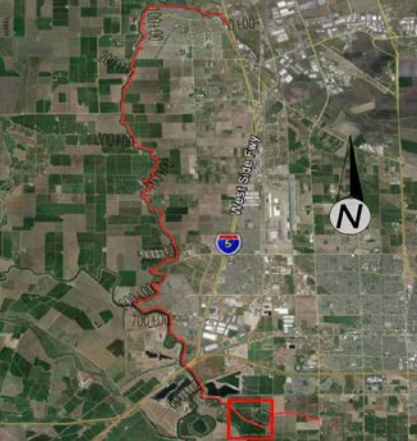
## 10.70 PROJECT REACH P2, STATION 876+00

<b>REACH P2 - STA 876+00</b>							
<b>Based on our evaluation, this reach does not meet the ULDC Criteria.</b>							
<b>Seepage Evaluation Summary</b>				<b>Slope Stability Evaluation Summary</b>			
200-Year DWSEL, Under Seepage:	<b>Meets Criteria</b>			Steady State Seepage 200-Year DWSEL, LS:	<b>Meets Criteria</b>		
200-Year DWSEL, Through Seepage:	<b>Fails Criteria</b>			Steady State Seepage HTOL, LS:	<b>Meets Criteria</b>		
HTOL, Under Seepage:	<b>Meets Criteria</b>			Rapid Drawdown, WS:	<b>Meets Criteria</b>		
				Seismic Slope Stability, WS:	<b>Meets Criteria</b>		
				Seismic Slope Stability, LS:	<b>Meets Criteria</b>		
<b>Reach Description</b>				<b>Reach Overview</b>			
Station Limits: 867+00 to 909+00

Feature(s) at Upstream Station Limit: Agriculture road							
Feature(s) at Downstream Station Limit: Approx. 450 feet south of irrigation ditch							
Approx. Crown Elevation Range (feet, NAVD88):	34	to	37

Approx. Levee Height Range (feet):	9	to	14				
Approx. Crown Width Range (feet):	16.5	to	42				
Approx. Landside Slope (H:V) Range:	2.5:1	to	5:1				
Approx. Waterside Slope (H:V) Range:	2.5:1	to	5:1				
Waterside Constraint(s): Dryland levee, agricultural land							
Landside Constraint(s): Agriculture land							
Landside repairs associated with PL84-99: None							
Improvements associated with LSRP P1: None							
Improvements associated with LSRP P2: None							
Proposed Improvements associated with LSRP P3: None							
<b>Generalized Subsurface Conditions</b>							
Levee Prism Soils: Silty SAND, SILT, Lean CLAY							
Landside Surface Layer: Lean Clay, SILT, Silty SAND and Clayey SAND							
Soils below surface layer: Silty SAND over Poorly Graded SAND with SILT							
<b>Historic Performance</b>							
According to the DWR Walthall Slough GER Draft 2, some underseepage was observed by KSN somewhere along the dryland levee after an upstream levee breached during the 1996-1997 high-water event. The locations of underseepage are unknown however.

<b>Liquefiable Soils</b>							
Based on our liquefaction assessment, we are not considering liquefiable soils in our slope stability analyses.							
<b>Seepage Analysis Results</b>							
Station	Water Surface	Figure	Exit Gradient			Through Seepage	Breakout Height (ft)*
			Levee Toe	Toe of Berm	Field		
<b>876+00</b>	200-Year	E-69-B	No Positive Gradient	---	0.05	Yes	2.6
	HTOL	E-69-C	No Positive Gradient	---	0.07	n/a	n/a
*Vertical distance from the toe of the levee (ground surface) to where the phreatic surface is calculated to daylight on the levee slope. Through seepage under HTOL conditions are not part of this evaluation.							
<b>Slope Stability Analysis Results</b>							
Station	Case Analyzed	Water Surface (ft)	Figure	Factor of Safety (Circular)		Factor of Safety (Non-Circular)	
				Waterside	Landside	Waterside	Landside
<b>876+00</b>	SS - 200yr	29.9	E-69-D	---	1.4	n/a	n/a
	SS - HTOL	32.9	E-69-E	---	1.2	n/a	n/a

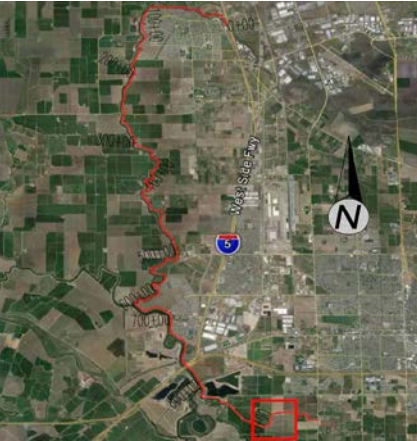
## 10.71 PROJECT REACH Q1, STATION 915+50

<b>REACH Q1 - STA 915+50</b>							
<b>Based on our evaluation, this reach does not meet the ULDC Criteria.</b>							
<b>Seepage Evaluation Summary</b>				<b>Slope Stability Evaluation Summary</b>			
200-Year DWSEL, Under Seepage:		Meets Criteria		Steady State Seepage 200-Year DWSEL, LS:		Meets Criteria	
200-Year DWSEL, Through Seepage:		Fails Criteria		Steady State Seepage HTOL, LS:		Meets Criteria	
HTOL, Under Seepage:		Meets Criteria		Rapid Drawdown, WS:		Meets Criteria	
				Seismic Slope Stability, WS:		Meets Criteria	
				Seismic Slope Stability, LS:		Meets Criteria	
<b>Reach Description</b>				<b>Reach Overview</b>			
Station Limits:		909+00 to 944+00

Feature(s) at Upstream Station Limit: Agriculture road							
Feature(s) at Downstream Station Limit: Agriculture road							
Approx. Crown Elevation Range (feet, NAVD88):		34 to 35					
Approx. Levee Height Range (feet):		11 to 14					
Approx. Crown Width Range (feet):		16 to 42

Approx. Landside Slope (H:V) Range:		4:1 to 7:1					
Approx. Waterside Slope (H:V) Range:		3.5:1 to 7:1					
Waterside Constraint(s): Orchards							
Landside Constraint(s): Agriculture							
Landside repairs associated with PL84-99: None							
Improvements associated with LSRP P1: None							
Improvements associated with LSRP P2: None							
Proposed Improvements associated with LSRP P3: None							
<b>Generalized Subsurface Conditions</b>							
Levee Prism Soils: Silty SAND and Poorly Graded SAND with SILT							
Landside Surface Layer: Silty Sand, approx. 15 feet thick							
Soils below surface layer: SILT and CLAY							
<b>Historic Performance</b>							
According to the DWR Walthall Slough GER Draft 2, some underseepage was observed by KSN somewhere along the dryland levee after an upstream levee breached during the 1996-1997 high-water event. The locations of underseepage are unknown however.

<b>Liquefiable Soils</b>							
Based on our liquefaction assessment, we are not considering liquefiable soils in our slope stability analyses.							
<b>Seepage Analysis Results</b>							
Station	Water Surface	Figure	Exit Gradient			Through Seepage	Breakout Height (ft)*
			Levee Toe	Toe of Berm	Field		
915+50	200-Year	E-70-B	0.34	---	---	Yes	2.5
	HTOL	E-70-C	0.40	---	---	n/a	n/a
*Vertical distance from the toe of the levee (ground surface) to where the phreatic surface is calculated to daylight on the levee slope. Through seepage under HTOL conditions are not part of this evaluation.							
<b>Slope Stability Analysis Results</b>							
Station	Case Analyzed	Water Surface (ft)	Figure	Factor of Safety (Circular)		Factor of Safety (Non-Circular)	
				Waterside	Landside	Waterside	Landside
915+50	SS - 200yr	30.4	E-70-D	---	2.3	n/a	n/a
	SS - HTOL	33.0	E-70-E	---	2.1	n/a	n/a
	RDD	19.5	E-70-D	3.4	---	n/a	n/a

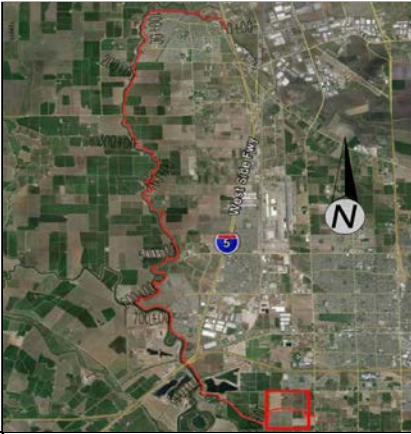
## 10.72 PROJECT REACH R1, STATION 955+00

<b>REACH R1 - STA 955+00</b>							
<b>Based on our evaluation, this reach does not meet the ULDC Criteria.</b>							
<b>Seepage Evaluation Summary</b>				<b>Slope Stability Evaluation Summary</b>			
200-Year DWSEL, Under Seepage:		<b>Meets Criteria</b>		Steady State Seepage 200-Year DWSEL, LS:		<b>Meets Criteria</b>	
200-Year DWSEL, Through Seepage:		<b>Fails Criteria</b>		Steady State Seepage HTOL, LS:		<b>Meets Criteria</b>	
HTOL, Under Seepage:		<b>Meets Criteria</b>		Rapid Drawdown, WS:		<b>Meets Criteria</b>	
				Seismic Slope Stability, WS:		<b>Meets Criteria</b>	
				Seismic Slope Stability, LS:		<b>Meets Criteria</b>	
<b>Reach Description</b>				<b>Reach Overview</b>			
Station Limits: 944+00 to 959+00

Feature(s) at Upstream Station Limit: Agriculture road							
Feature(s) at Downstream Station Limit: Agriculture road							
Approx. Crown Elevation Range (feet, NAVD88):		32 to 35

Approx. Levee Height Range (feet):		9 to 13					
Approx. Crown Width Range (feet):		13 to 23					
Approx. Landside Slope (H:V) Range:		2.5:1 to 3.5:1					
Approx. Waterside Slope (H:V) Range:		2.9:1 to 5:1					
Waterside Constraint(s): Dryland levee, orchard							
Landside Constraint(s): None - agricultural land							
Landside repairs associated with PL84-99: None							
Improvements associated with LSRP P1: None							
Improvements associated with LSRP P2: None							
Proposed Improvements associated with LSRP P3: None							
<b>Generalized Subsurface Conditions</b>							
Levee Prism Soils: Silty SAND							
Landside Surface Layer: Silty Sand, approx. 4.5 feet thick							
Soils below surface layer: Silty CLAY, Poorly Graded SAND, and Silty SAND							
<b>Historic Performance</b>							
According to the DWR Walthall Slough GER Draft 2, some underseepage was observed by KSN after an upstream levee breached during the 1996-1997 high-water event. The locations of underseepage are unknown however.

<b>Liquefiable Soils</b>							
Based on our liquefaction assessment, we are not considering liquefiable soils in our slope stability analyses.							
<b>Seepage Analysis Results</b>							
Station	Water Surface	Figure	Exit Gradient			Through Seepage	Breakout Height (ft)*
			Levee Toe	Toe of Berm	Field		
955+00	200-Year	E-71-B	0.49	---	---	Yes	2.8
	HTOL	E-71-C	0.64	---	---	n/a	n/a
*Vertical distance from the toe of the levee (ground surface) to where the phreatic surface is calculated to daylight on the levee slope. Through seepage under HTOL conditions are not part of this evaluation.							
<b>Slope Stability Analysis Results</b>							
Station	Case Analyzed	Water Surface (ft)	Figure	Factor of Safety (Circular)		Factor of Safety (Non-Circular)	
				Waterside	Landside	Waterside	Landside
955+00	SS - 200yr	30.4	E-71-D	---	1.7	n/a	n/a
	SS - HTOL	33.0	E-71-E	---	1.5	n/a	n/a
	RDD	19.5	E-71-D	3.0	---	n/a	n/a

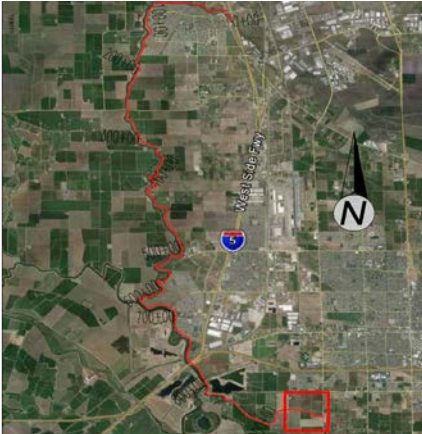
### 10.73 PROJECT REACH S1, STATION 965+00

<b>REACH S1 - STA 965+00</b>							
<b>Based on our evaluation, this reach does not meet the ULDC Criteria.</b>							
<b>Seepage Evaluation Summary</b>				<b>Slope Stability Evaluation Summary</b>			
200-Year DWSEL, Under Seepage:		Meets Criteria		Steady State Seepage 200-Year DWSEL, LS:		Meets Criteria	
200-Year DWSEL, Through Seepage:		Fails Criteria		Steady State Seepage HTOL, LS:		Meets Criteria	
HTOL, Under Seepage:		Meets Criteria		Rapid Drawdown, WS:		Meets Criteria	
				Seismic Slope Stability, WS:		Meets Criteria	
				Seismic Slope Stability, LS:		Meets Criteria	
<b>Reach Description</b>				<b>Reach Overview</b>			
Station Limits: 959+00 to 972+00 Feature(s) at Upstream Station Limit: 90 degree bend in levee Feature(s) at Downstream Station Limit: 90 degree bend in levee Approx. Crown Elevation Range (feet, NAVD88): 34 to 35 Approx. Levee Height Range (feet): 9 to 11 Approx. Crown Width Range (feet): 12 to 14 Approx. Landside Slope (H:V) Range: 2.0:1 to 4.5:1 Approx. Waterside Slope (H:V) Range: 2.5:1 to 3.0:1 Waterside Constraint(s): Orchard and ditch at waterside toe, 15 to 34 feet wide, 3 to 4 feet deep Landside Constraint(s): None - agricultural land Landside repairs associated with PL84-99: None Improvements associated with LSRP P1: None Improvements associated with LSRP P2: None Proposed Improvements associated with LSRP P3: None

<b>Generalized Subsurface Conditions</b>							
Levee Prism Soils: Silty SAND Landside Surface Layer: Silty Sand, approx. 2 to 10 feet thick Soils below surface layer: Poorly Graded SAND and Lean CLAY							
<b>Historic Performance</b>							
According to the DWR Walthall Slough GER Draft 2, some underseepage was observed by KSN after an upstream levee breached during the 1996-1997 high-water event. The locations of underseepage are unknown however.							
<b>Liquefiable Soils</b>							
Based on our liquefaction assessment, we are not considering liquefiable soils in our slope stability analyses.							
<b>Seepage Analysis Results</b>							
Station	Water Surface	Figure	Exit Gradient			Through Seepage	Breakout Height (ft)*
			Levee Toe	Toe of Berm	Field		
965+00	200-Year	E-72-B	0.26	---	---	Yes	1
	HTOL	E-72-C	0.45	---	---	n/a	n/a
*Vertical distance from the toe of the levee (ground surface) to where the phreatic surface is calculated to daylight on the levee slope. Through seepage under HTOL conditions are not part of this evaluation.

<b>Slope Stability Analysis Results</b>							
Station	Case Analyzed	Water Surface (ft)	Figure	Factor of Safety (Circular)		Factor of Safety (Non-Circular)	
				Waterside	Landside	Waterside	Landside
965+00	SS - 200yr	30.5	E-72-D	---	1.5	n/a	n/a
	SS - HTOL	33.0	E-72-E	---	1.3	n/a	n/a
	RDD	19.5	E-72-D	1.9	---	n/a	n/a
	PS	10.4	E-72-F	1.7	1.5	n/a	n/a
	Post-EQ	n/a	n/a	n/a	n/a	n/a	n/a

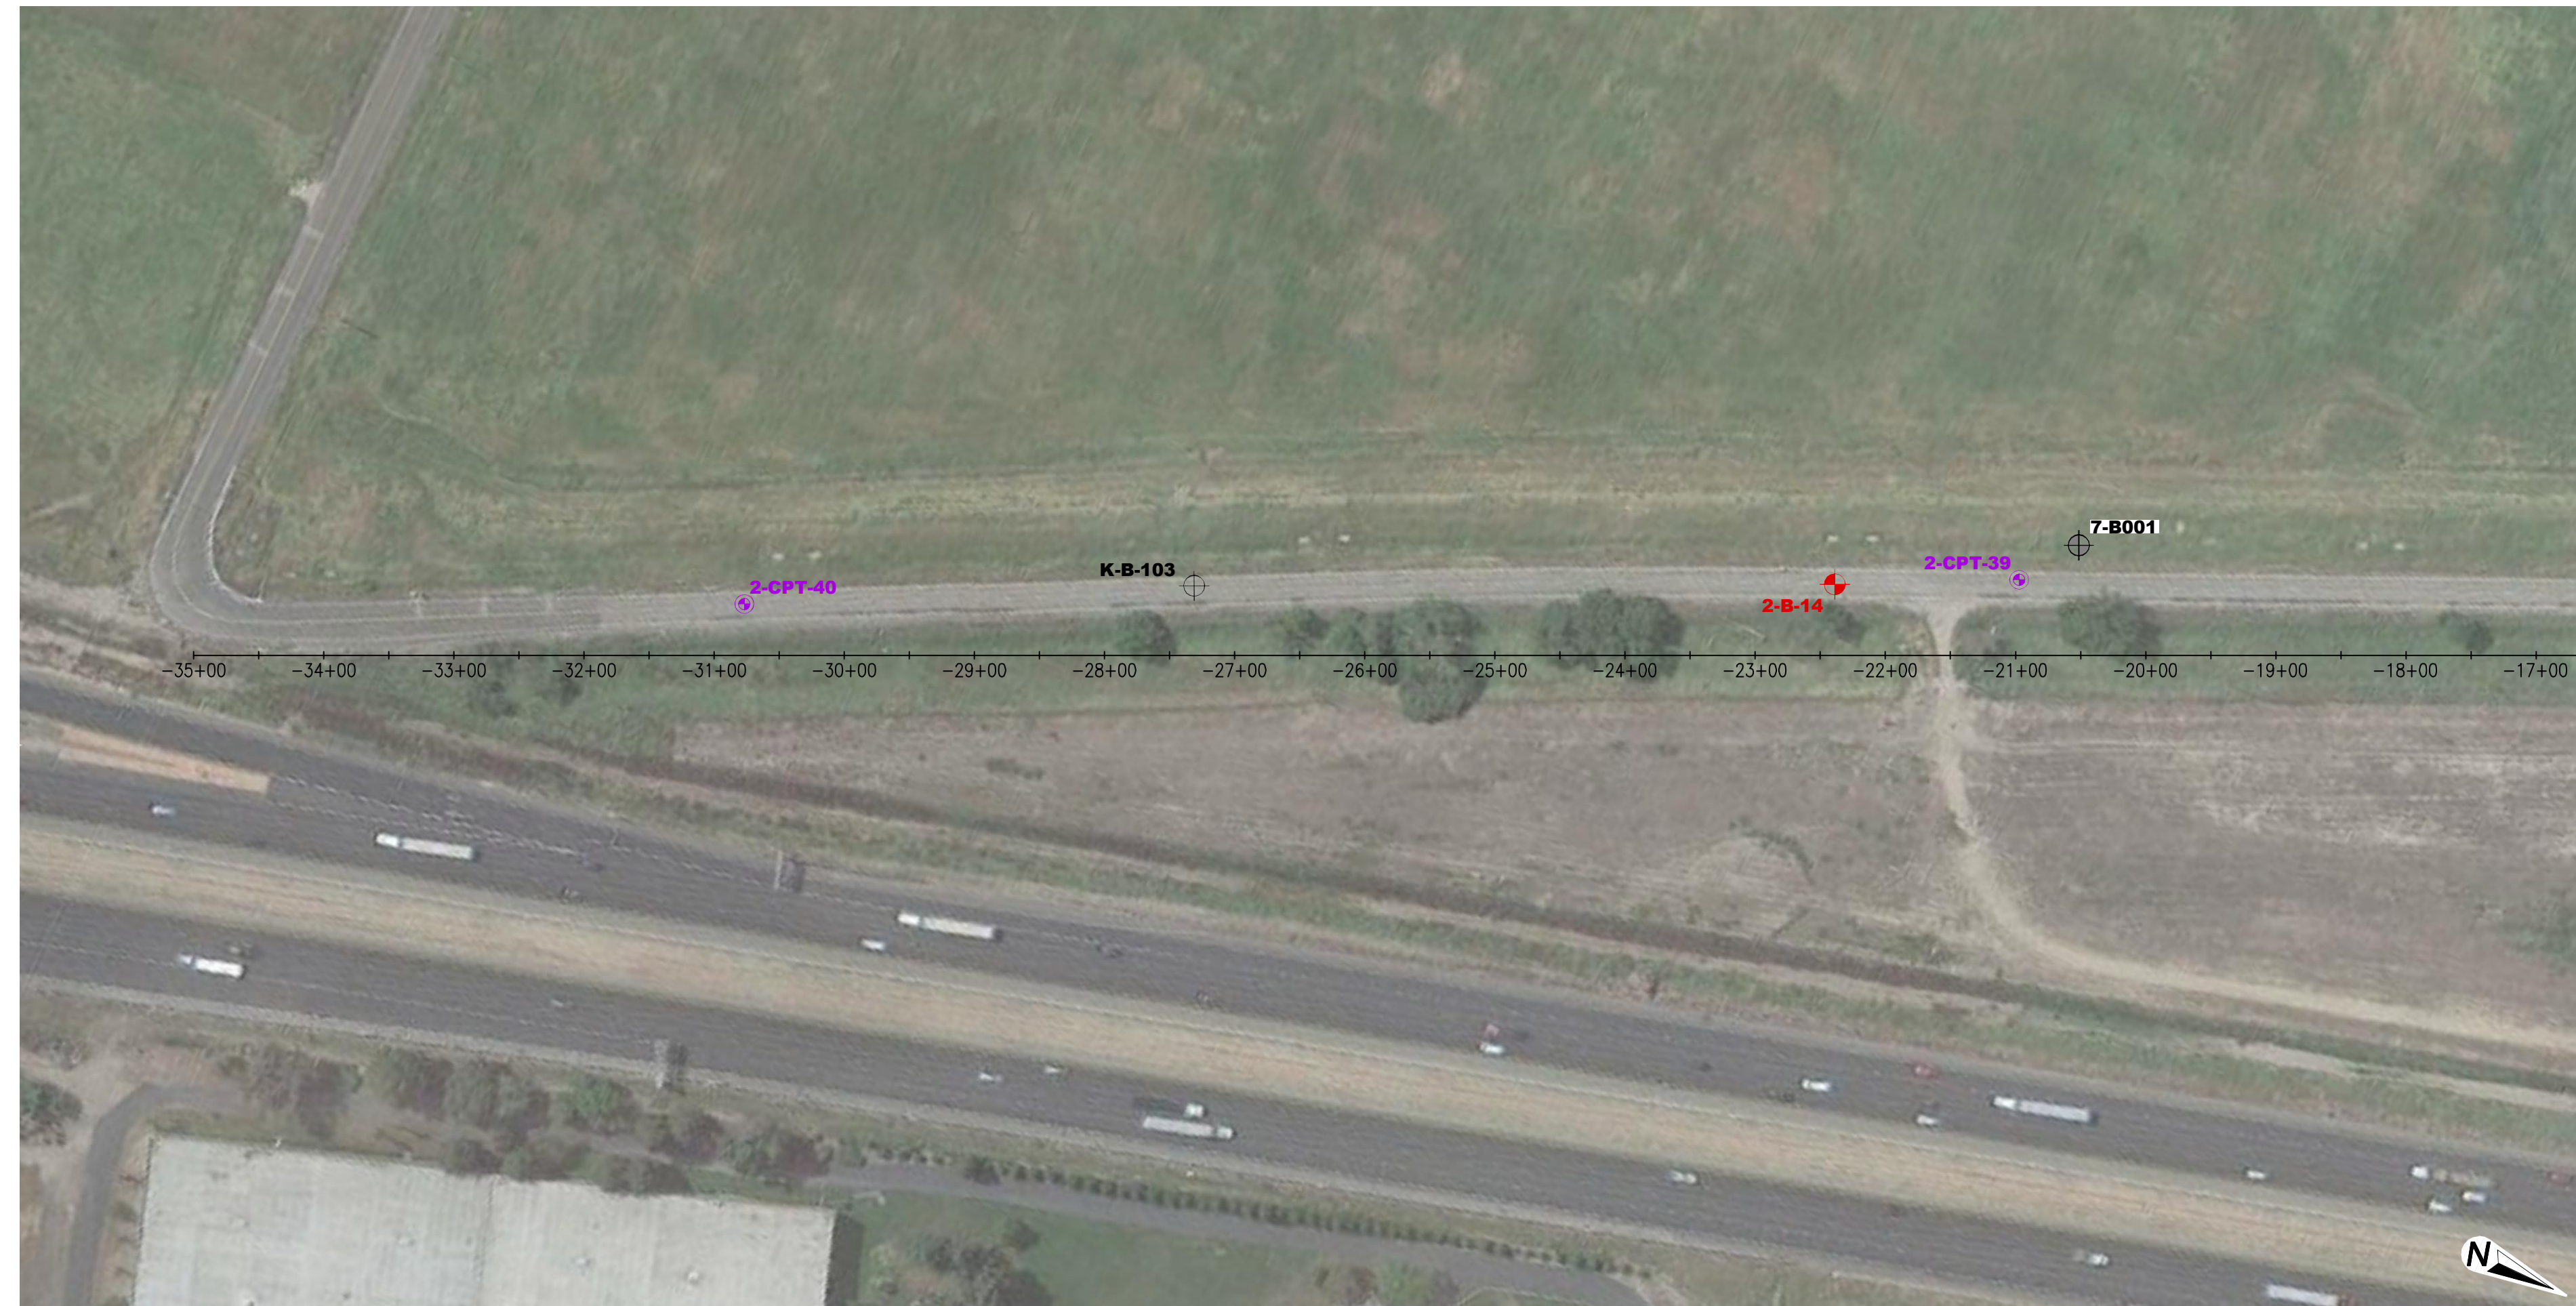
PLAN  
SCALE: 1"=100'

PROFILE  
SCALE: H:1"=100', V:1"=20'
