# URBAN LEVEE DESIGN CRITERIA EVALUATION

MOSSDALE TRACT  
RECLAMATION DISTRICT NO. 17  
SAN JOAQUIN COUNTY, CALIFORNIA

Subject: Mossdale Tract  
Reclamation District No. 17  
San Joaquin County, California

## URBAN LEVEE DESIGN CRITERIA EVALUATION

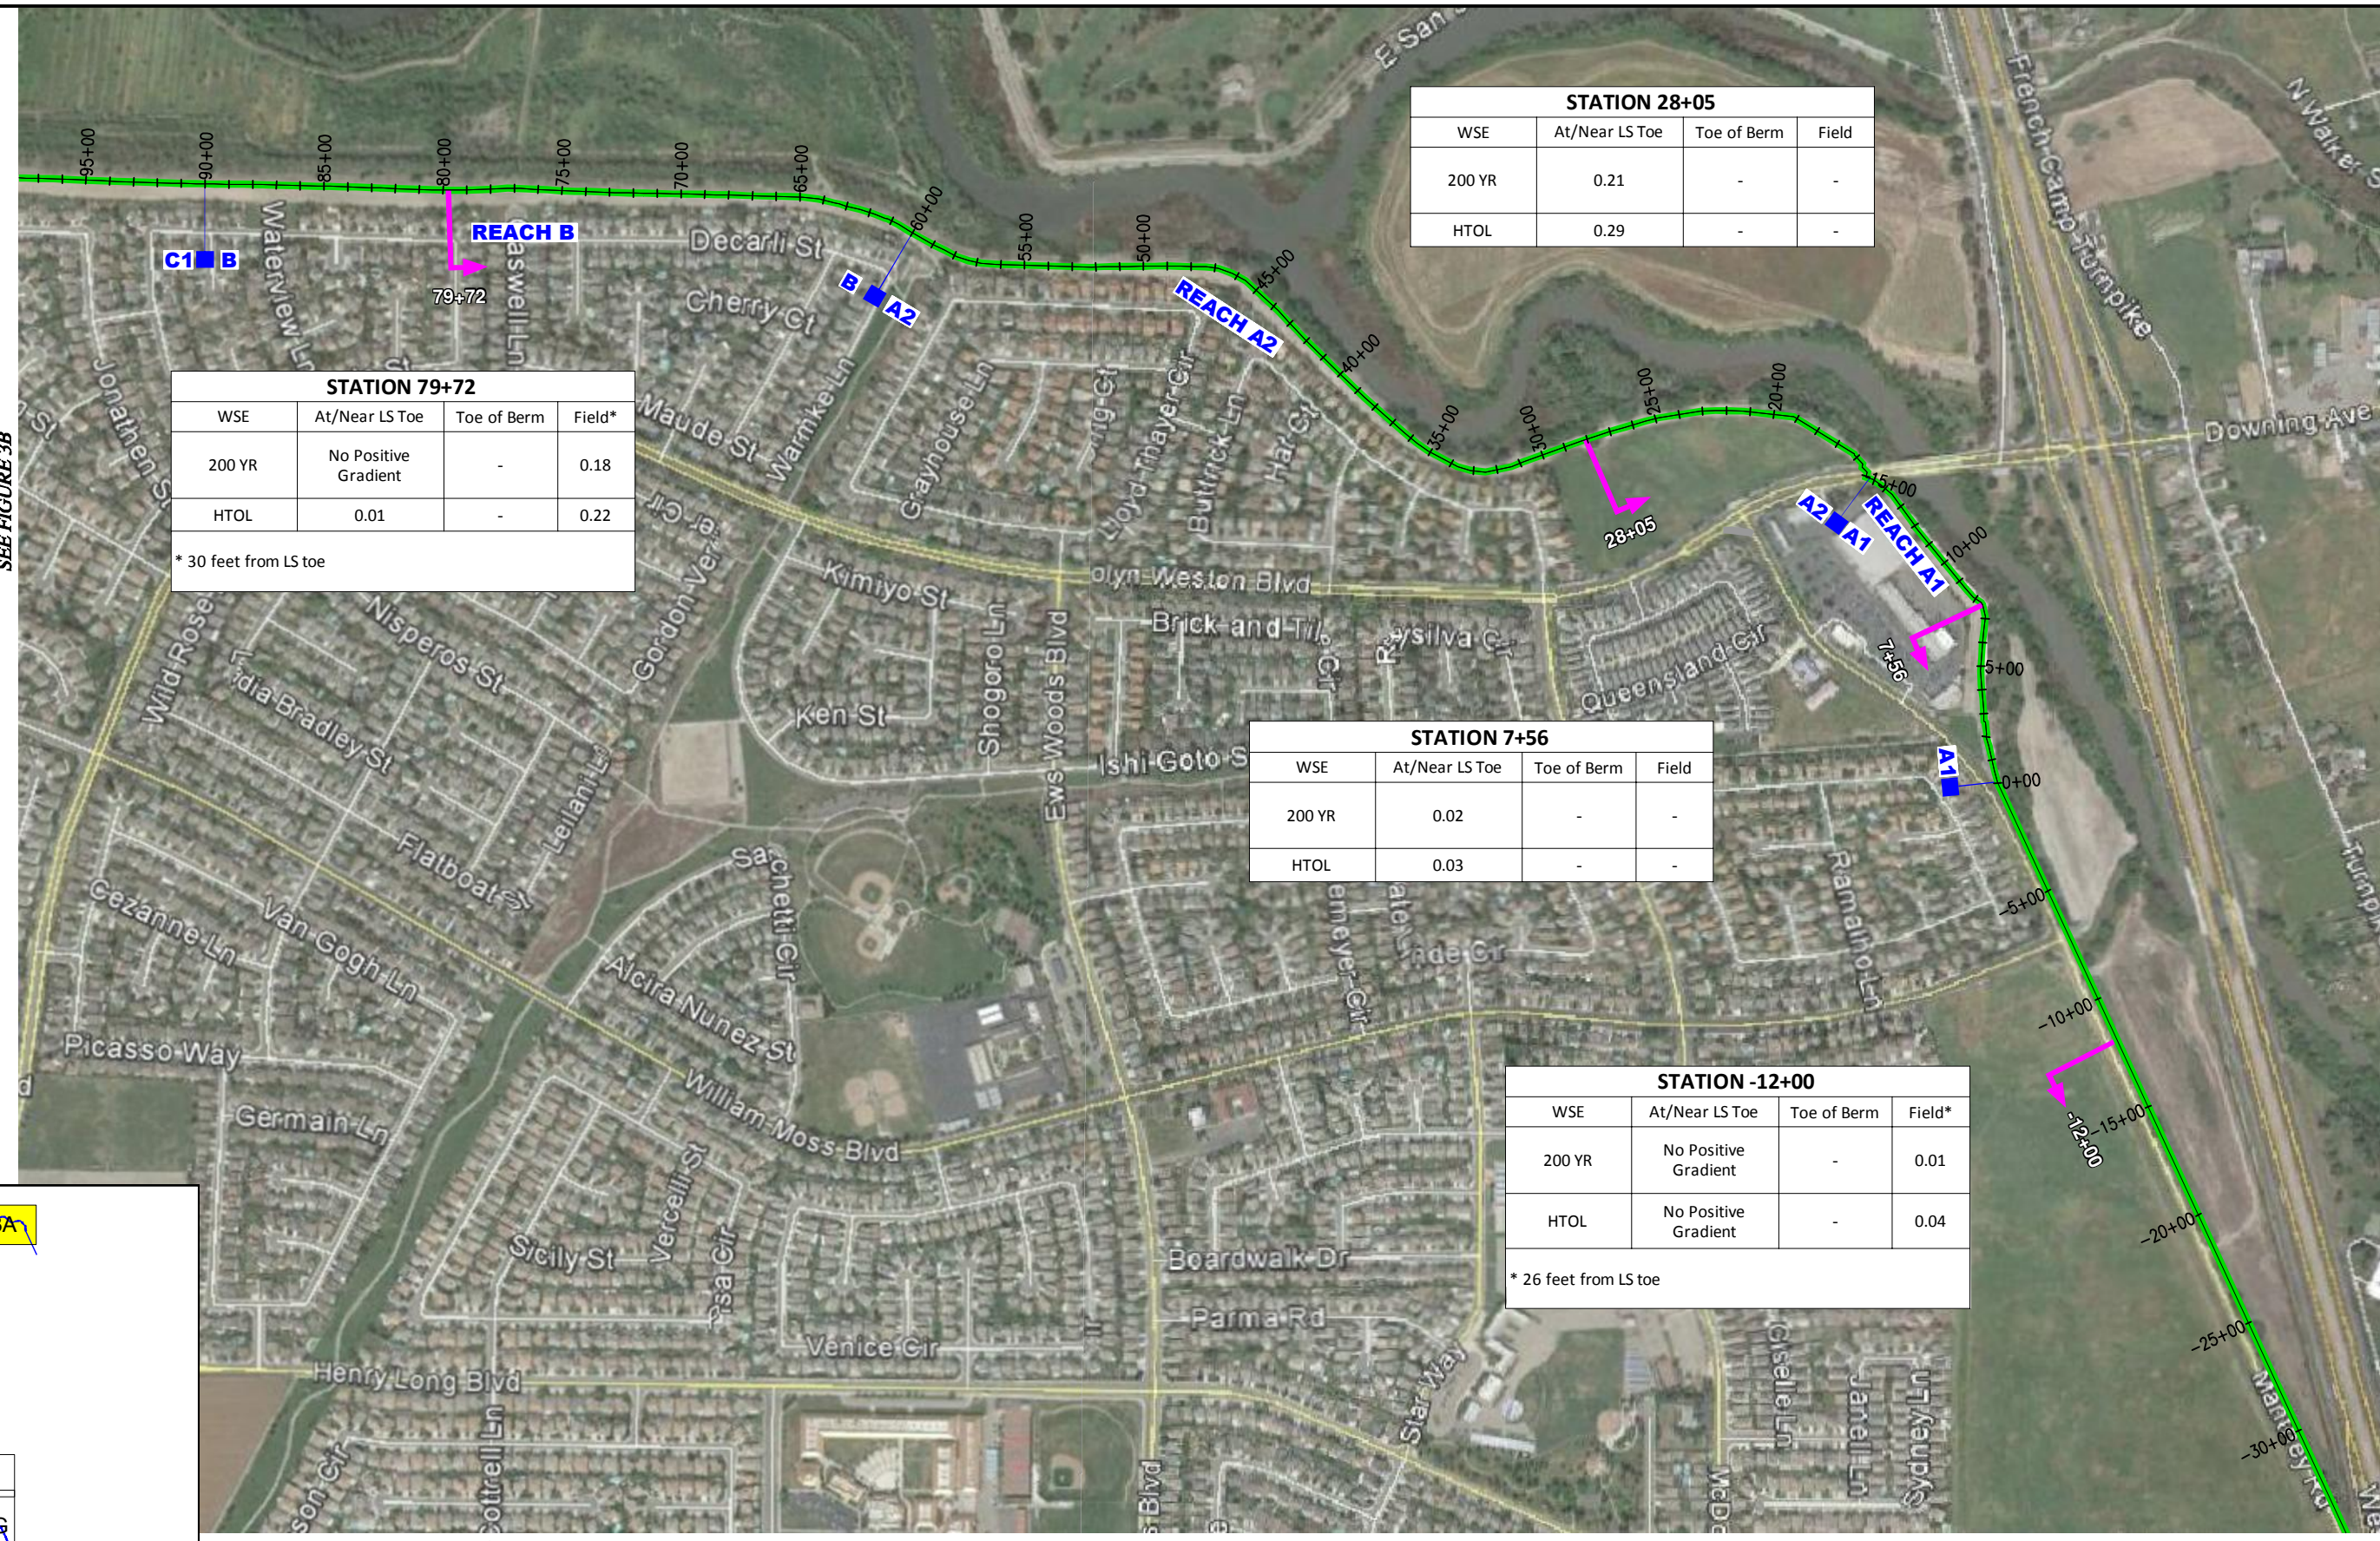
FIGURE NO.  
**3A**

STATION 79+72			
WSE	At/Near LS Toe	Toe of Berm	Field*
200 YR	No Positive Gradient	-	0.18
HTOL	0.01	-	0.22

\* 30 feet from LS toe

STATION -12+00			
WSE	At/Near LS Toe	Toe of Berm	Field*
200 YR	No Positive Gradient	-	0.01
HTOL	No Positive Gradient	-	0.04

\* 26 feet from LS toe

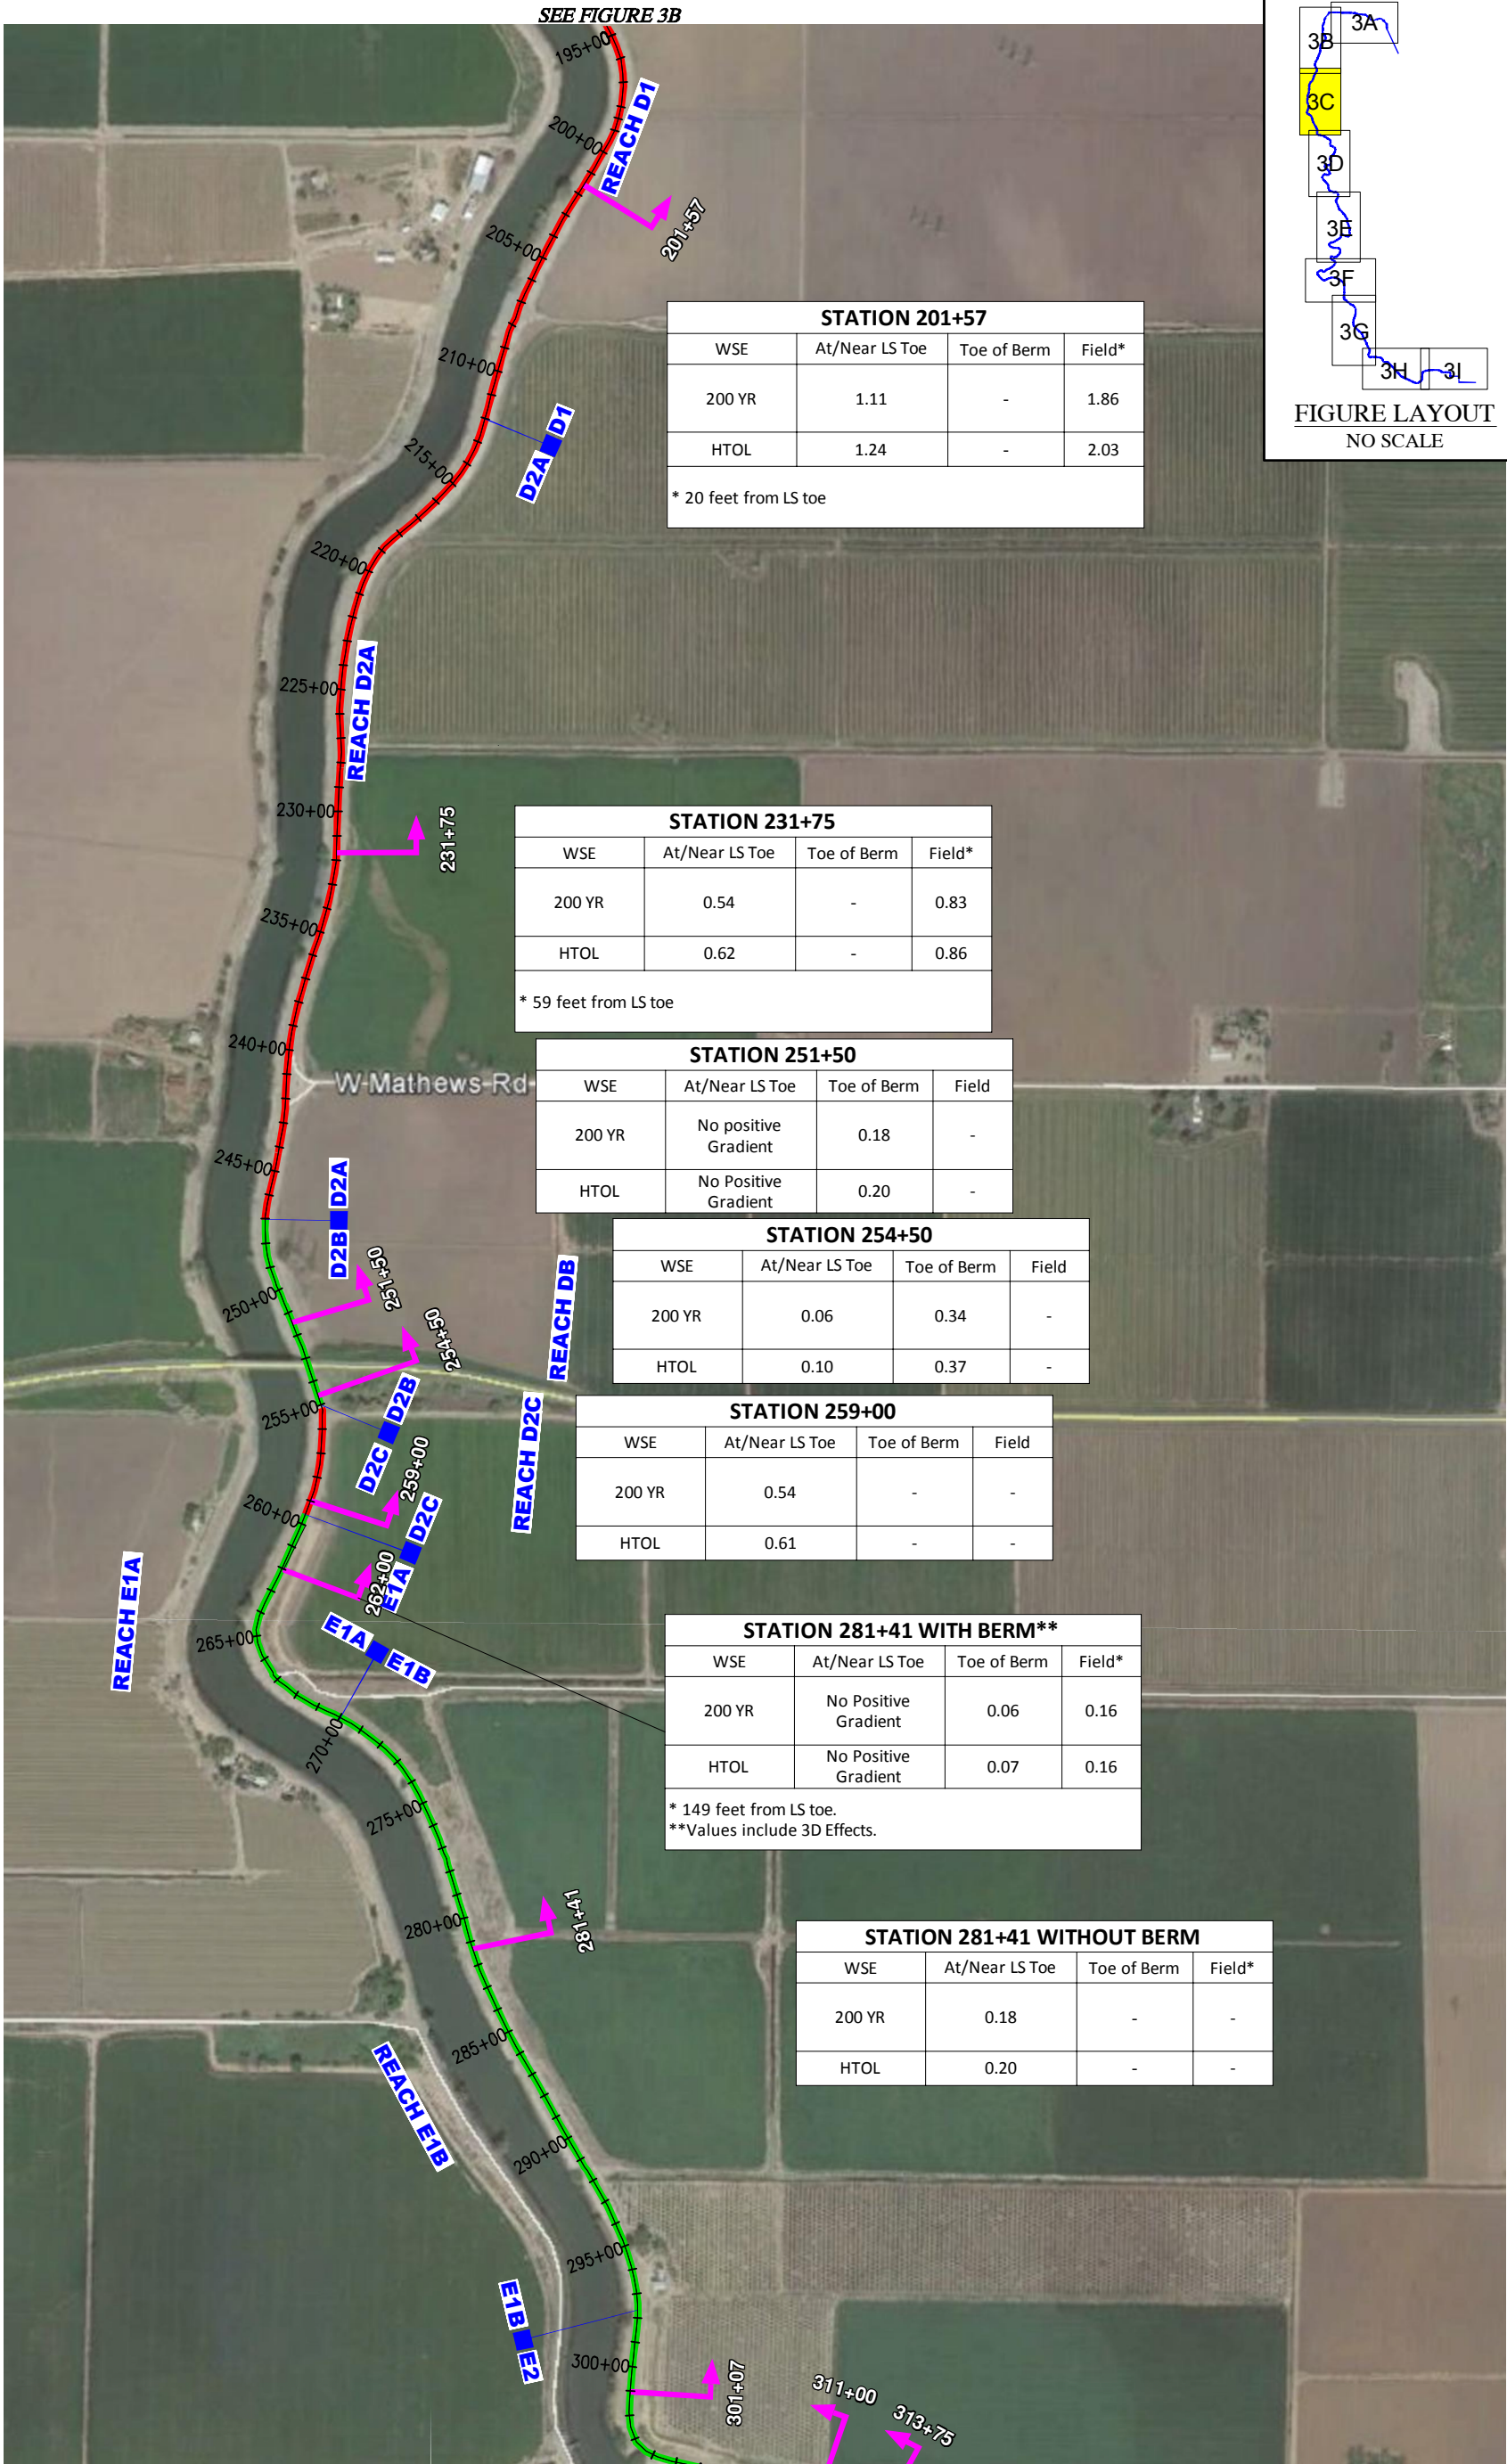
FIGURE NO.  
**3C**

**STATION 201+57**

WSE	At/Near LS Toe	Toe of Berm	Field*
200 YR	1.11	-	1.86
HTOL	1.24	-	2.03

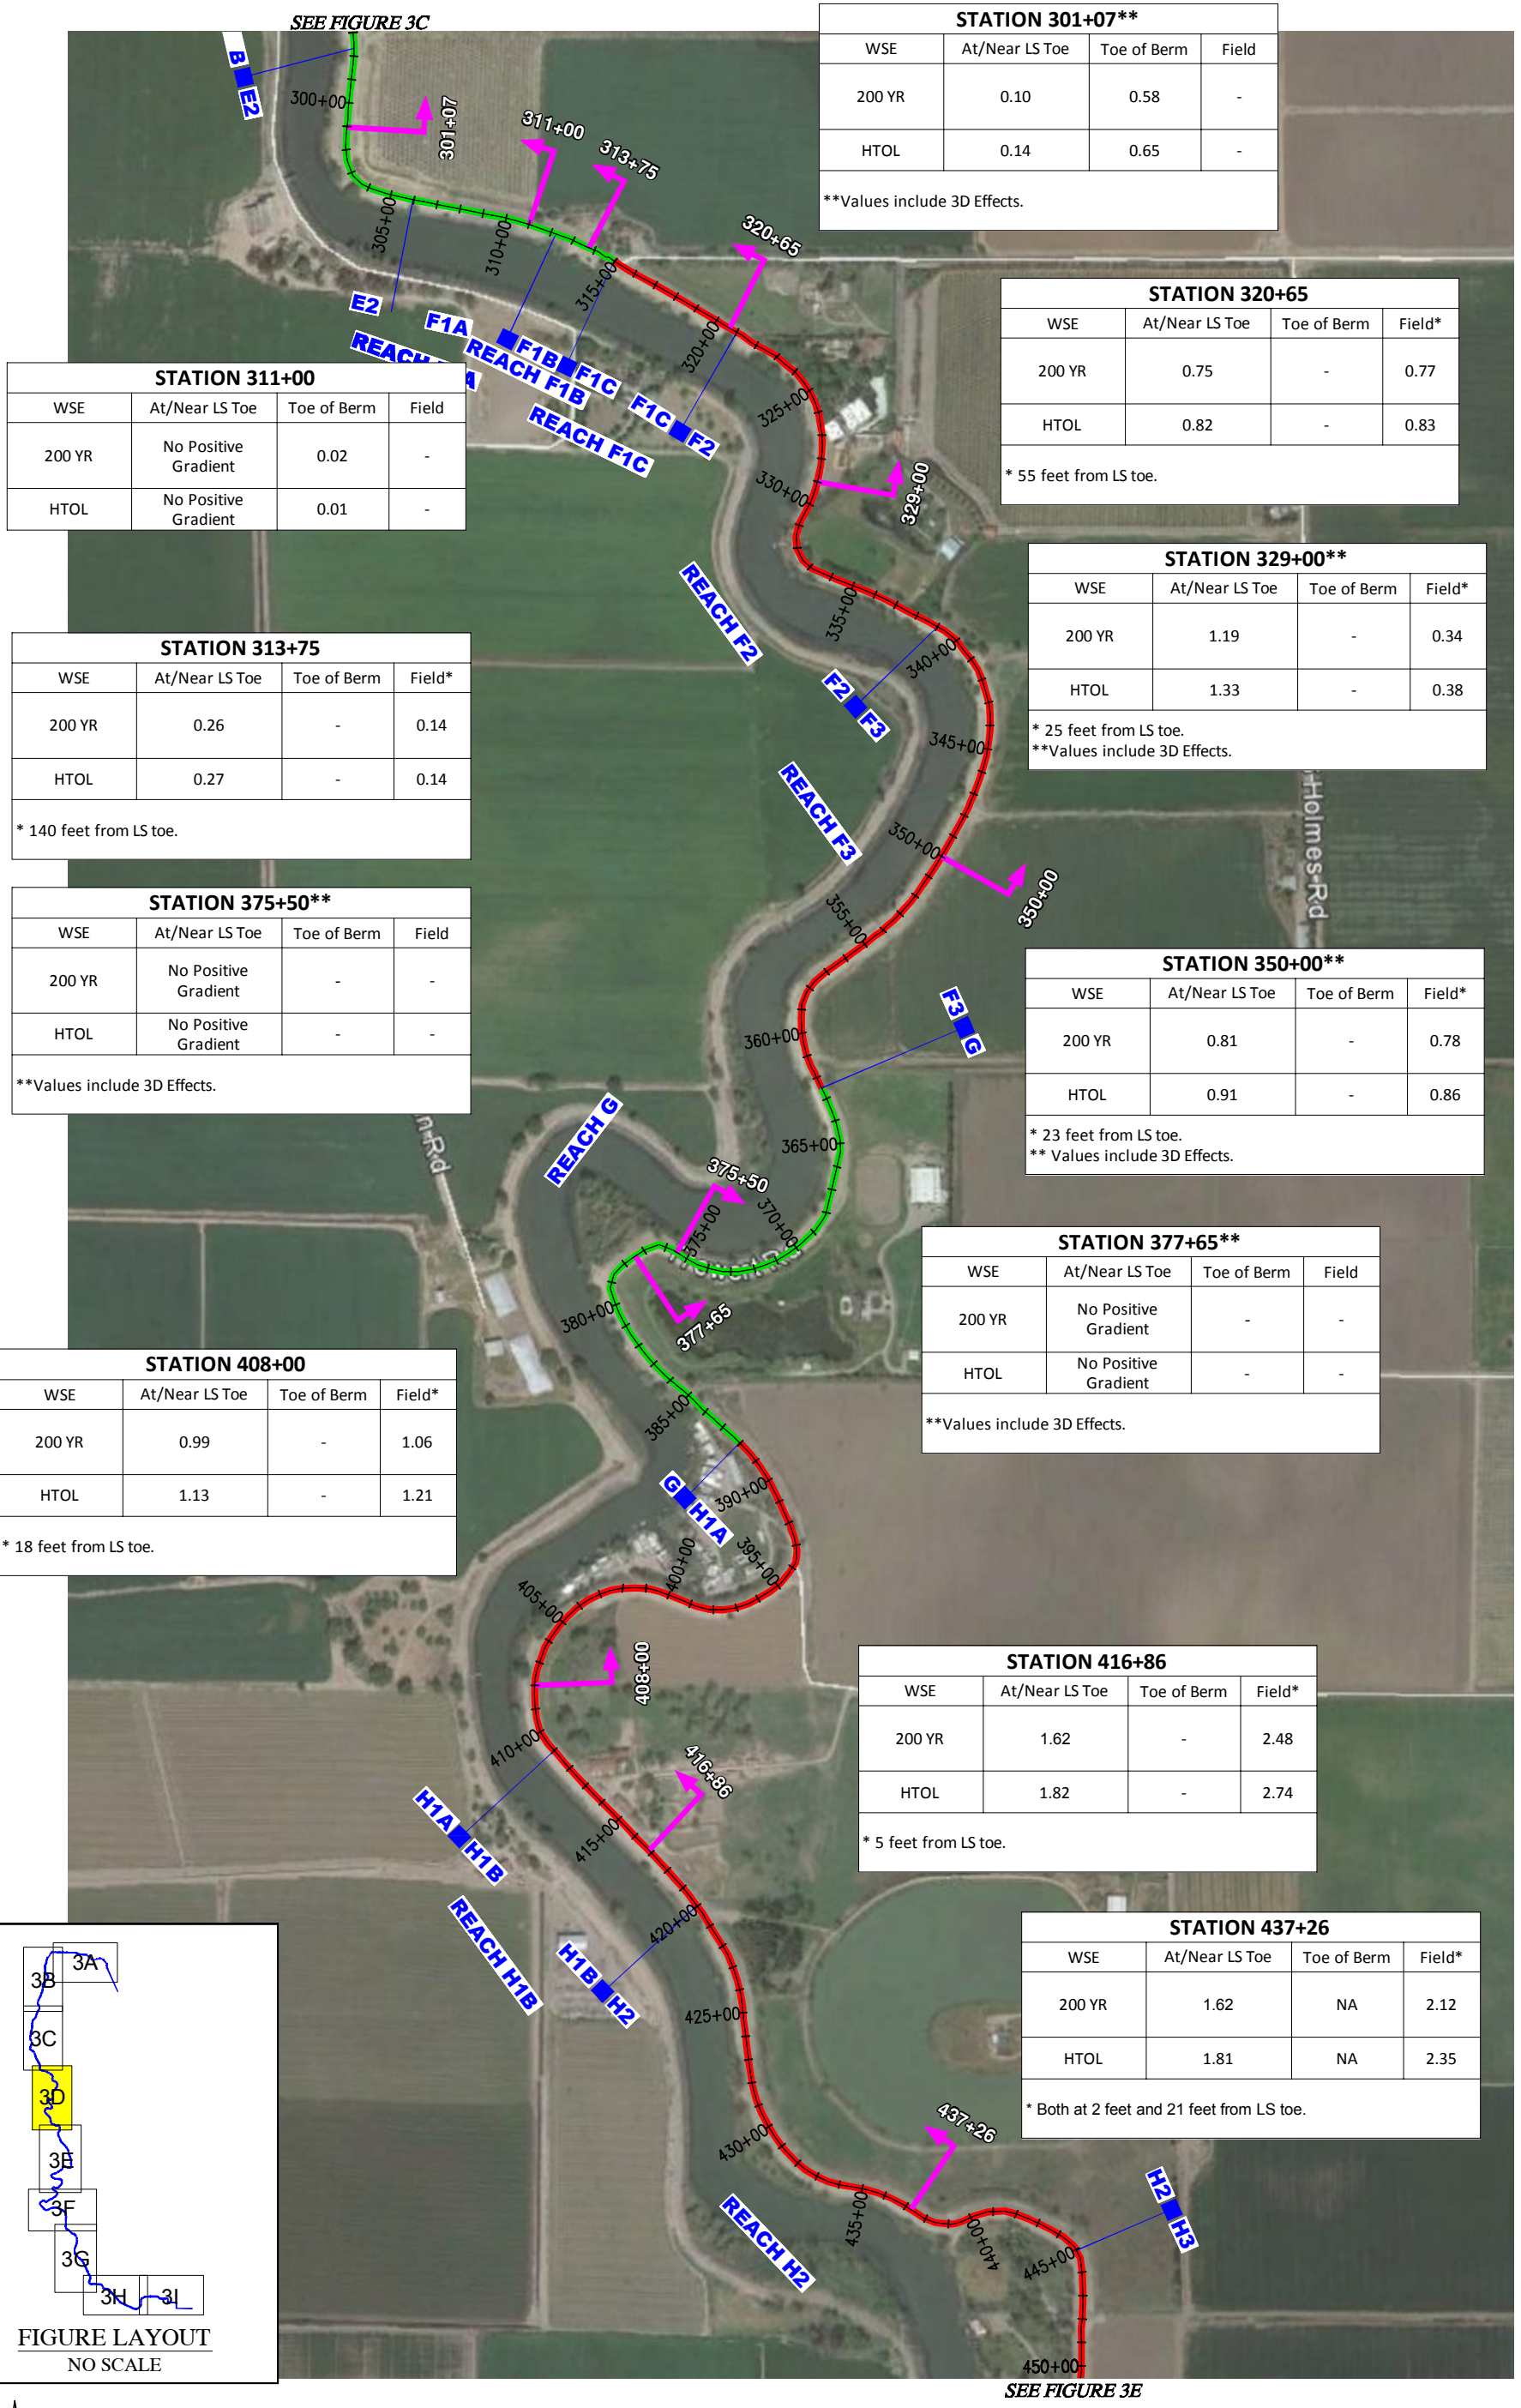
FIGURE NO.  
**3D**

STATION 301+07**			
WSE	At/Near LS Toe	Toe of Berm	Field
200 YR	0.10	0.58	-
HTOL	0.14	0.65	-

\*\*Values include 3D Effects.

STATION 437+26			
WSE	At/Near LS Toe	Toe of Berm	Field*
200 YR	1.62	NA	2.12
HTOL	1.81	NA	2.35

\* Both at 2 feet and 21 feet from LS toe.

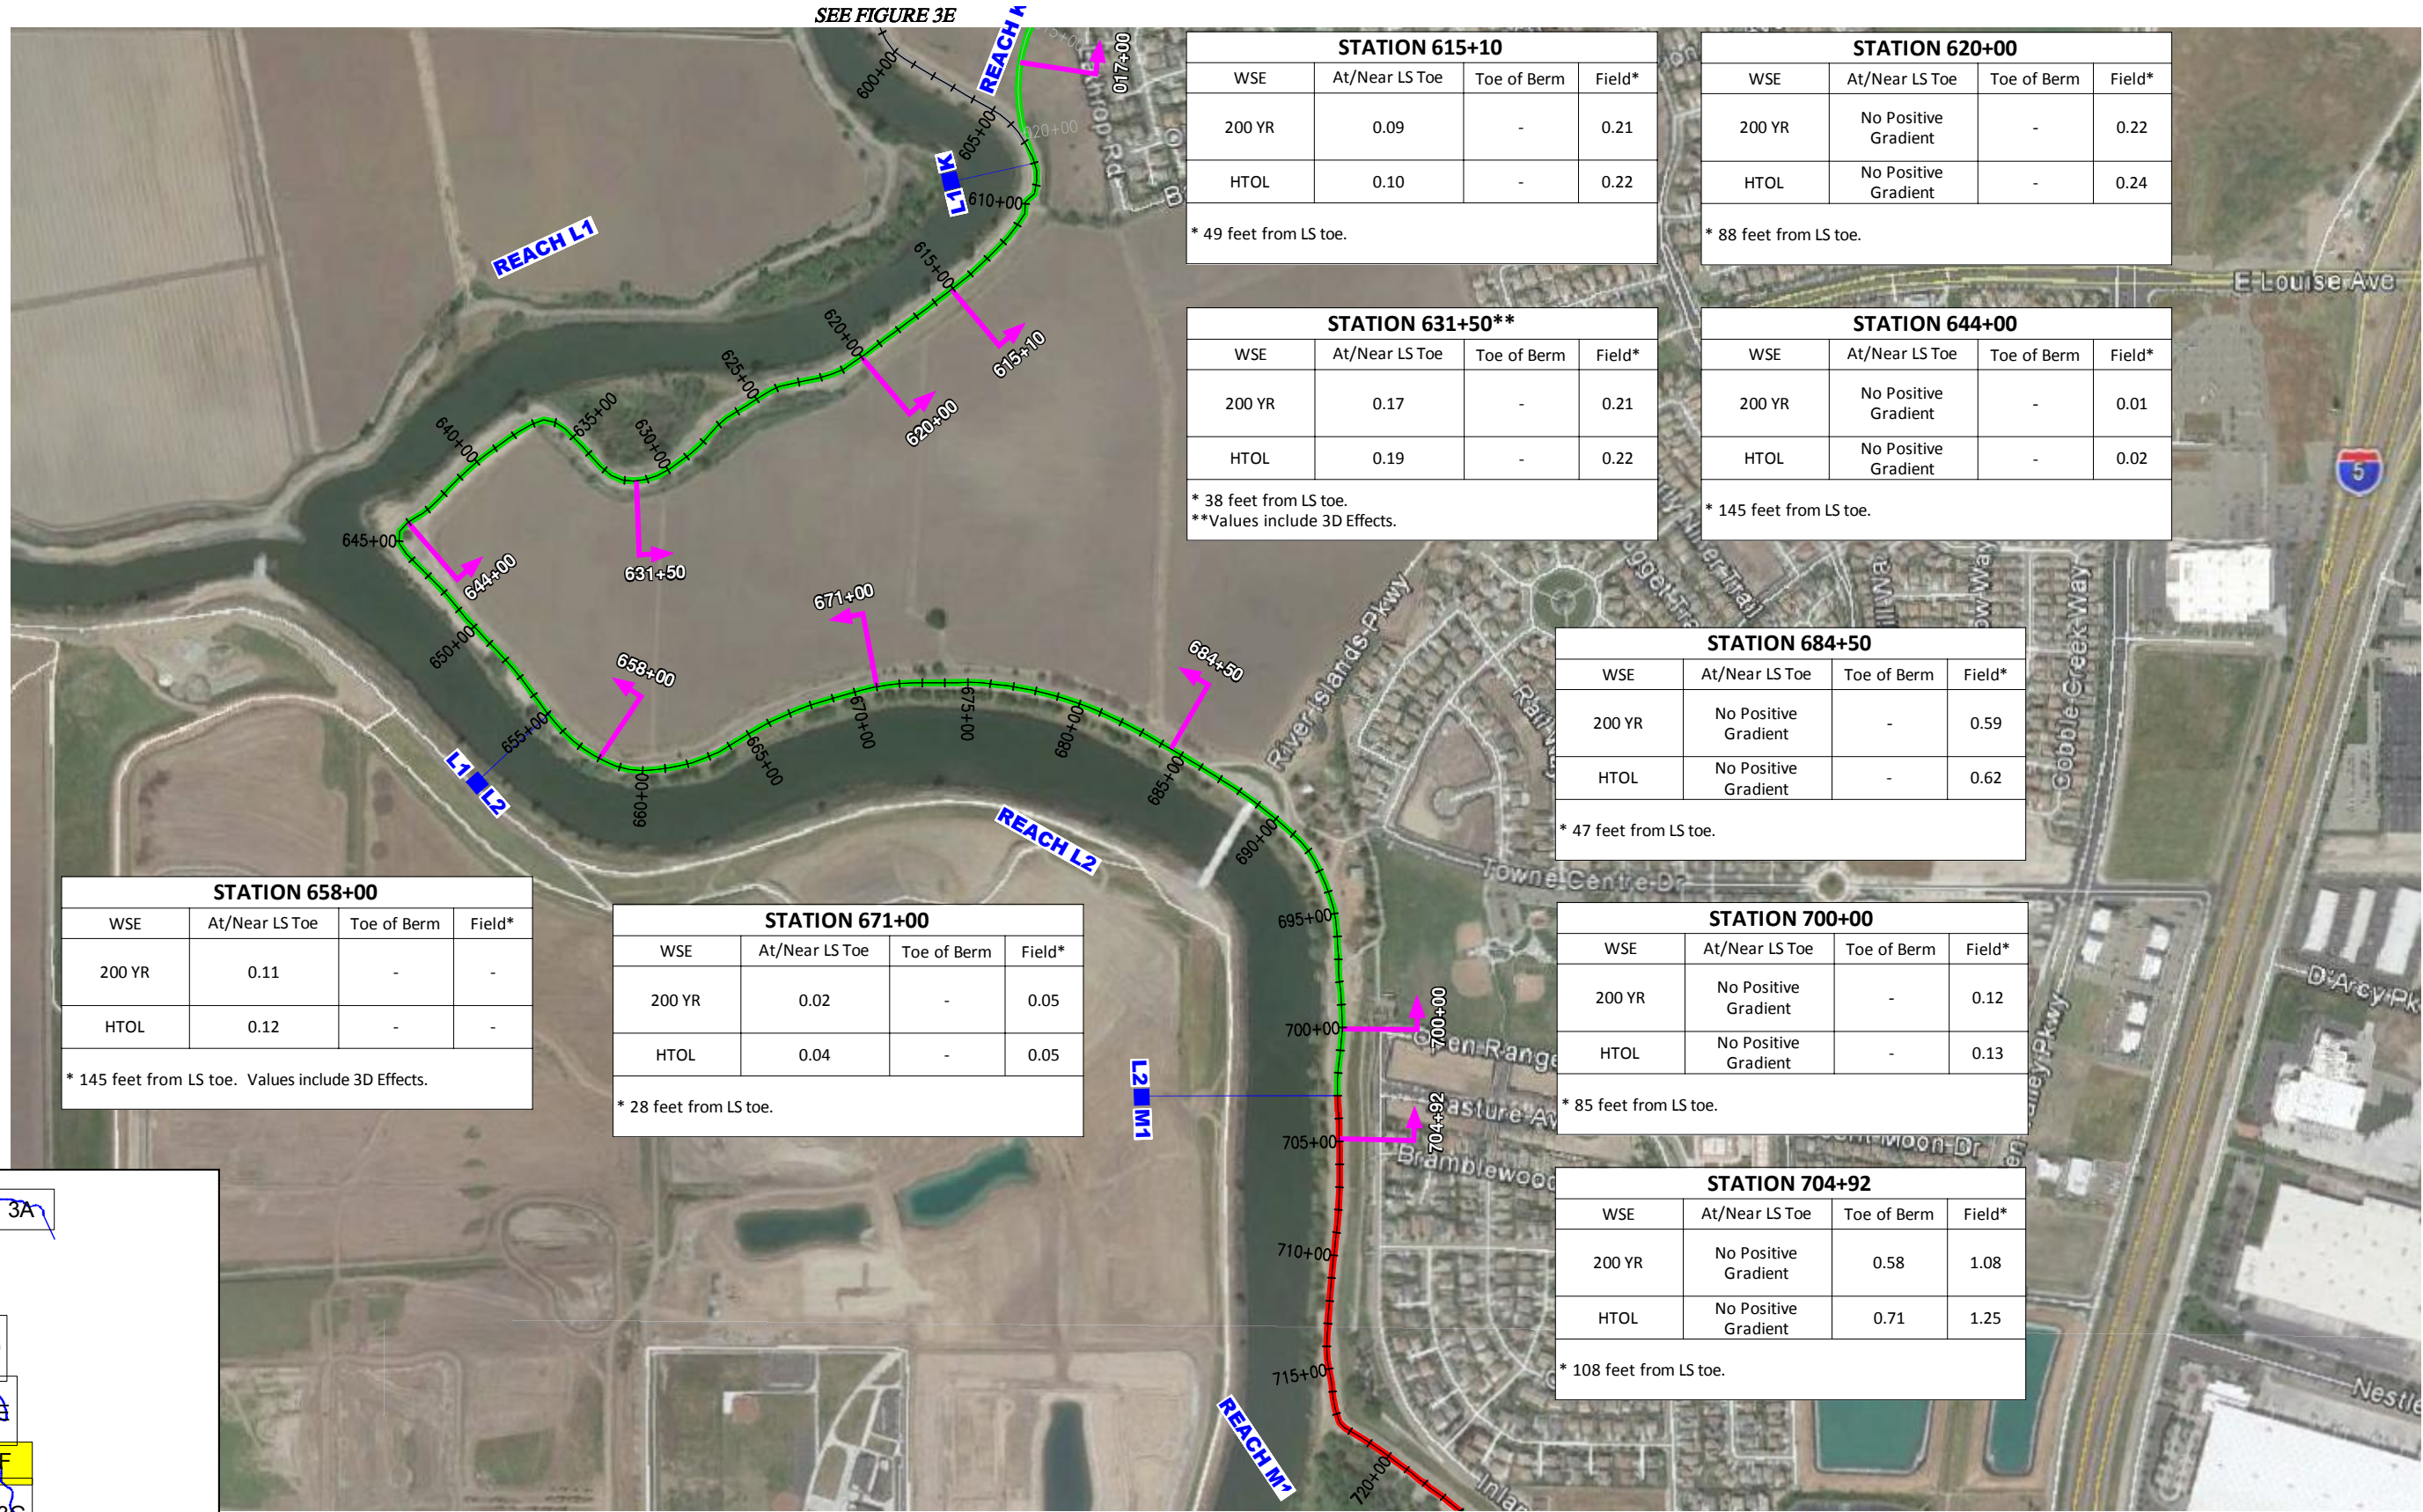
FIGURE NO.  
**3F**

**STATION 615+10**

WSE	At/Near LS Toe	Toe of Berm	Field*
200 YR	0.09	-	0.21
HTOL	0.10	-	0.22

WSE	At/Near LS Toe	Toe of Berm	Field*
200 YR	No Positive Gradient	0.58	1.08
HTOL	No Positive Gradient	0.71	1.25

\* 108 feet from LS toe.

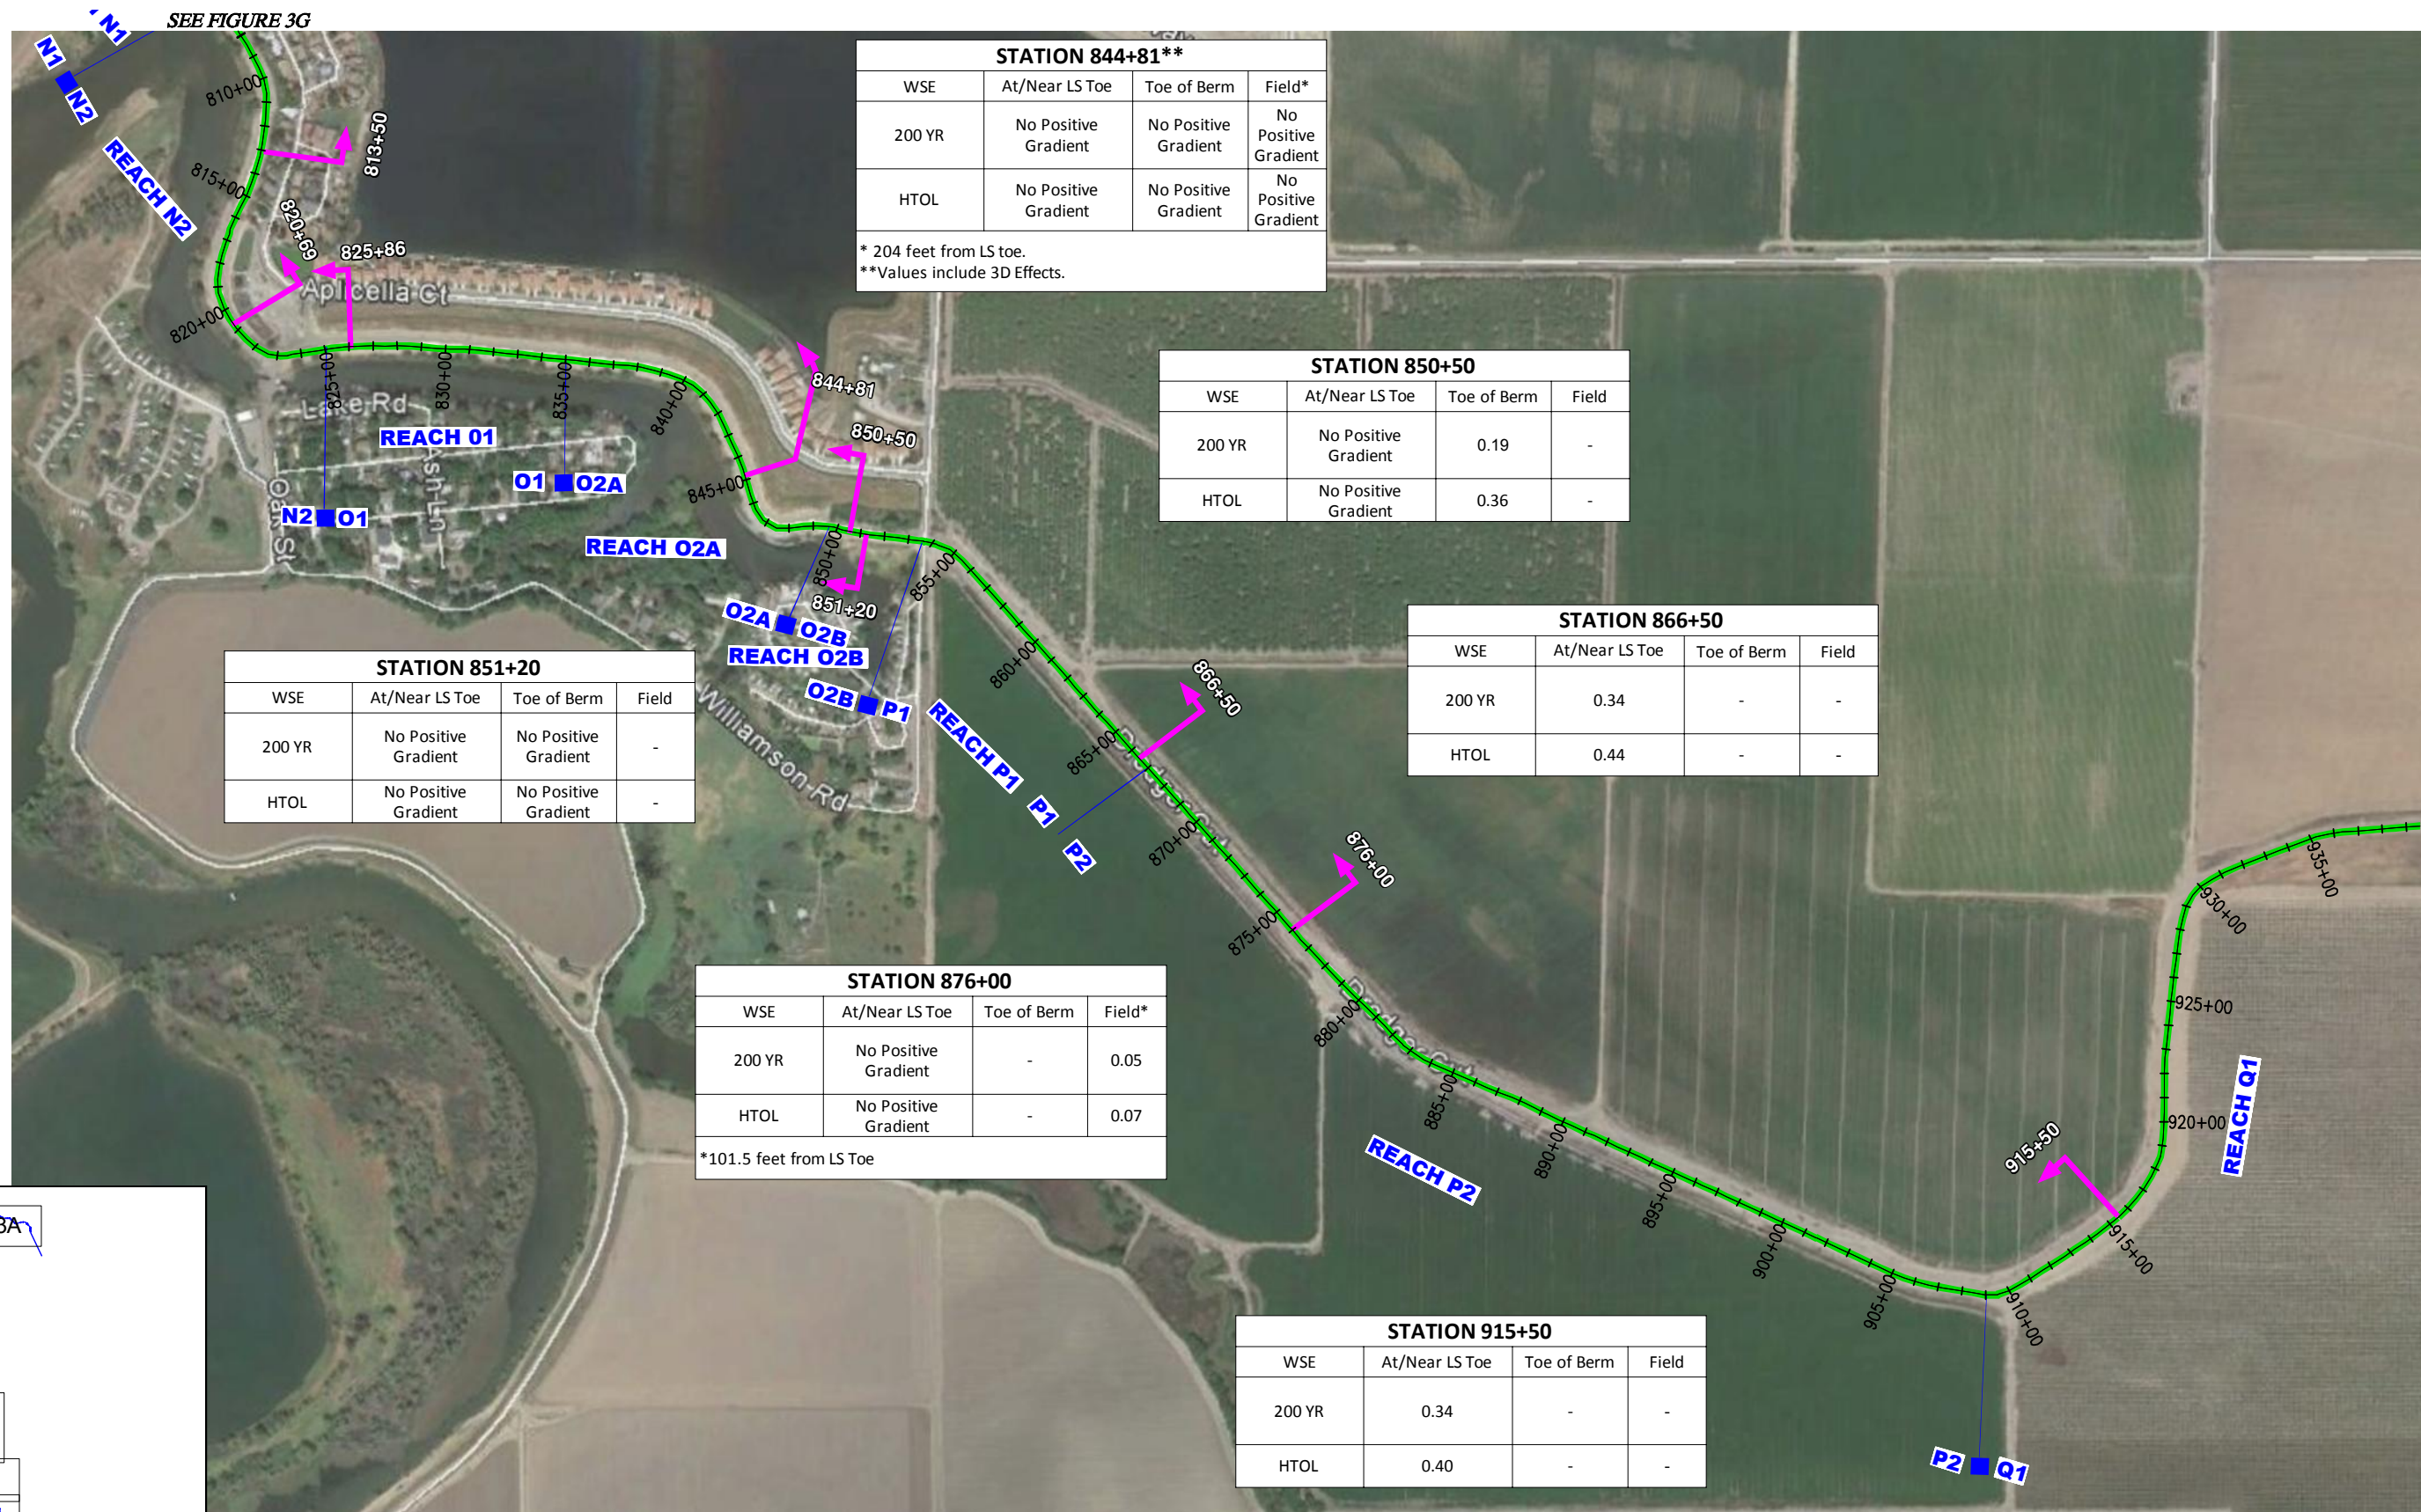
FIGURE NO.  
**3H**

STATION 844+81**			
WSE	At/Near LS Toe	Toe of Berm	Field*
200 YR	No Positive Gradient	No Positive Gradient	No Positive Gradient
HTOL	No Positive Gradient	No Positive Gradient	No Positive Gradient

\* 204 feet from LS toe.  
\*\*Values include 3D Effects.

STATION 915+50			
WSE	At/Near LS Toe	Toe of Berm	Field
200 YR	0.34	-	-
HTOL	0.40	-	-

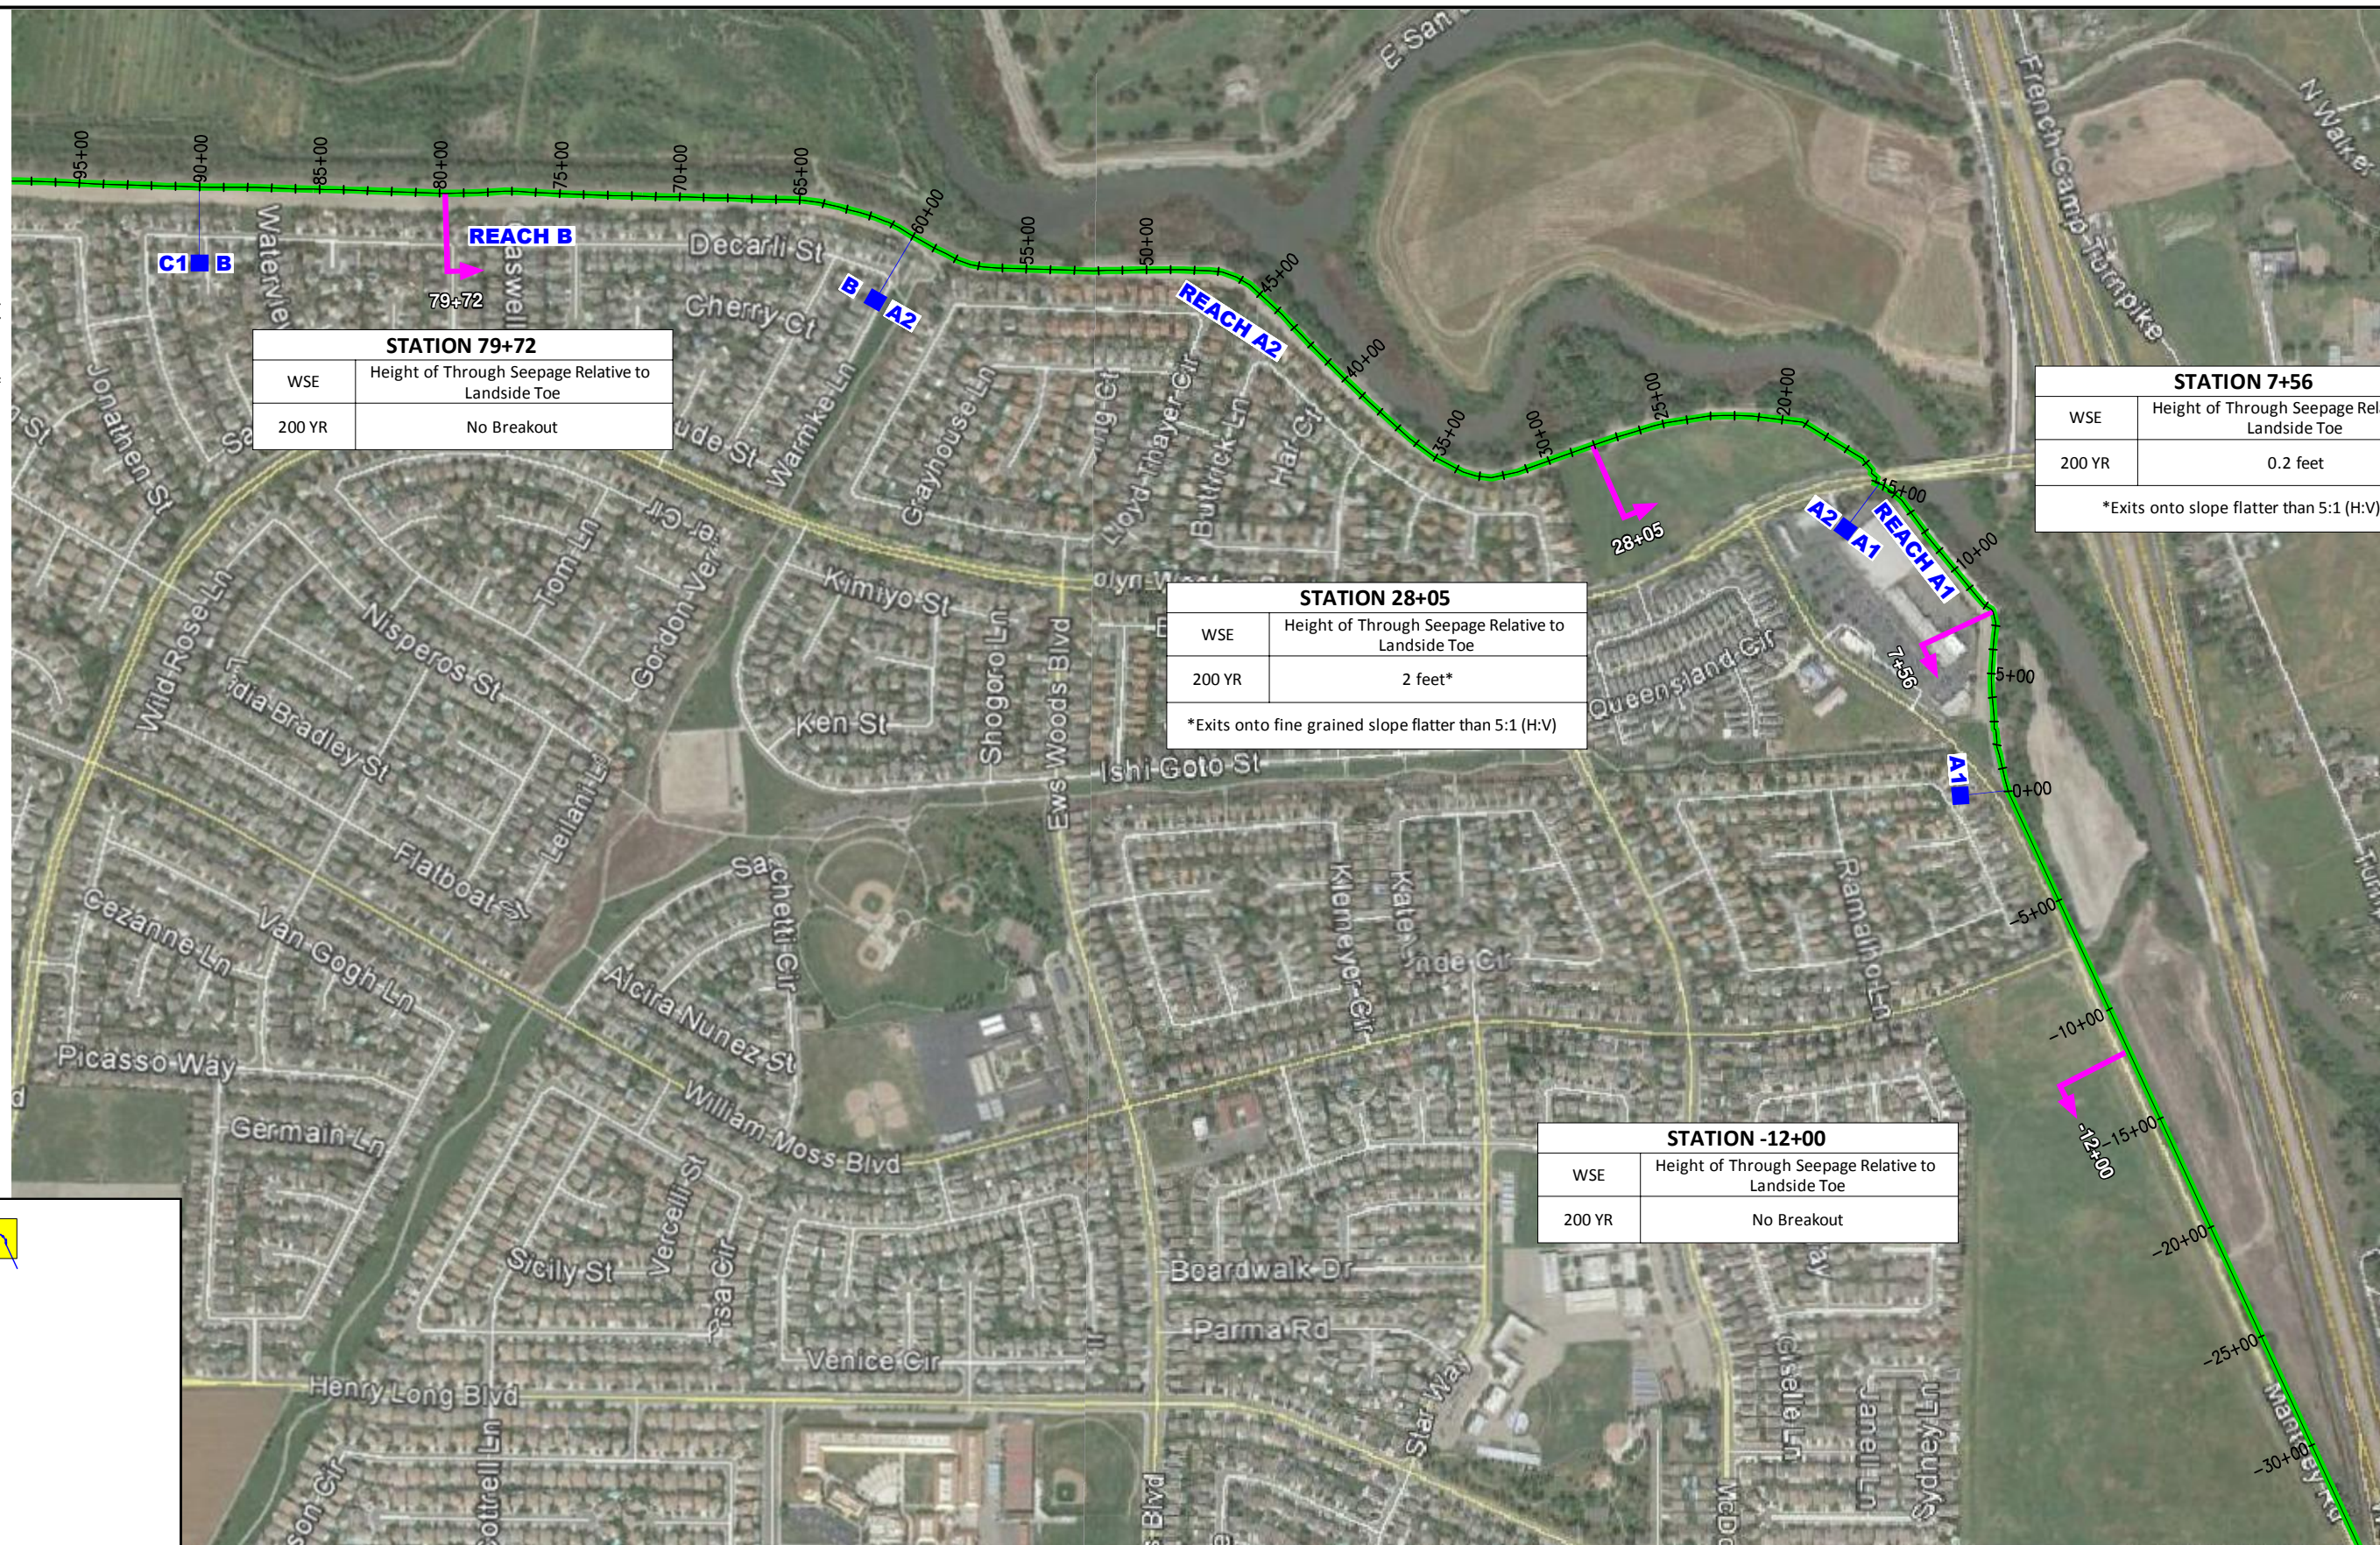
FIGURE NO.  
**4A**

STATION 79+72	
WSE	Height of Through Seepage Relative to Landside Toe
200 YR	No Breakout

STATION 28+05	
WSE	Height of Through Seepage Relative to Landside Toe
200 YR	2 feet*

STATION 7+56	
WSE	Height of Through Seepage Relative to Landside Toe
200 YR	0.2 feet

\*Exits onto slope flatter than 5:1 (H:V)
