# URBAN LEVEE DESIGN CRITERIA EVALUATION

MOSSDALE TRACT  
RECLAMATION DISTRICT NO. 17  
SAN JOAQUIN COUNTY, CALIFORNIA

Subject: Mossdale Tract  
Reclamation District No. 17  
San Joaquin County, California

## URBAN LEVEE DESIGN CRITERIA EVALUATION

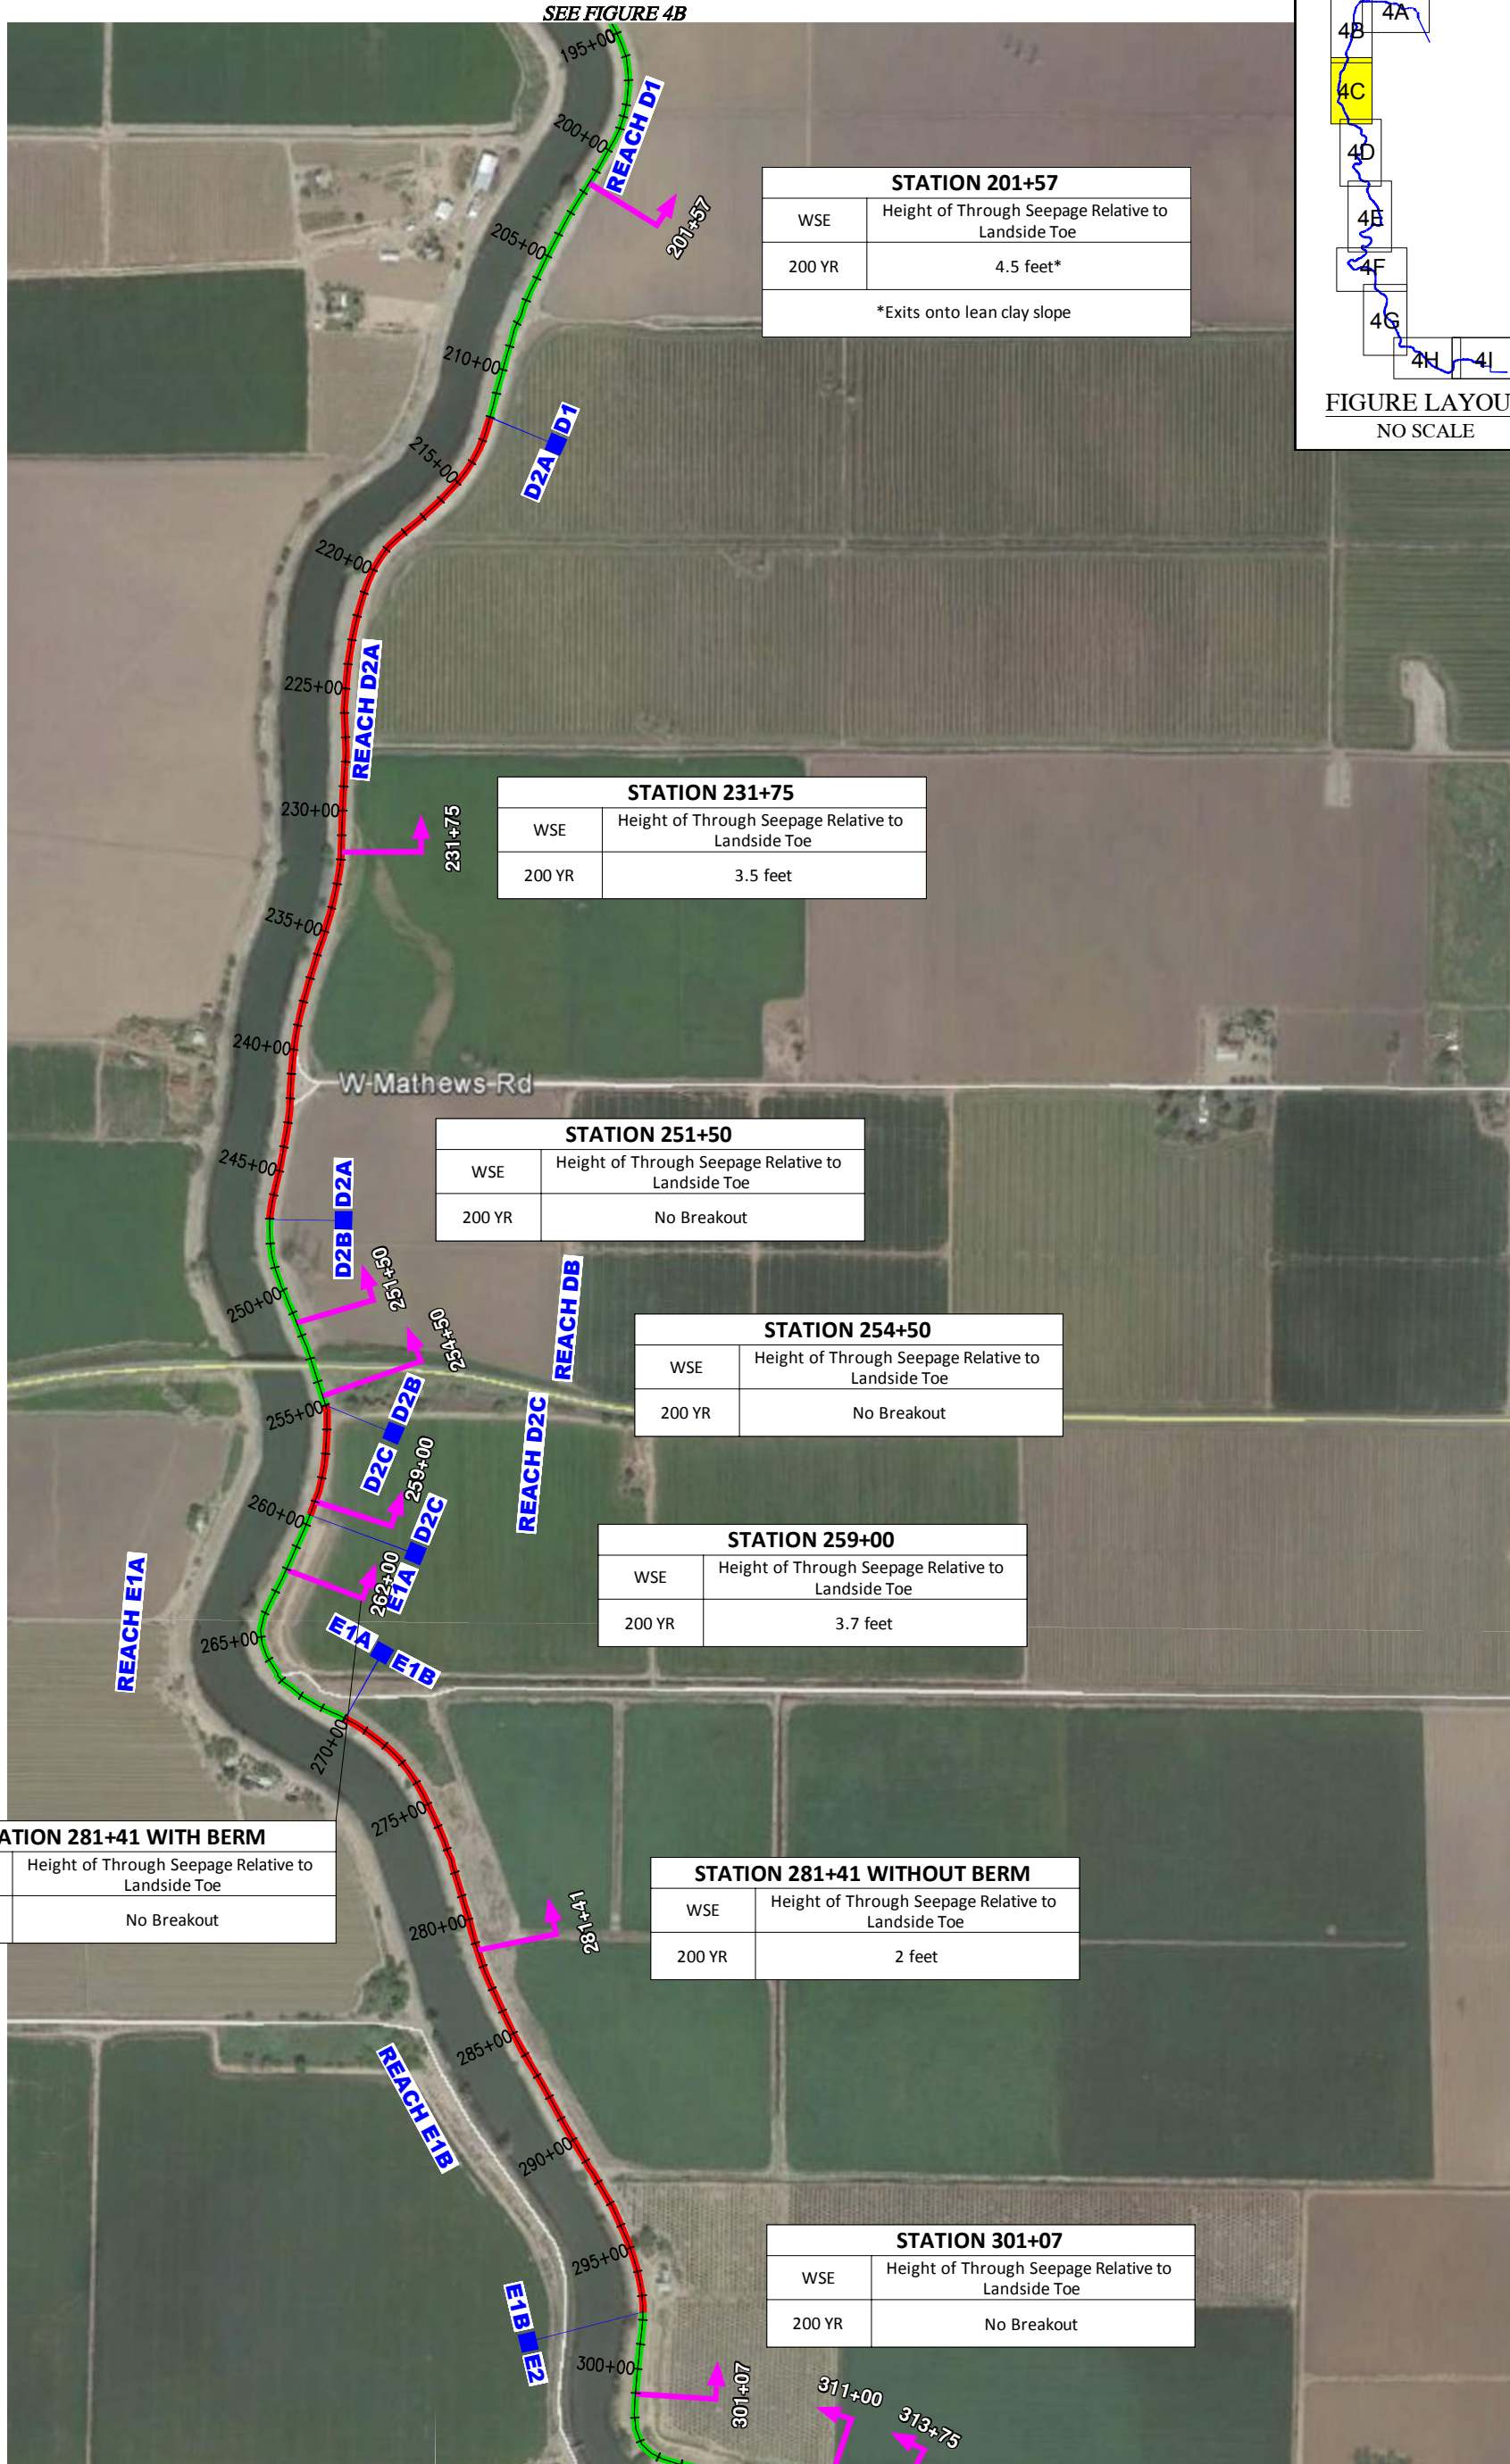
FIGURE NO.  
**4C**

STATION 201+57	
WSE	Height of Through Seepage Relative to Landside Toe
200 YR	4.5 feet*
*Exits onto lean clay slope

STATION 231+75	
WSE	Height of Through Seepage Relative to Landside Toe
200 YR	3.5 feet

STATION 281+41 WITHOUT BERM	
WSE	Height of Through Seepage Relative to Landside Toe
200 YR	2 feet

STATION 301+07	
WSE	Height of Through Seepage Relative to Landside Toe
200 YR	No Breakout

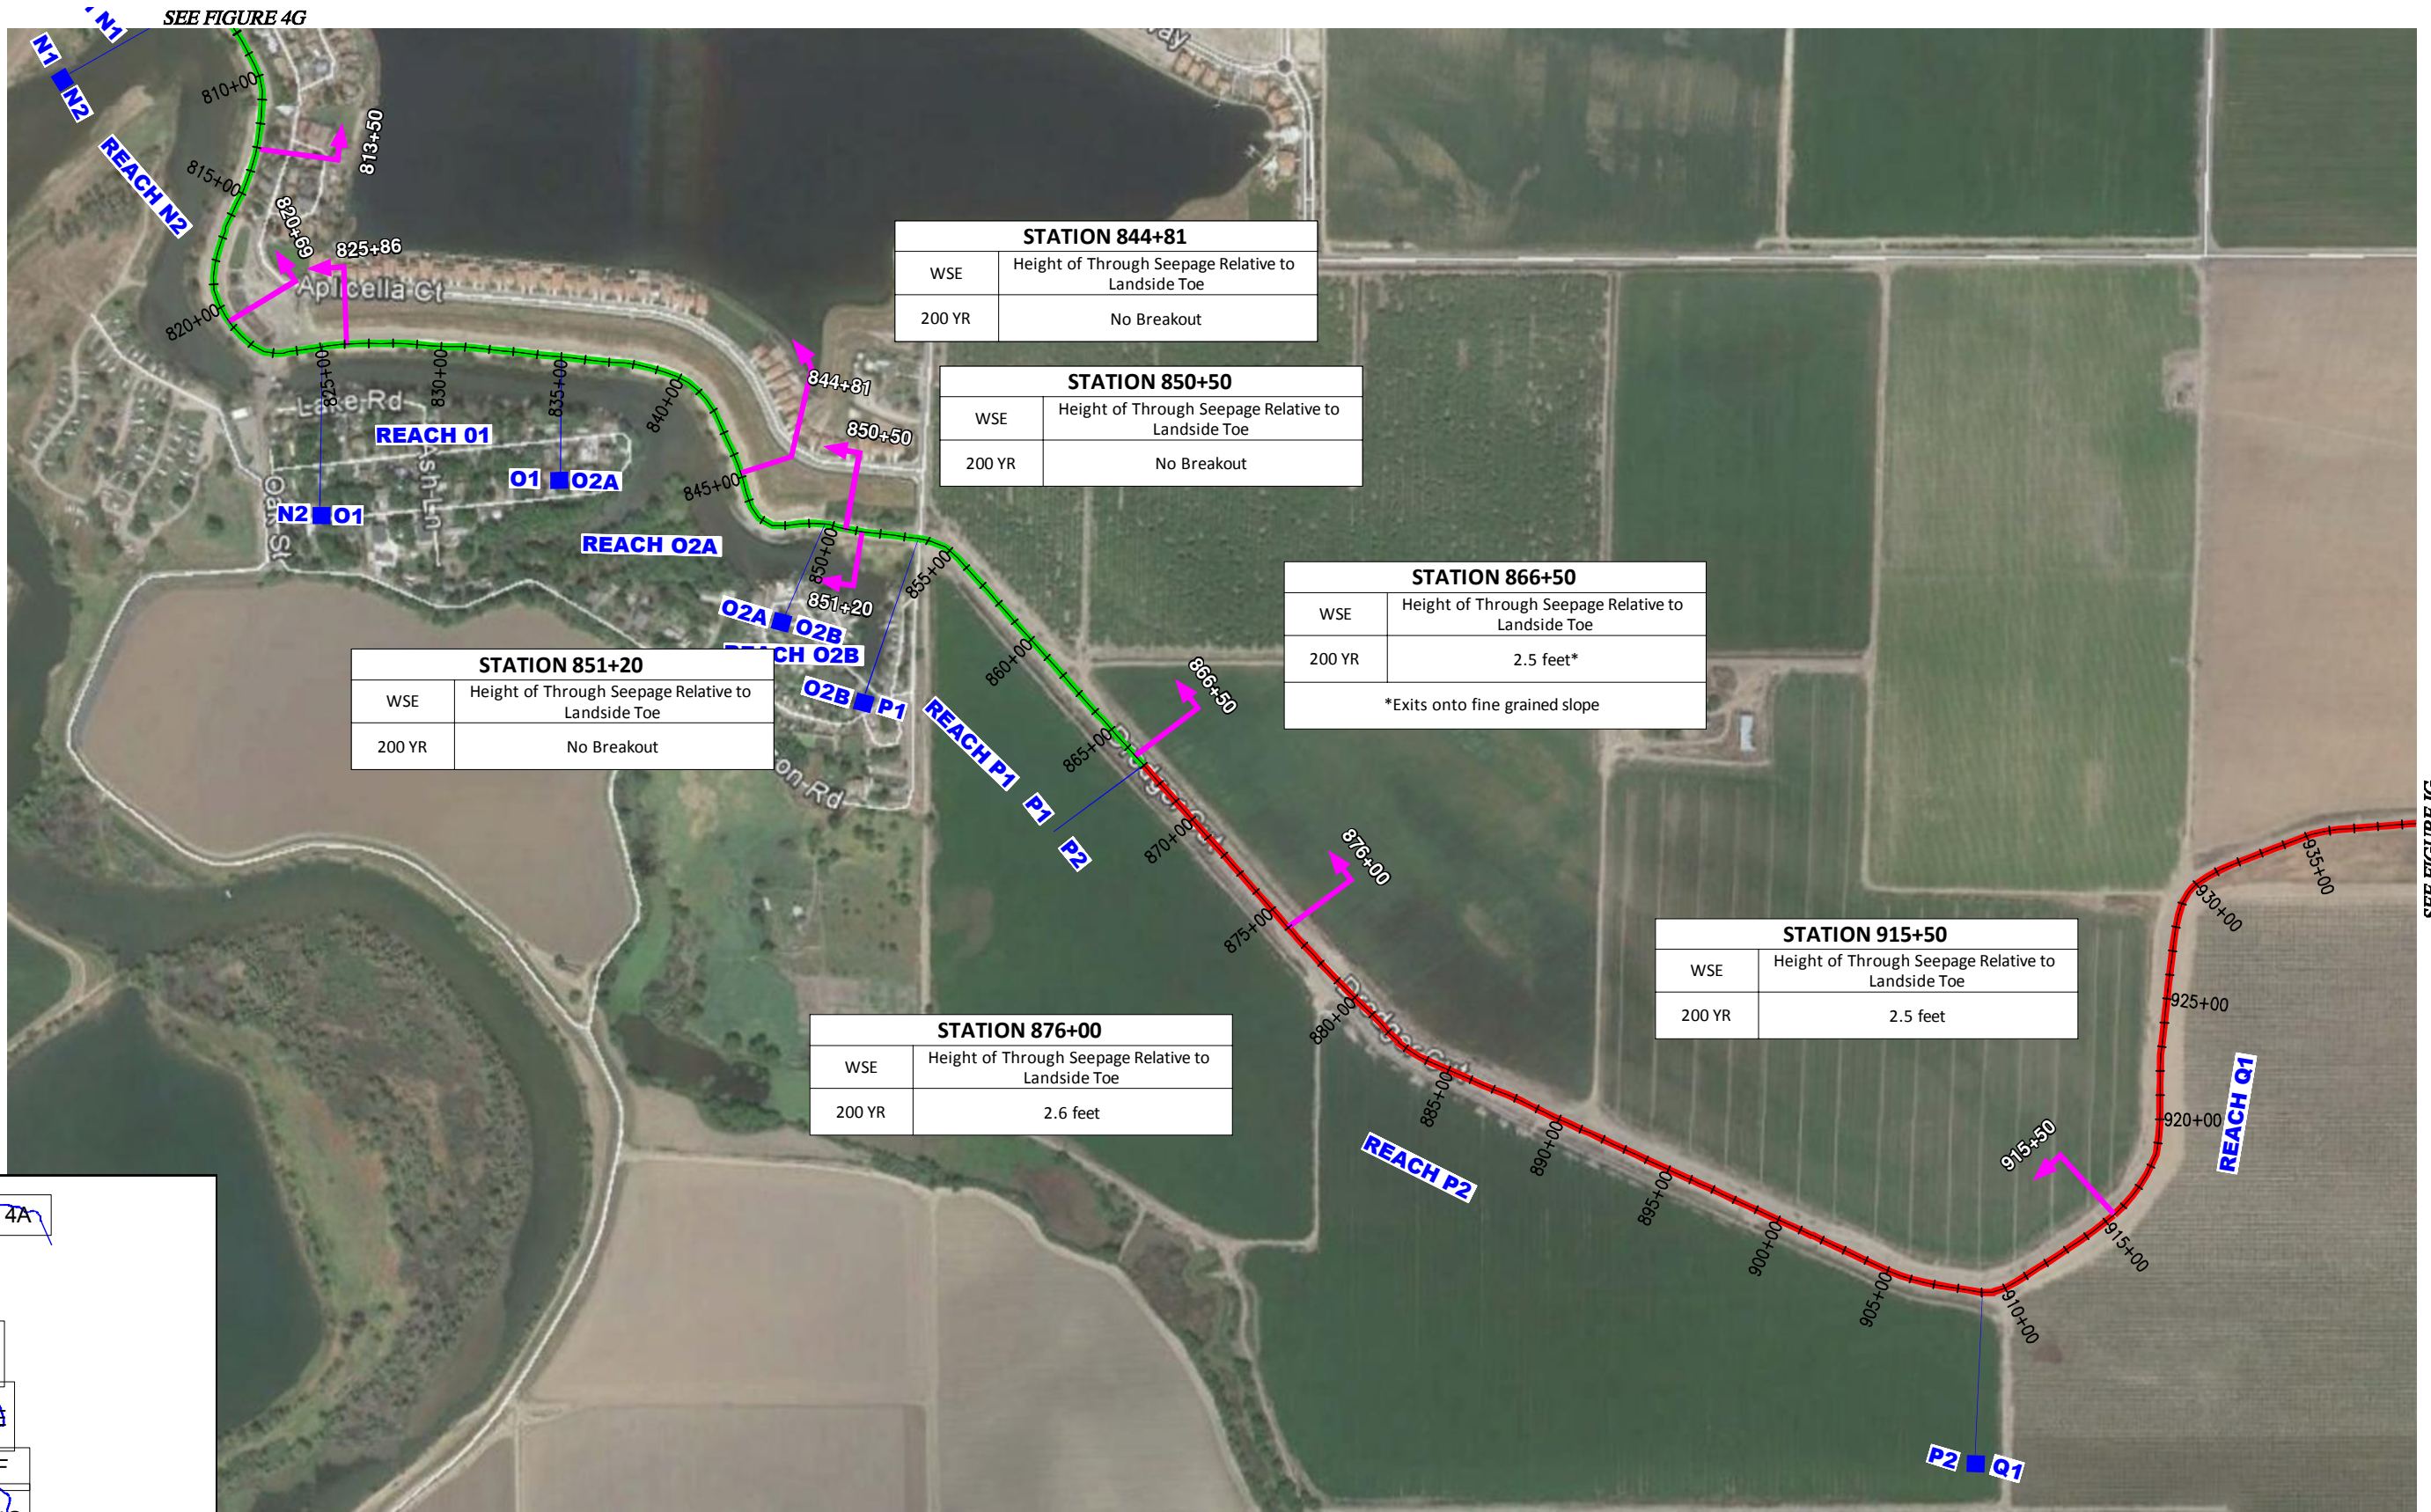
FIGURE NO.  
**4H**

STATION 844+81	
WSE	Height of Through Seepage Relative to Landside Toe
200 YR	No Breakout

STATION 850+50	
WSE	Height of Through Seepage Relative to Landside Toe
200 YR	No Breakout

STATION 876+00	
WSE	Height of Through Seepage Relative to Landside Toe
200 YR	2.6 feet

STATION 915+50	
WSE	Height of Through Seepage Relative to Landside Toe
200 YR	2.5 feet

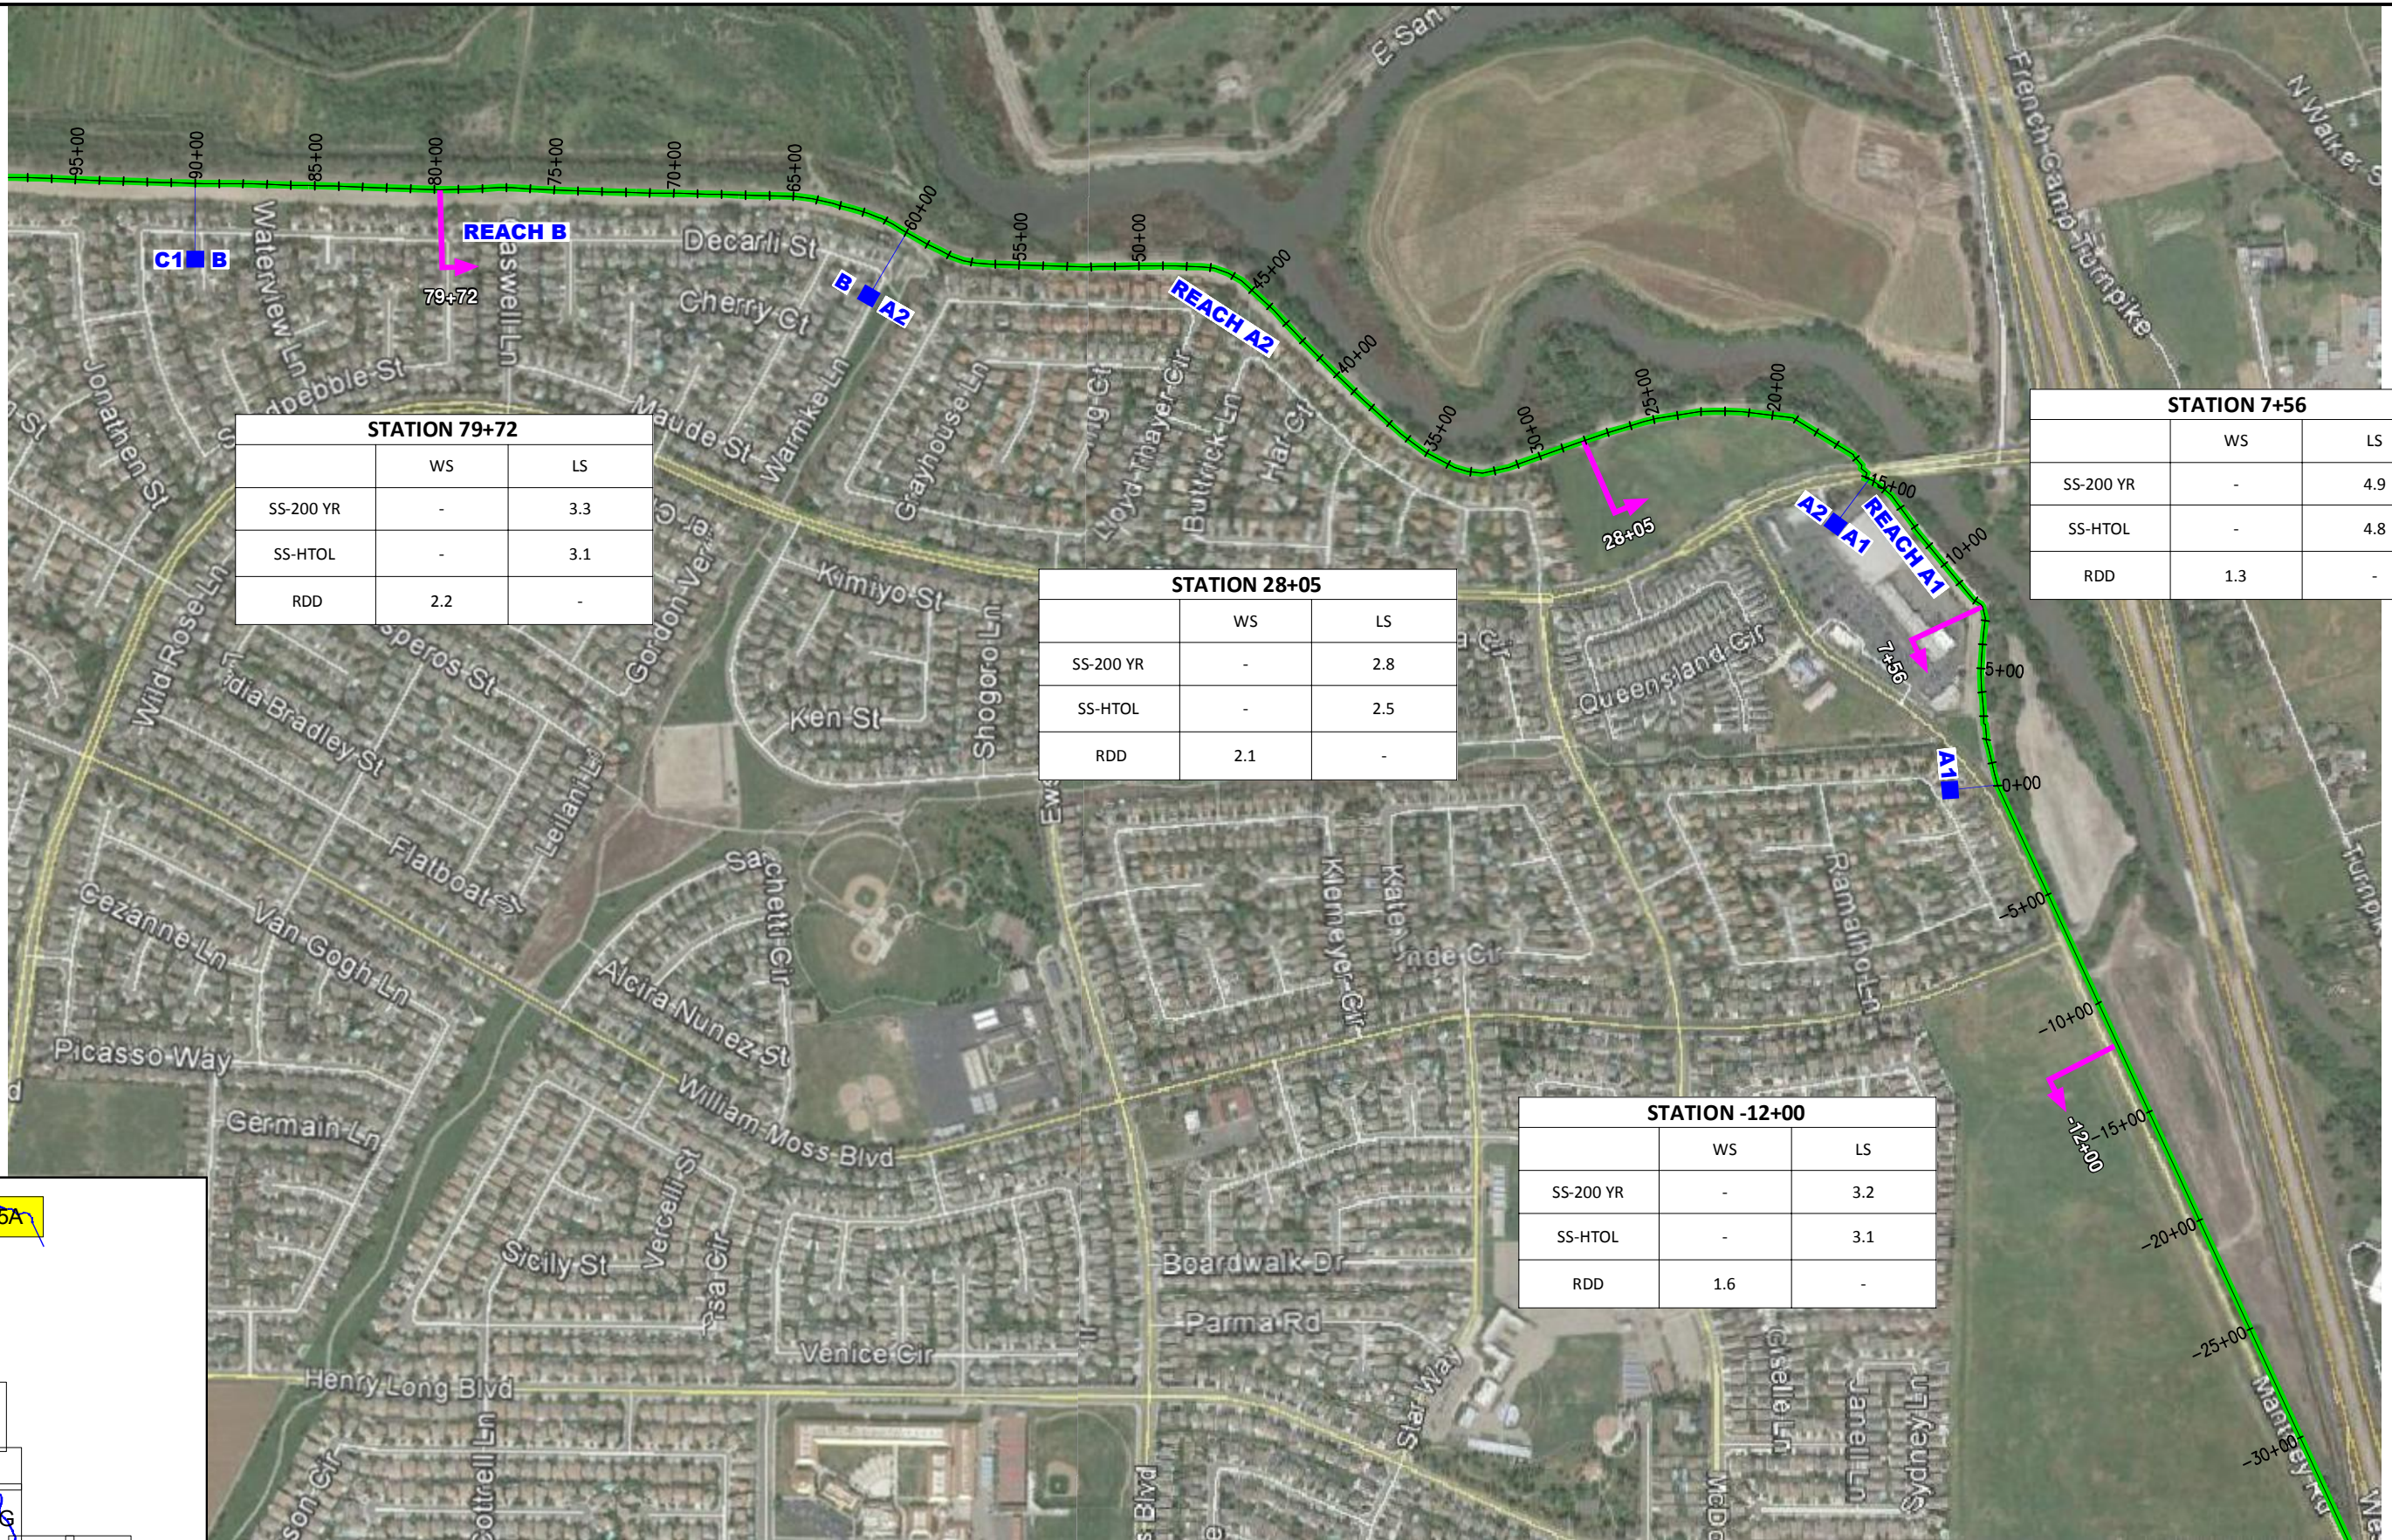
FIGURE NO  
**5A**

WS	LS
SS-200 YR	-	3.3
SS-HTOL	-	3.1
RDD	2.2	-

WS	LS
SS-200 YR	-	2.8
SS-HTOL	-	2.5
RDD	2.1	-

WS	LS
SS-200 YR	-	3.2
SS-HTOL	-	3.1
RDD	1.6	-

WS	LS
SS-200 YR	-	4.9
SS-HTOL	-	4.8
RDD	1.3	-

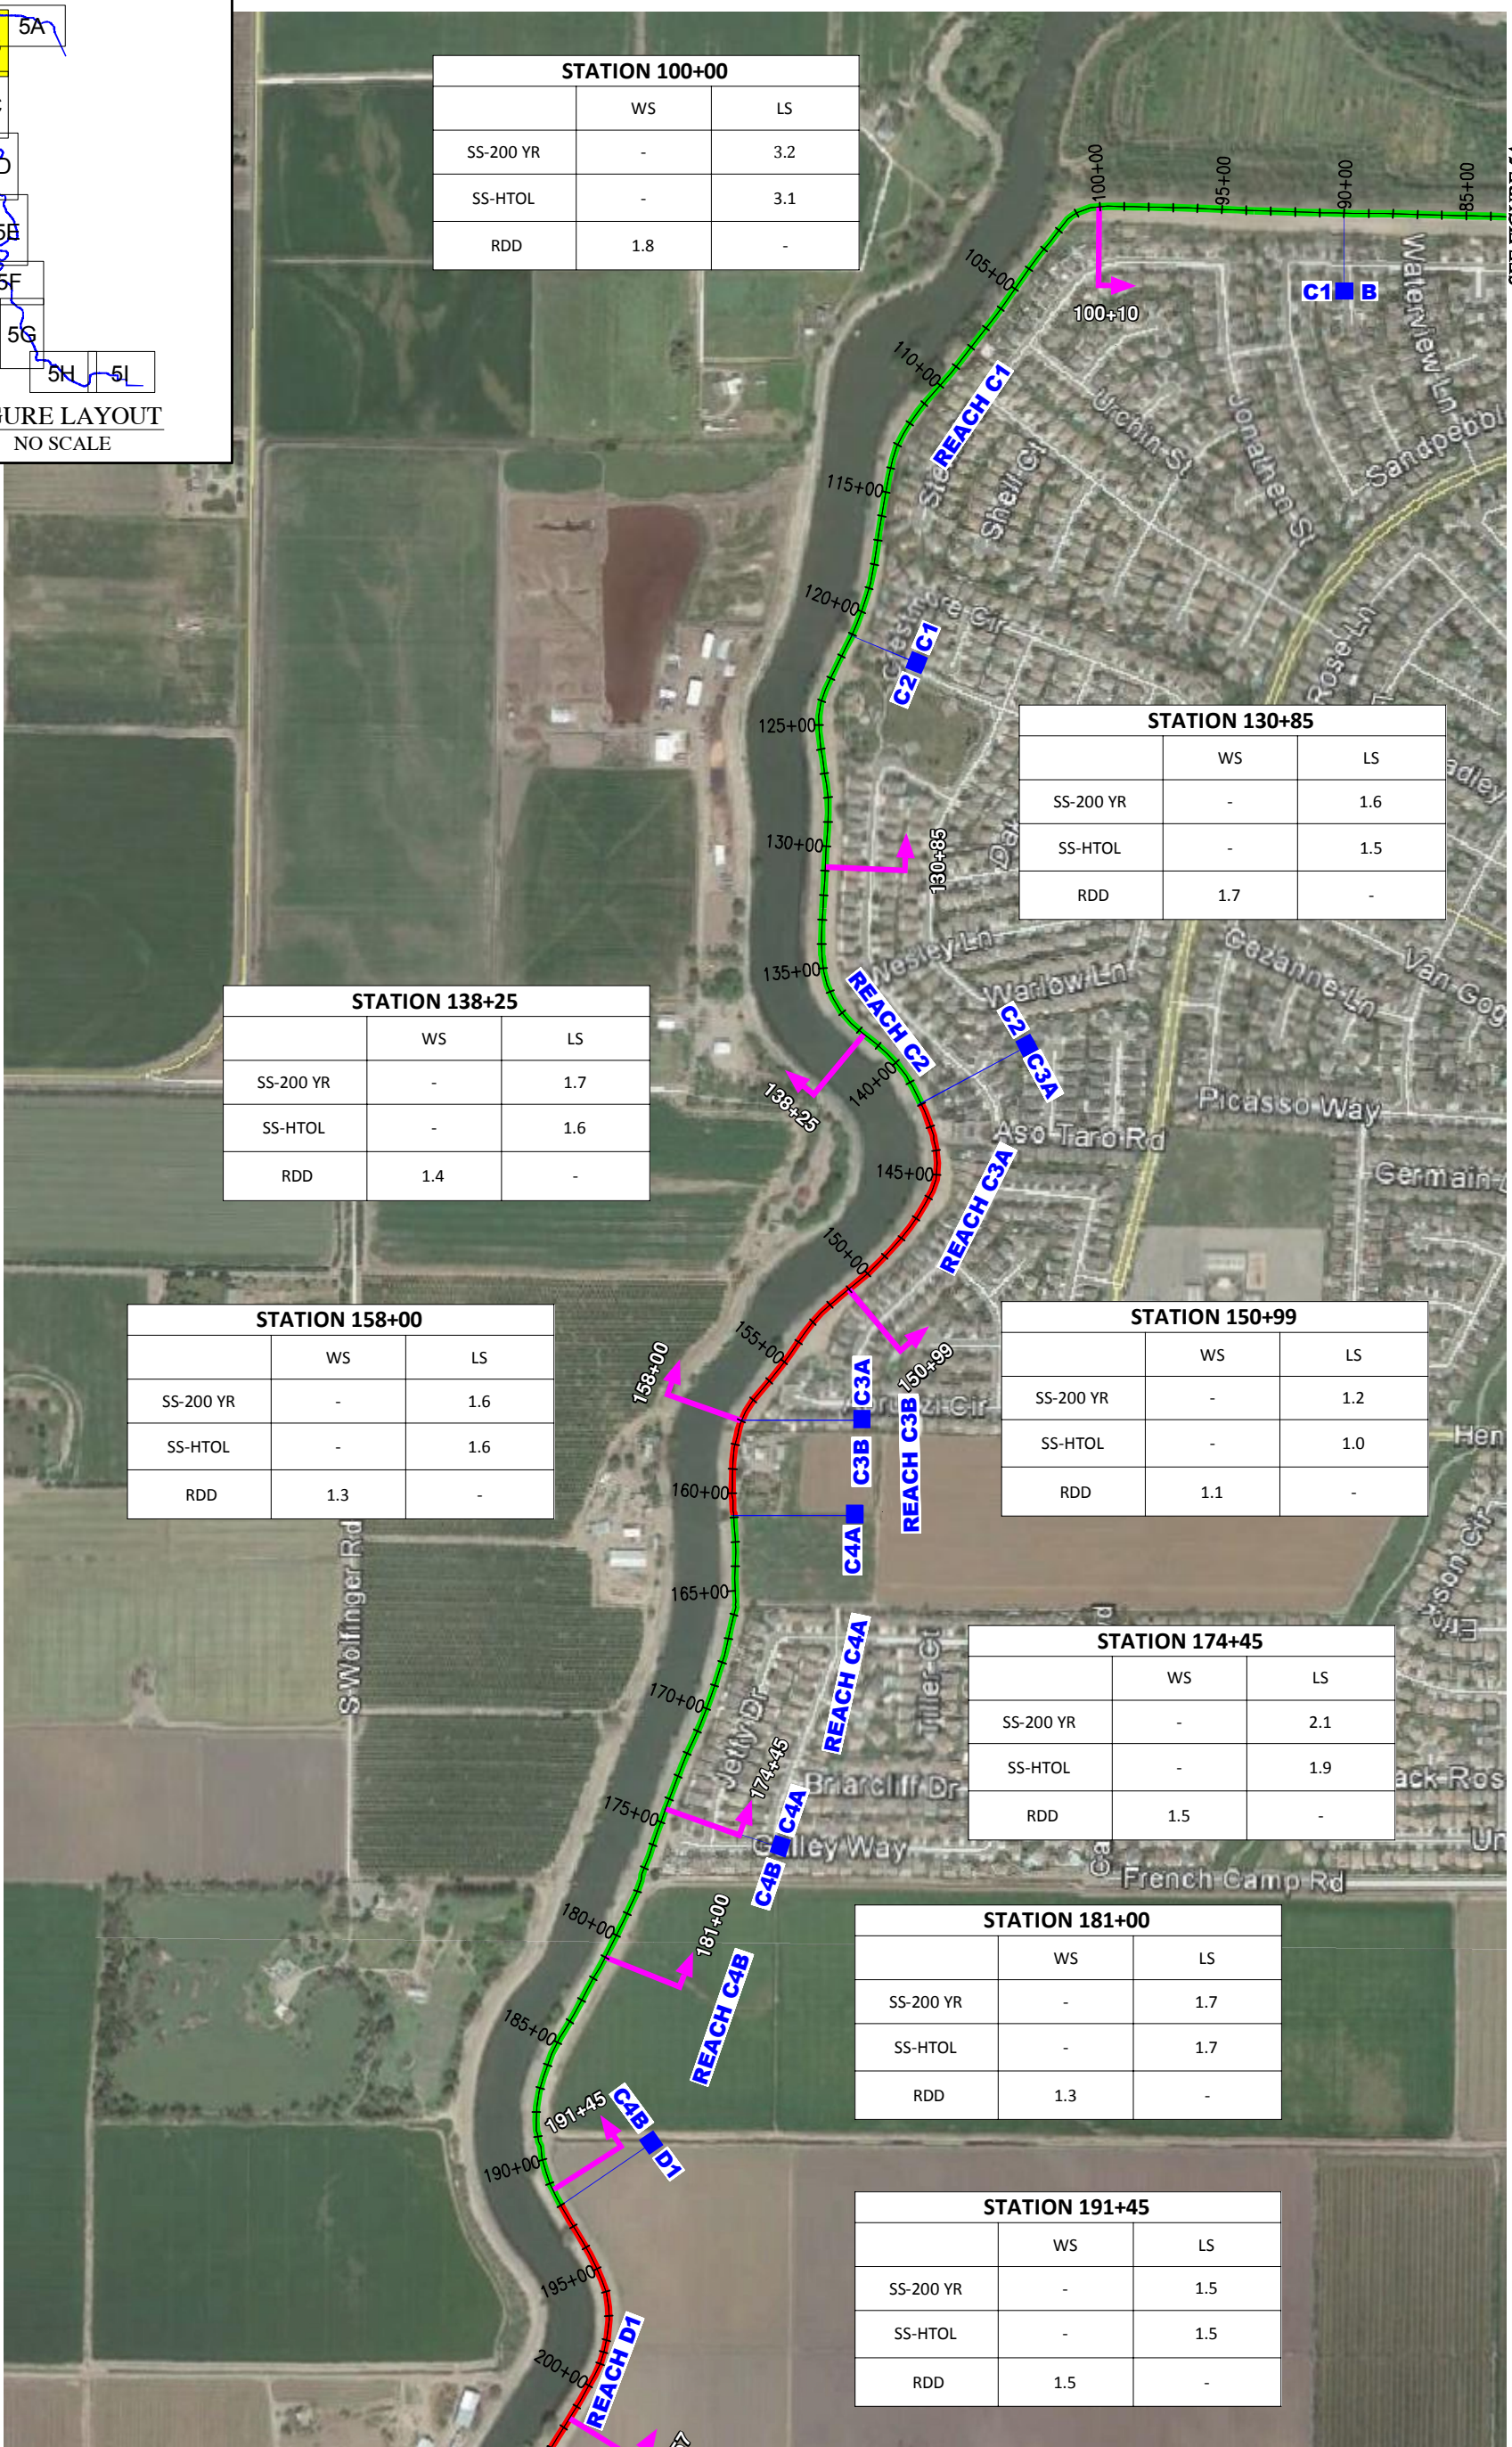
STATION 100+00		
	WS	LS
SS-200 YR	-	3.2
SS-HTOL	-	3.1
RDD	1.8	-

STATION 130+85		
	WS	LS
SS-200 YR	-	1.6
SS-HTOL	-	1.5
RDD	1.7	-

STATION 181+00		
	WS	LS
SS-200 YR	-	1.7
SS-HTOL	-	1.7
RDD	1.3	-

STATION 191+45		
	WS	LS
SS-200 YR	-	1.5
SS-HTOL	-	1.5
RDD	1.5	-

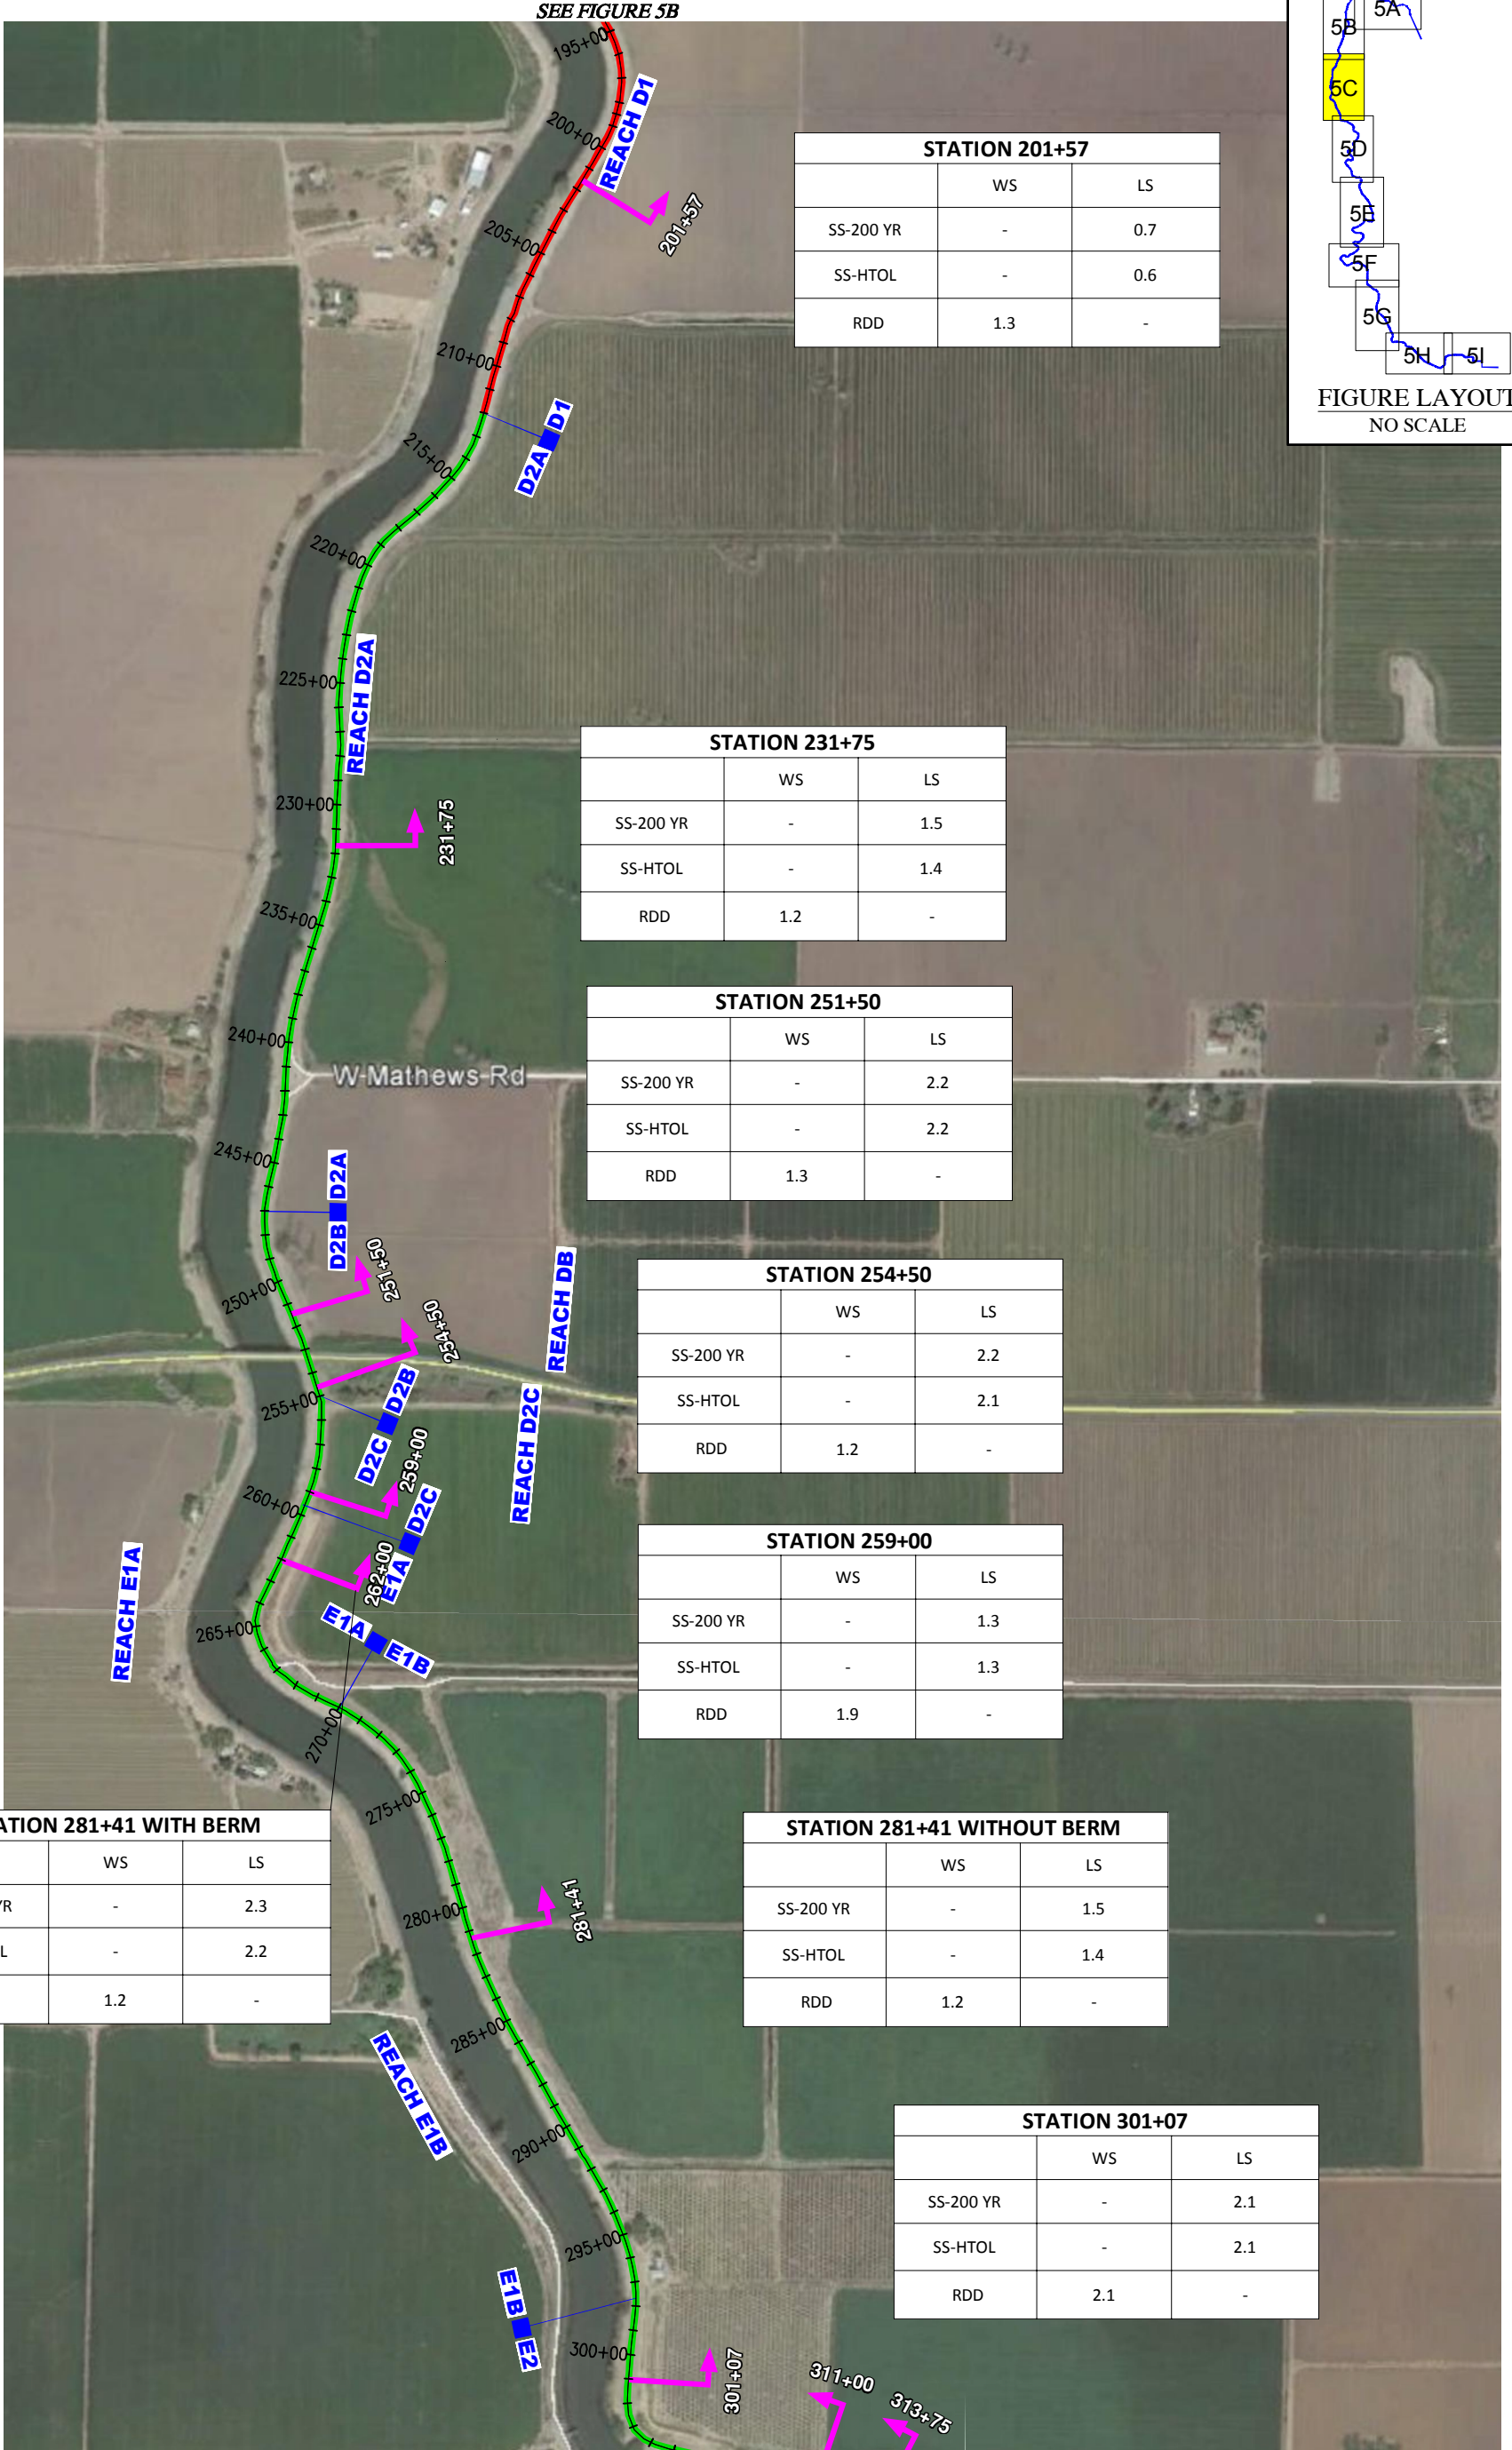
STATION 201+57		
	WS	LS
SS-200 YR	-	0.7
SS-HTOL	-	0.6
RDD	1.3	-

STATION 231+75		
	WS	LS
SS-200 YR	-	1.5
SS-HTOL	-	1.4
RDD	1.2	-

STATION 281+41 WITHOUT BERM		
	WS	LS
SS-200 YR	-	1.5
SS-HTOL	-	1.4
RDD	1.2	-

STATION 301+07		
	WS	LS
SS-200 YR	-	2.1
SS-HTOL	-	2.1
RDD	2.1	-

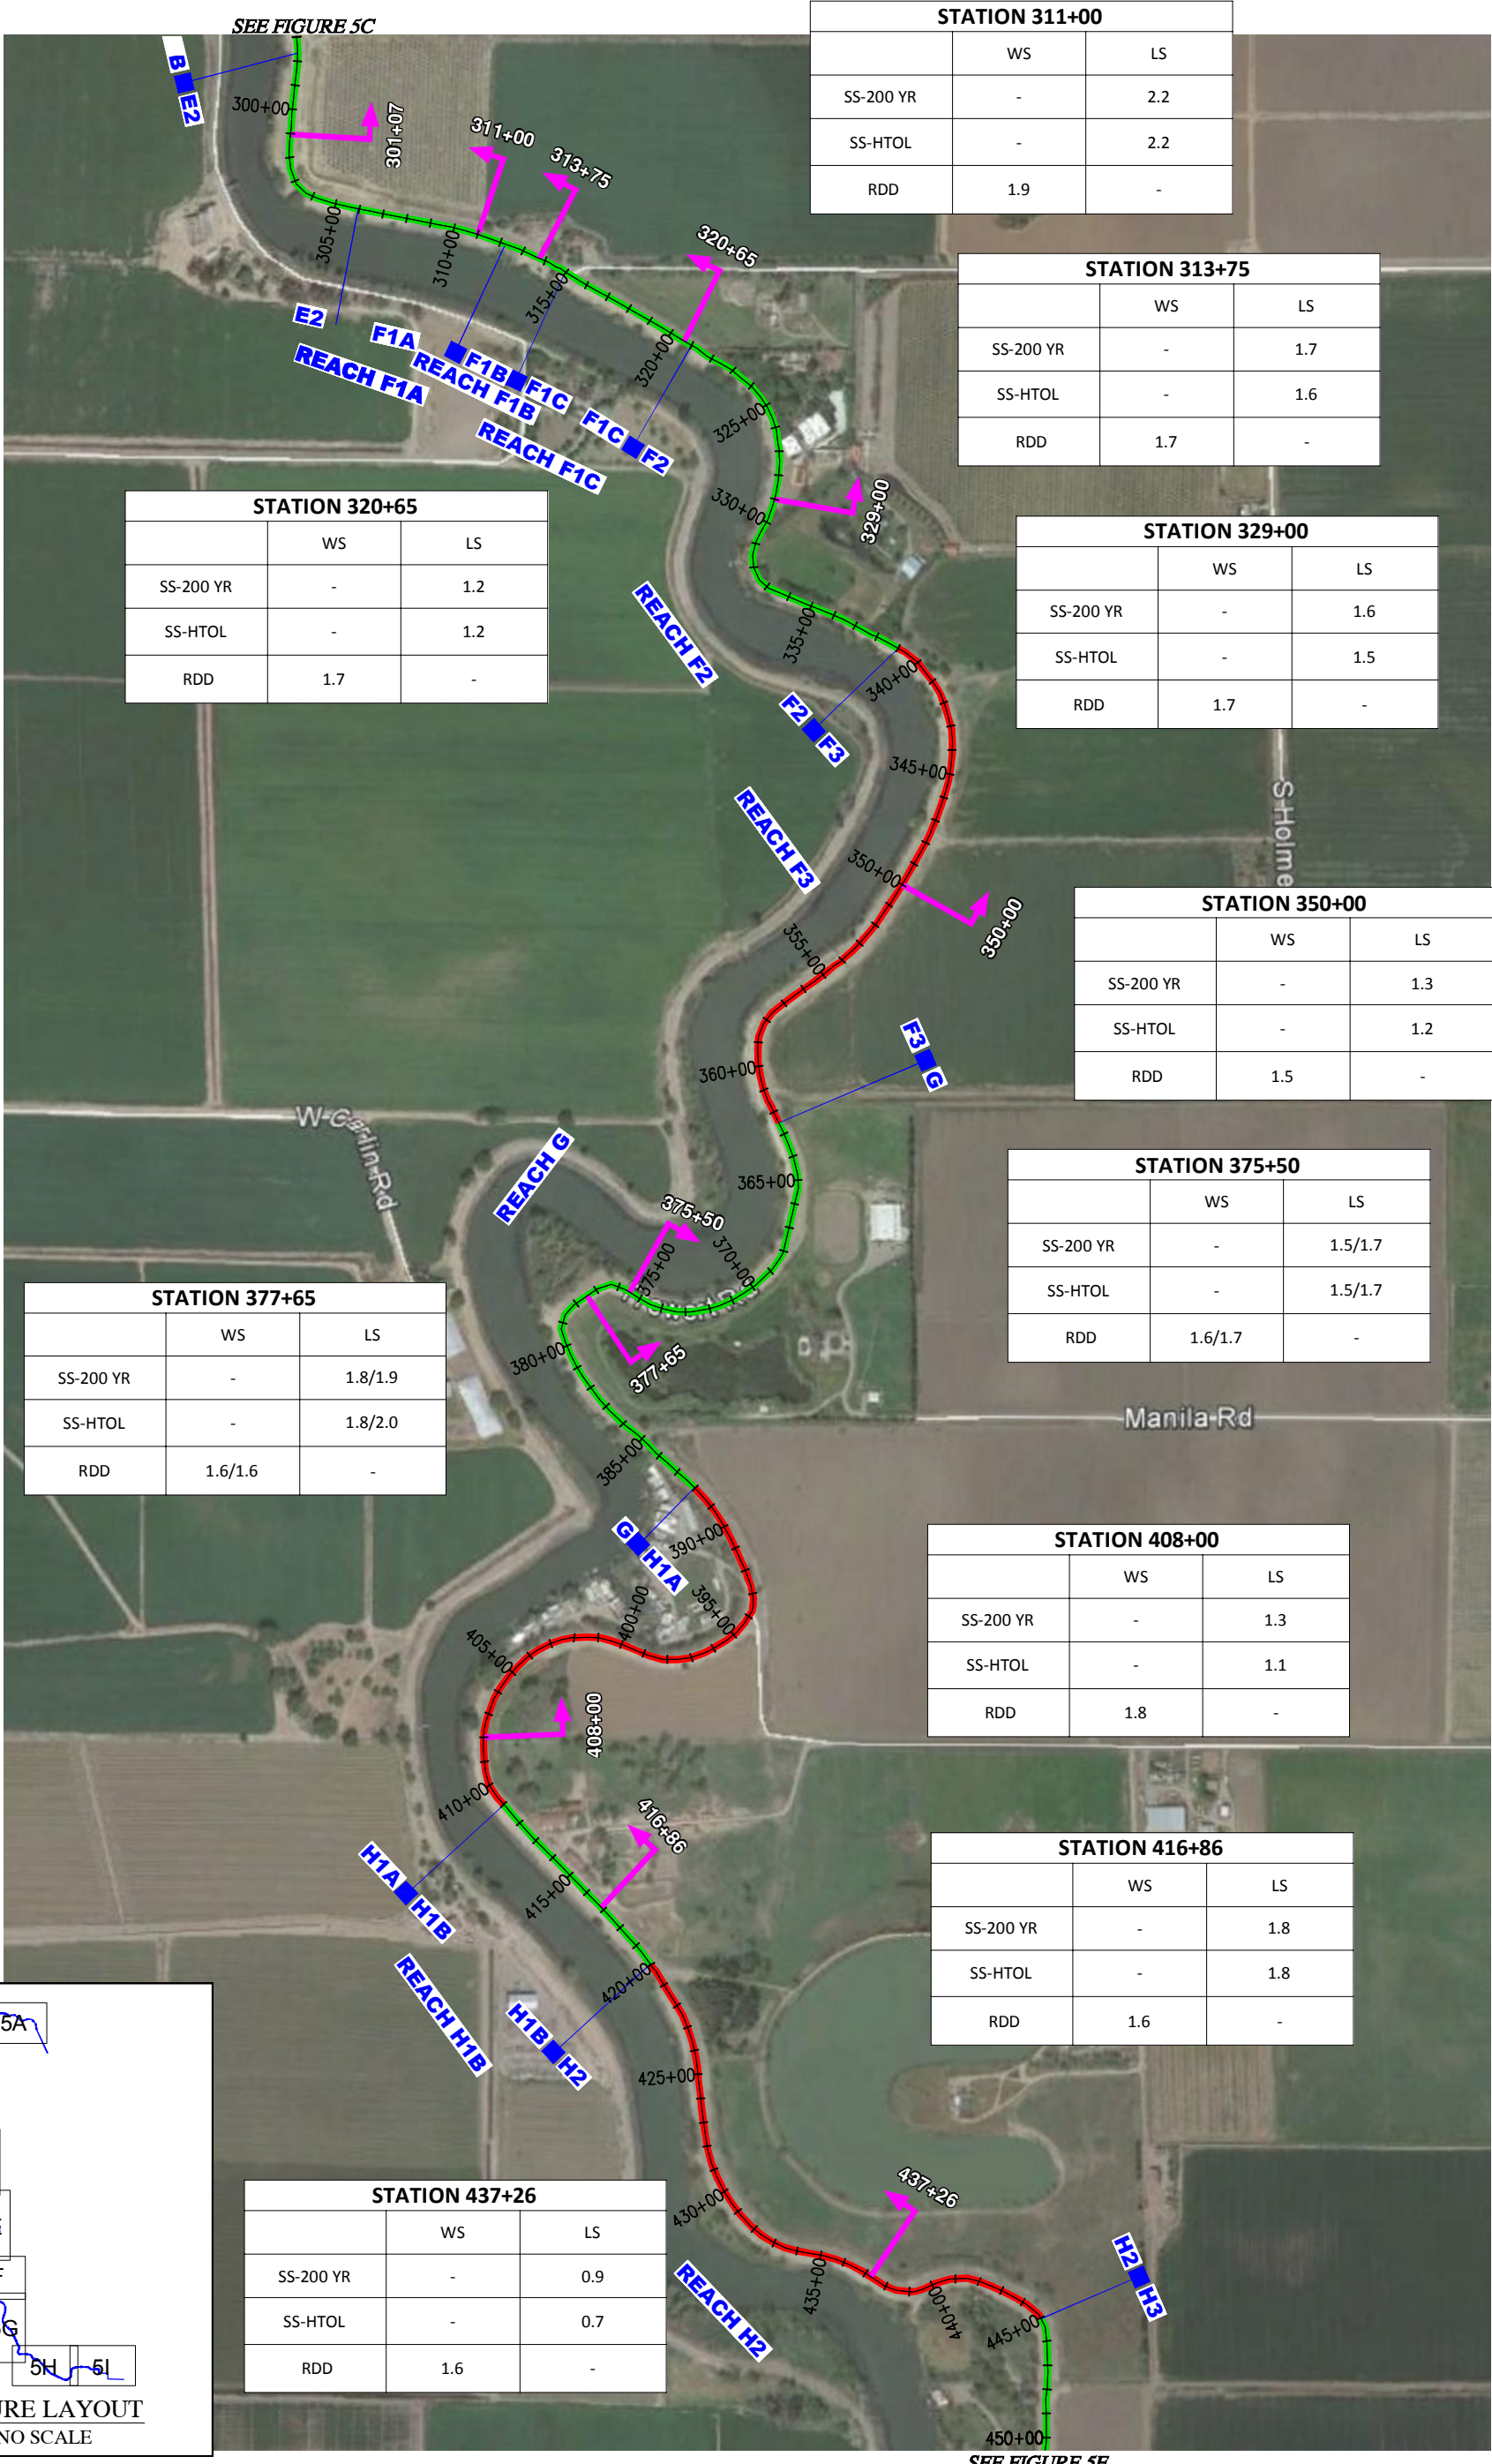
STATION 311+00		
	WS	LS
SS-200 YR	-	2.2
SS-HTOL	-	2.2
RDD	1.9	-

STATION 313+75		
	WS	LS
SS-200 YR	-	1.7
SS-HTOL	-	1.6
RDD	1.7	-

STATION 416+86		
	WS	LS
SS-200 YR	-	1.8
SS-HTOL	-	1.8
RDD	1.6	-

STATION 437+26		
	WS	LS
SS-200 YR	-	0.9
SS-HTOL	-	0.7
RDD	1.6	-
