# URBAN LEVEE DESIGN CRITERIA EVALUATION

MOSSDALE TRACT  
RECLAMATION DISTRICT NO. 17  
SAN JOAQUIN COUNTY, CALIFORNIA

Subject: Mossdale Tract  
Reclamation District No. 17  
San Joaquin County, California

## URBAN LEVEE DESIGN CRITERIA EVALUATION

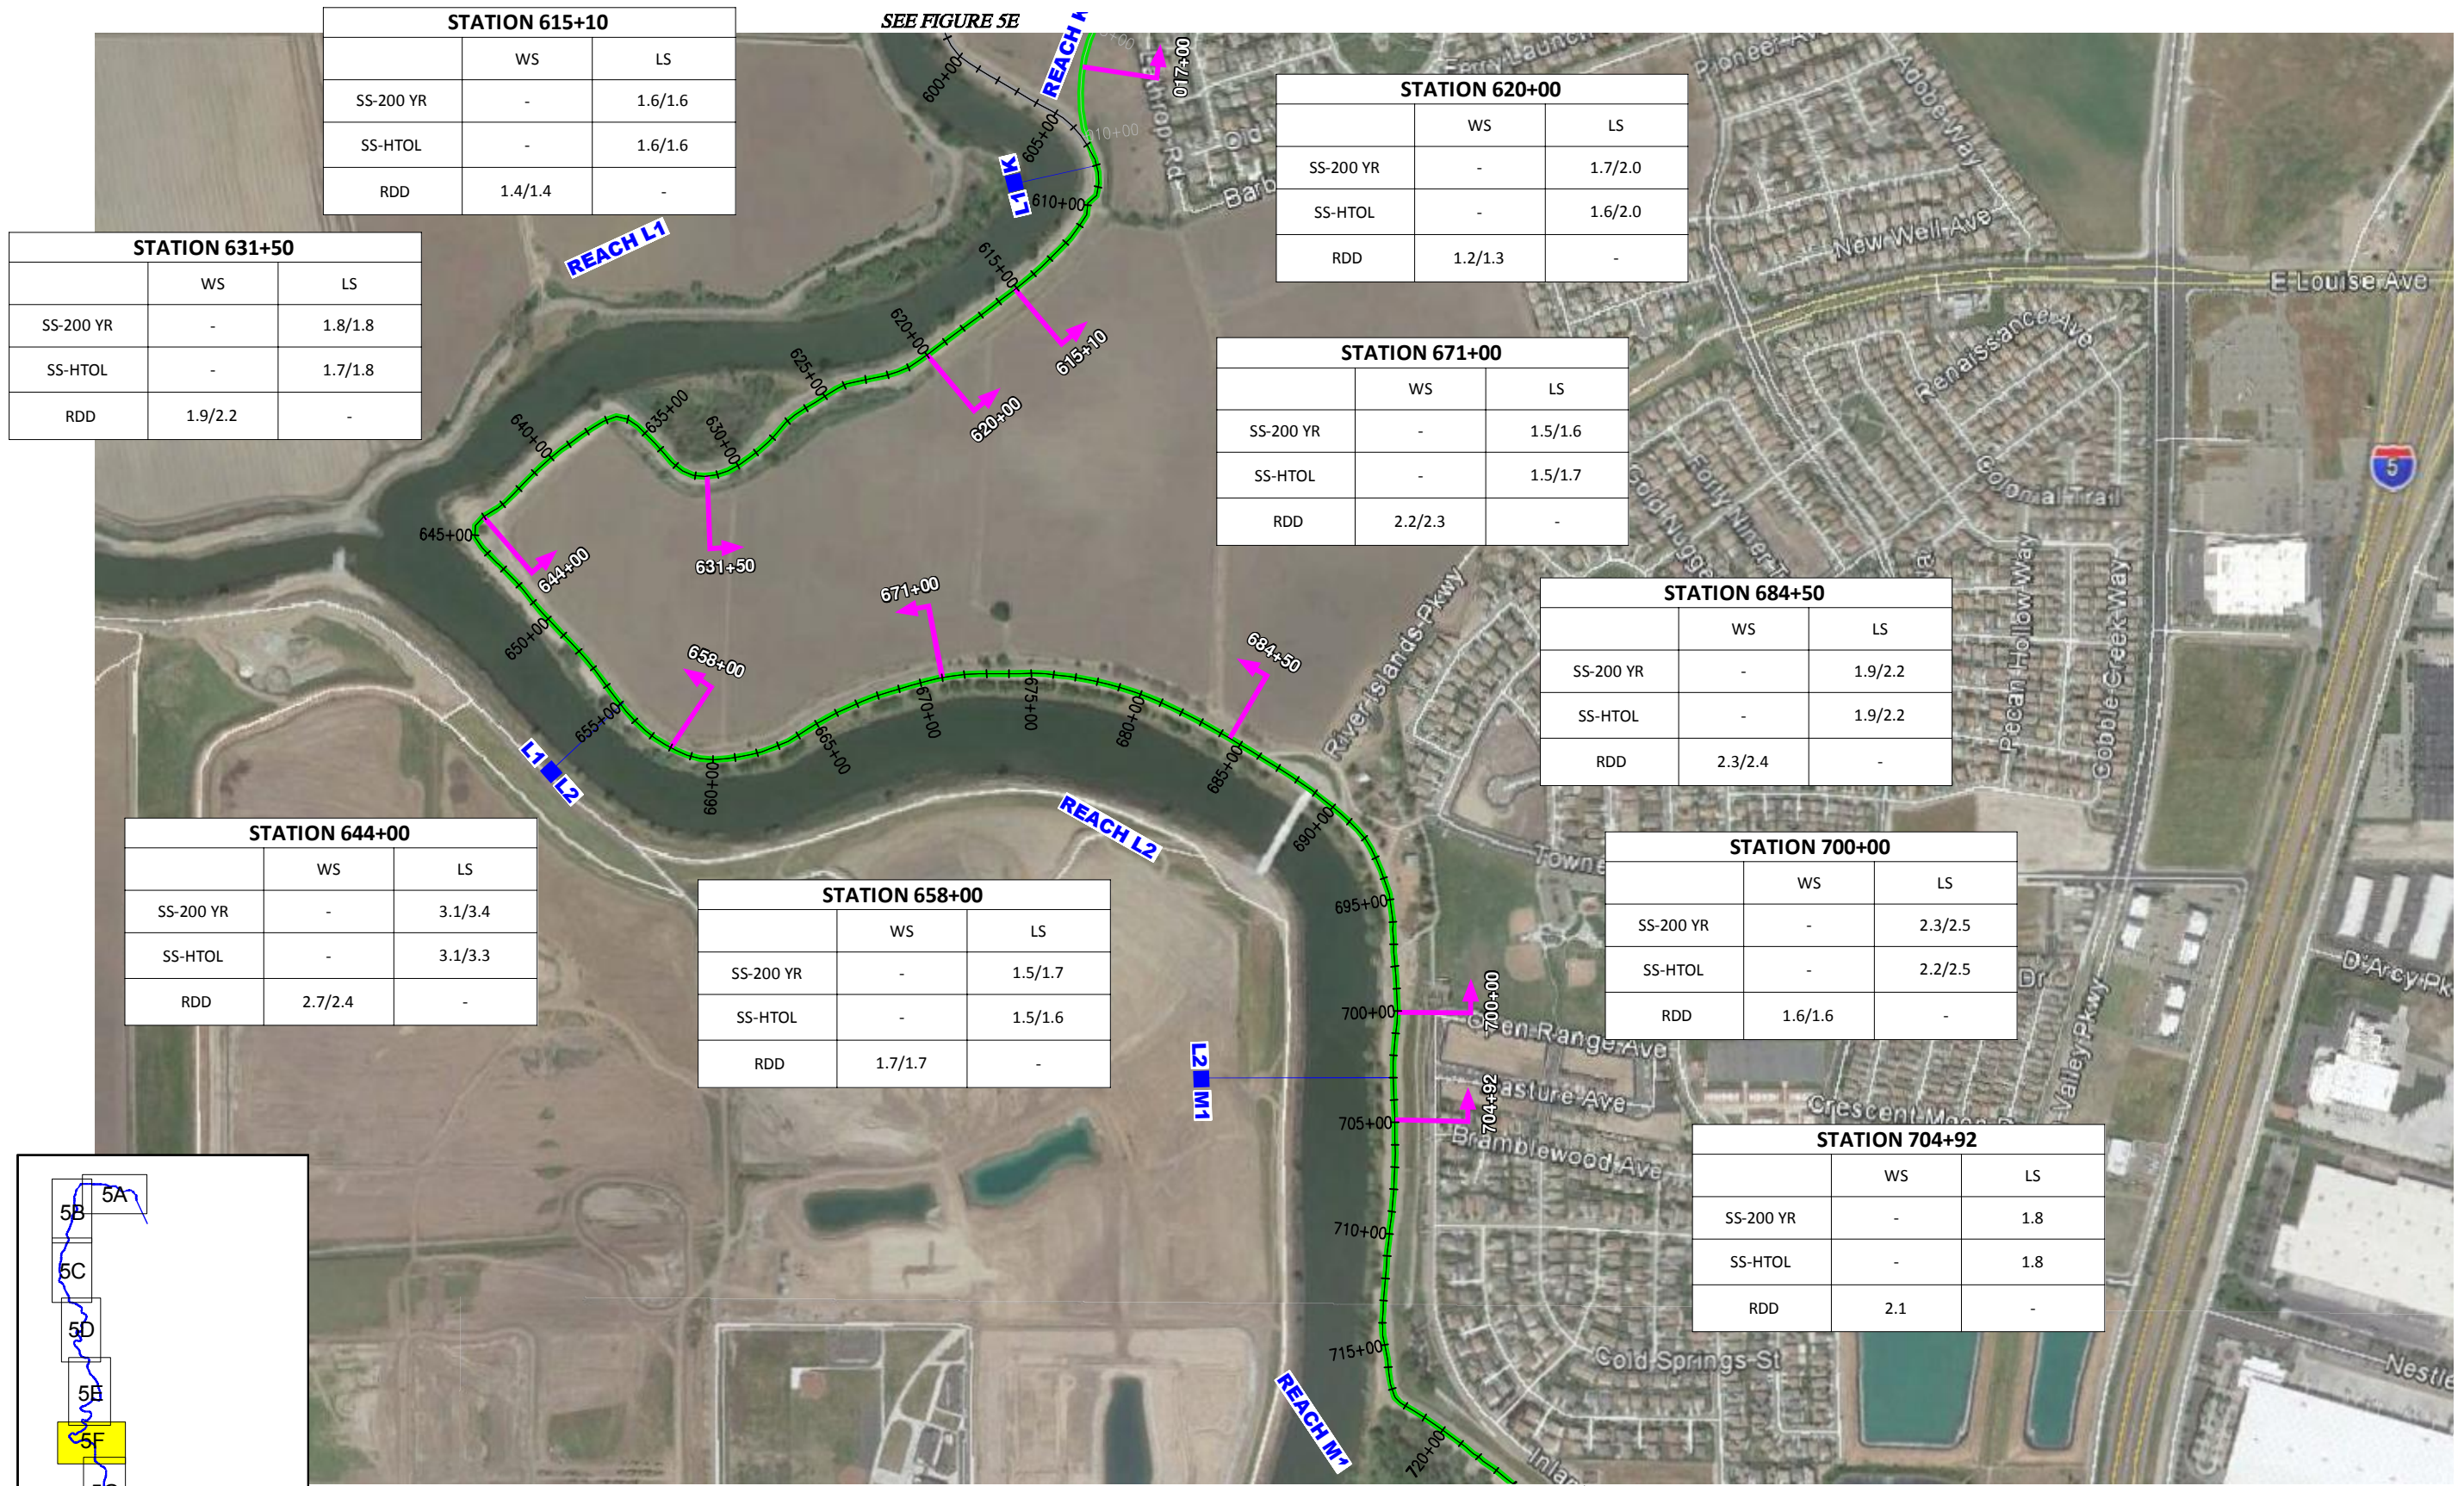
STATION 615+10		
	WS	LS
SS-200 YR	-	1.6/1.6
SS-HTOL	-	1.6/1.6
RDD	1.4/1.4	-

STATION 620+00		
	WS	LS
SS-200 YR	-	1.7/2.0
SS-HTOL	-	1.6/2.0
RDD	1.2/1.3	-

STATION 700+00		
	WS	LS
SS-200 YR	-	2.3/2.5
SS-HTOL	-	2.2/2.5
RDD	1.6/1.6	-

STATION 704+92		
	WS	LS
SS-200 YR	-	1.8
SS-HTOL	-	1.8
RDD	2.1	-

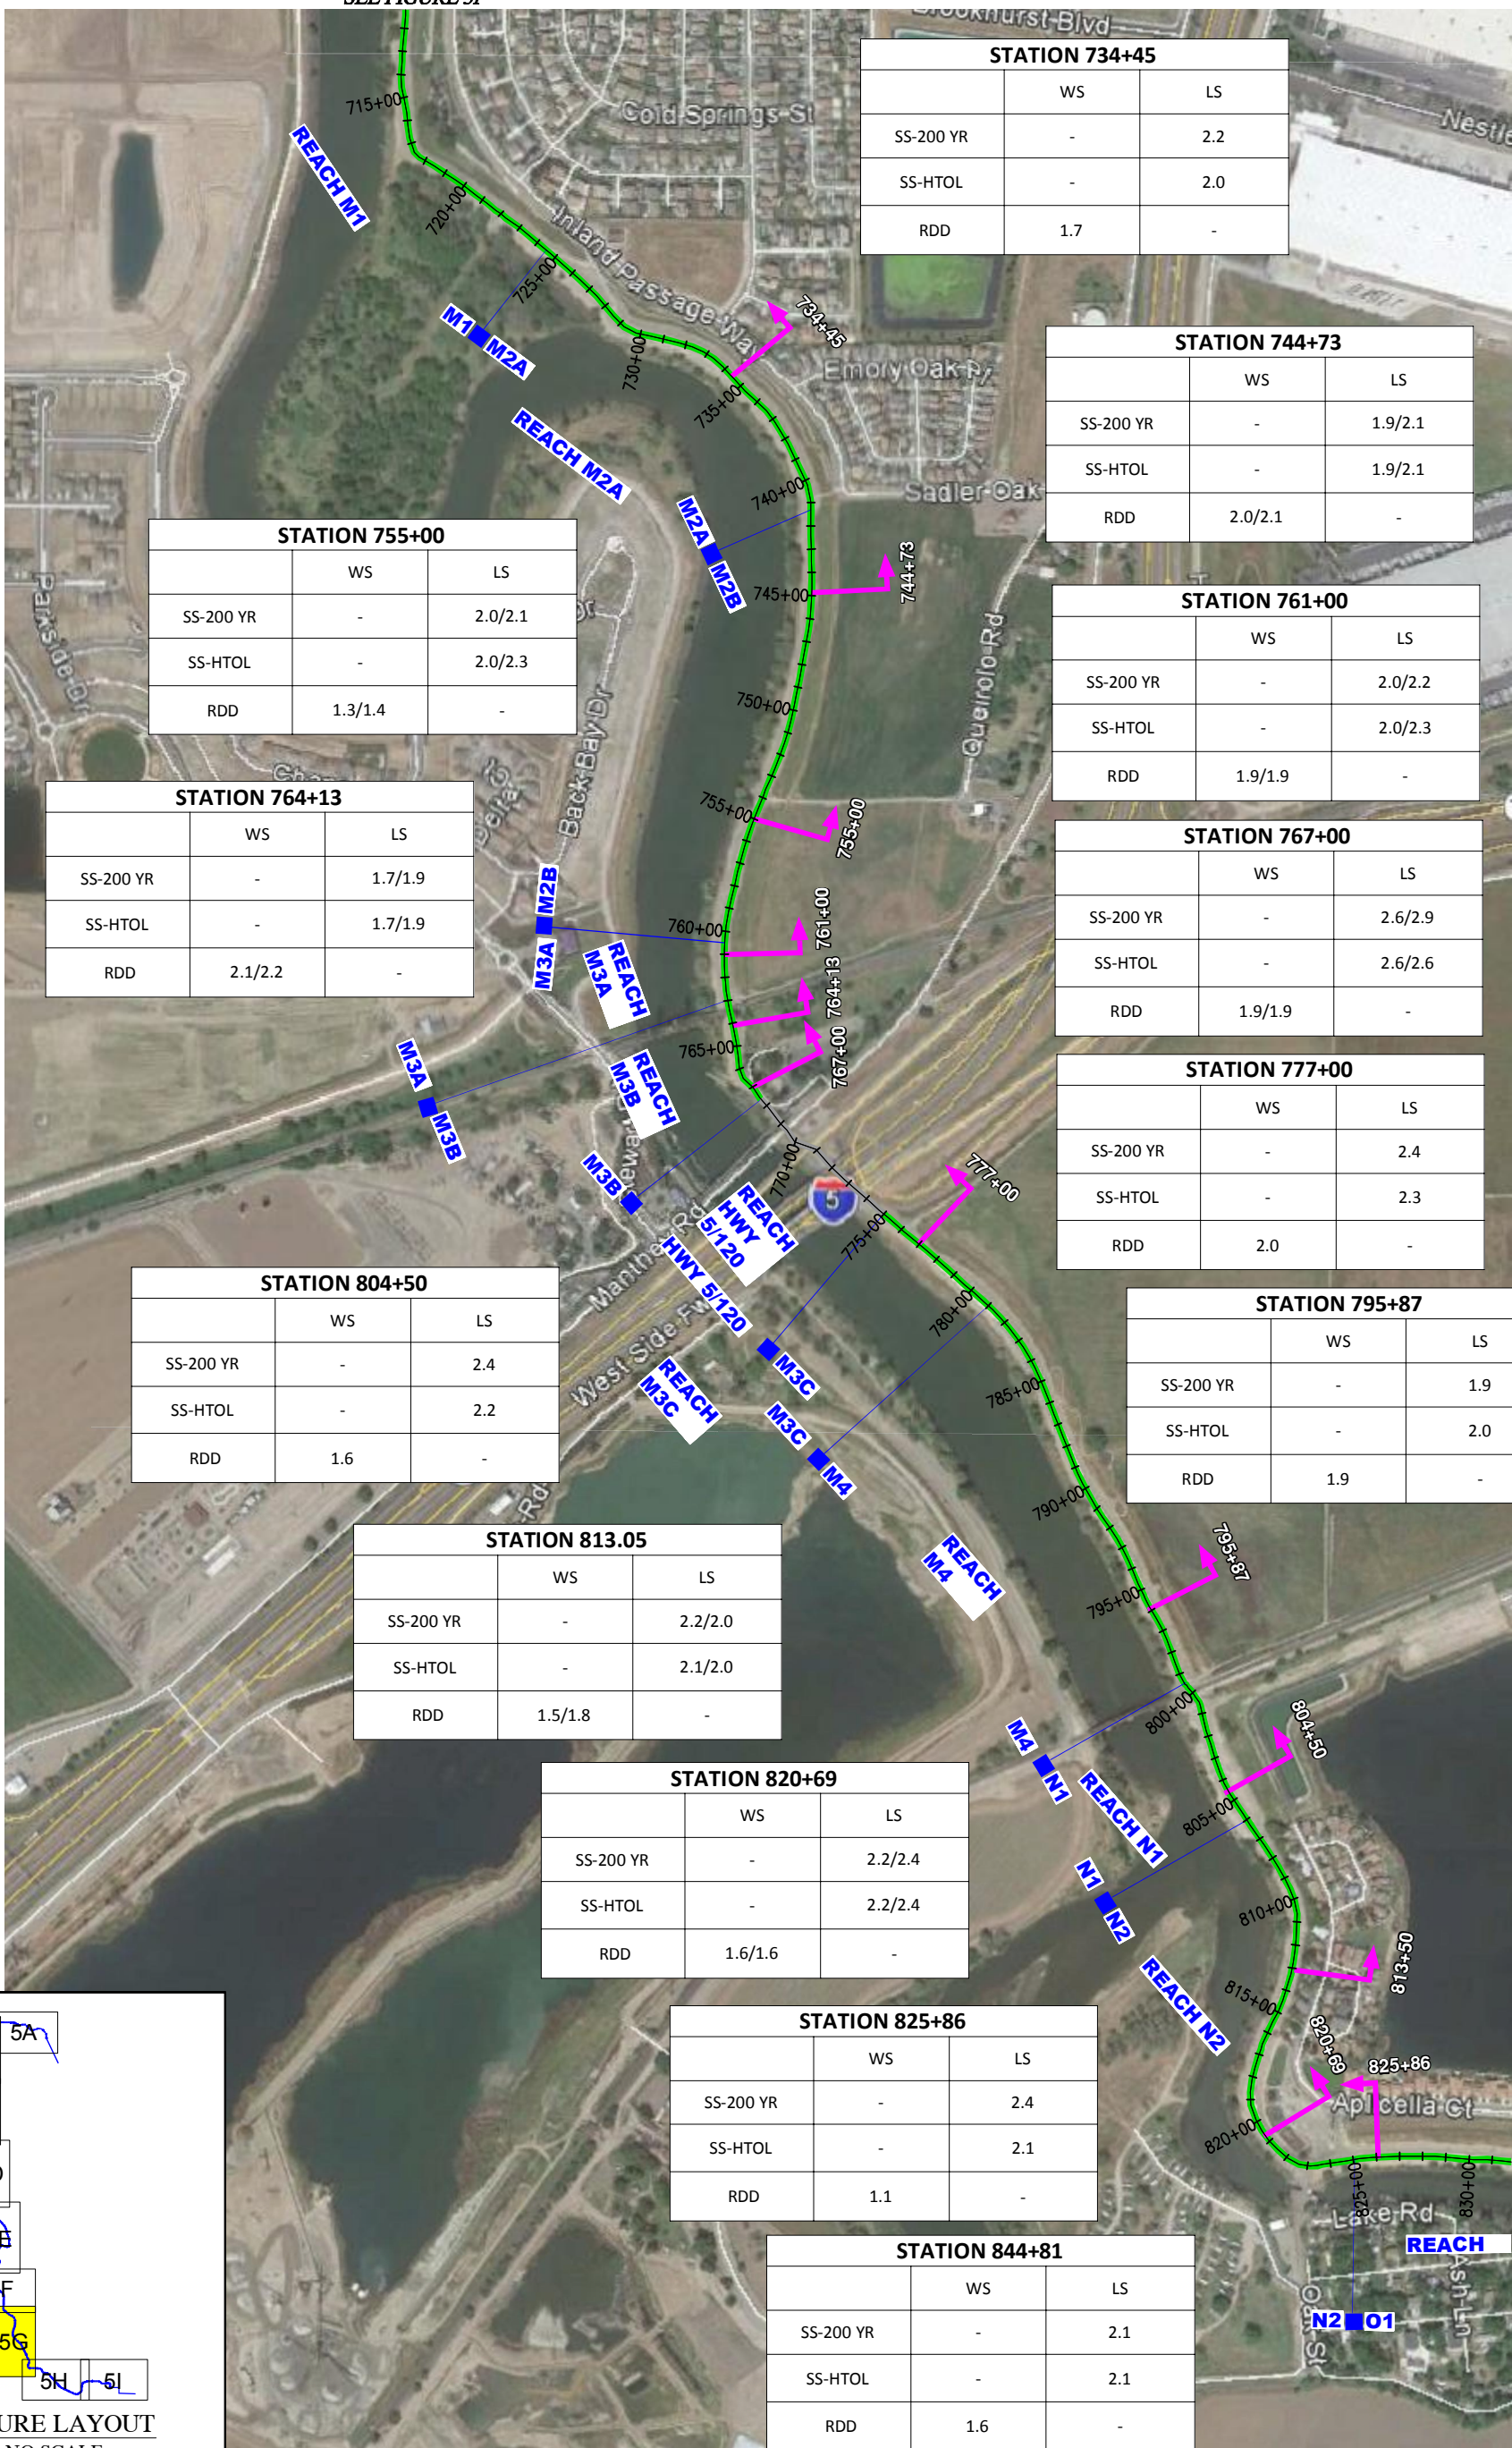
STATION 734+45		
	WS	LS
SS-200 YR	-	2.2
SS-HTOL	-	2.0
RDD	1.7	-

STATION 744+73		
	WS	LS
SS-200 YR	-	1.9/2.1
SS-HTOL	-	1.9/2.1
RDD	2.0/2.1	-

STATION 825+86		
	WS	LS
SS-200 YR	-	2.4
SS-HTOL	-	2.1
RDD	1.1	-

STATION 844+81		
	WS	LS
SS-200 YR	-	2.1
SS-HTOL	-	2.1
RDD	1.6	-

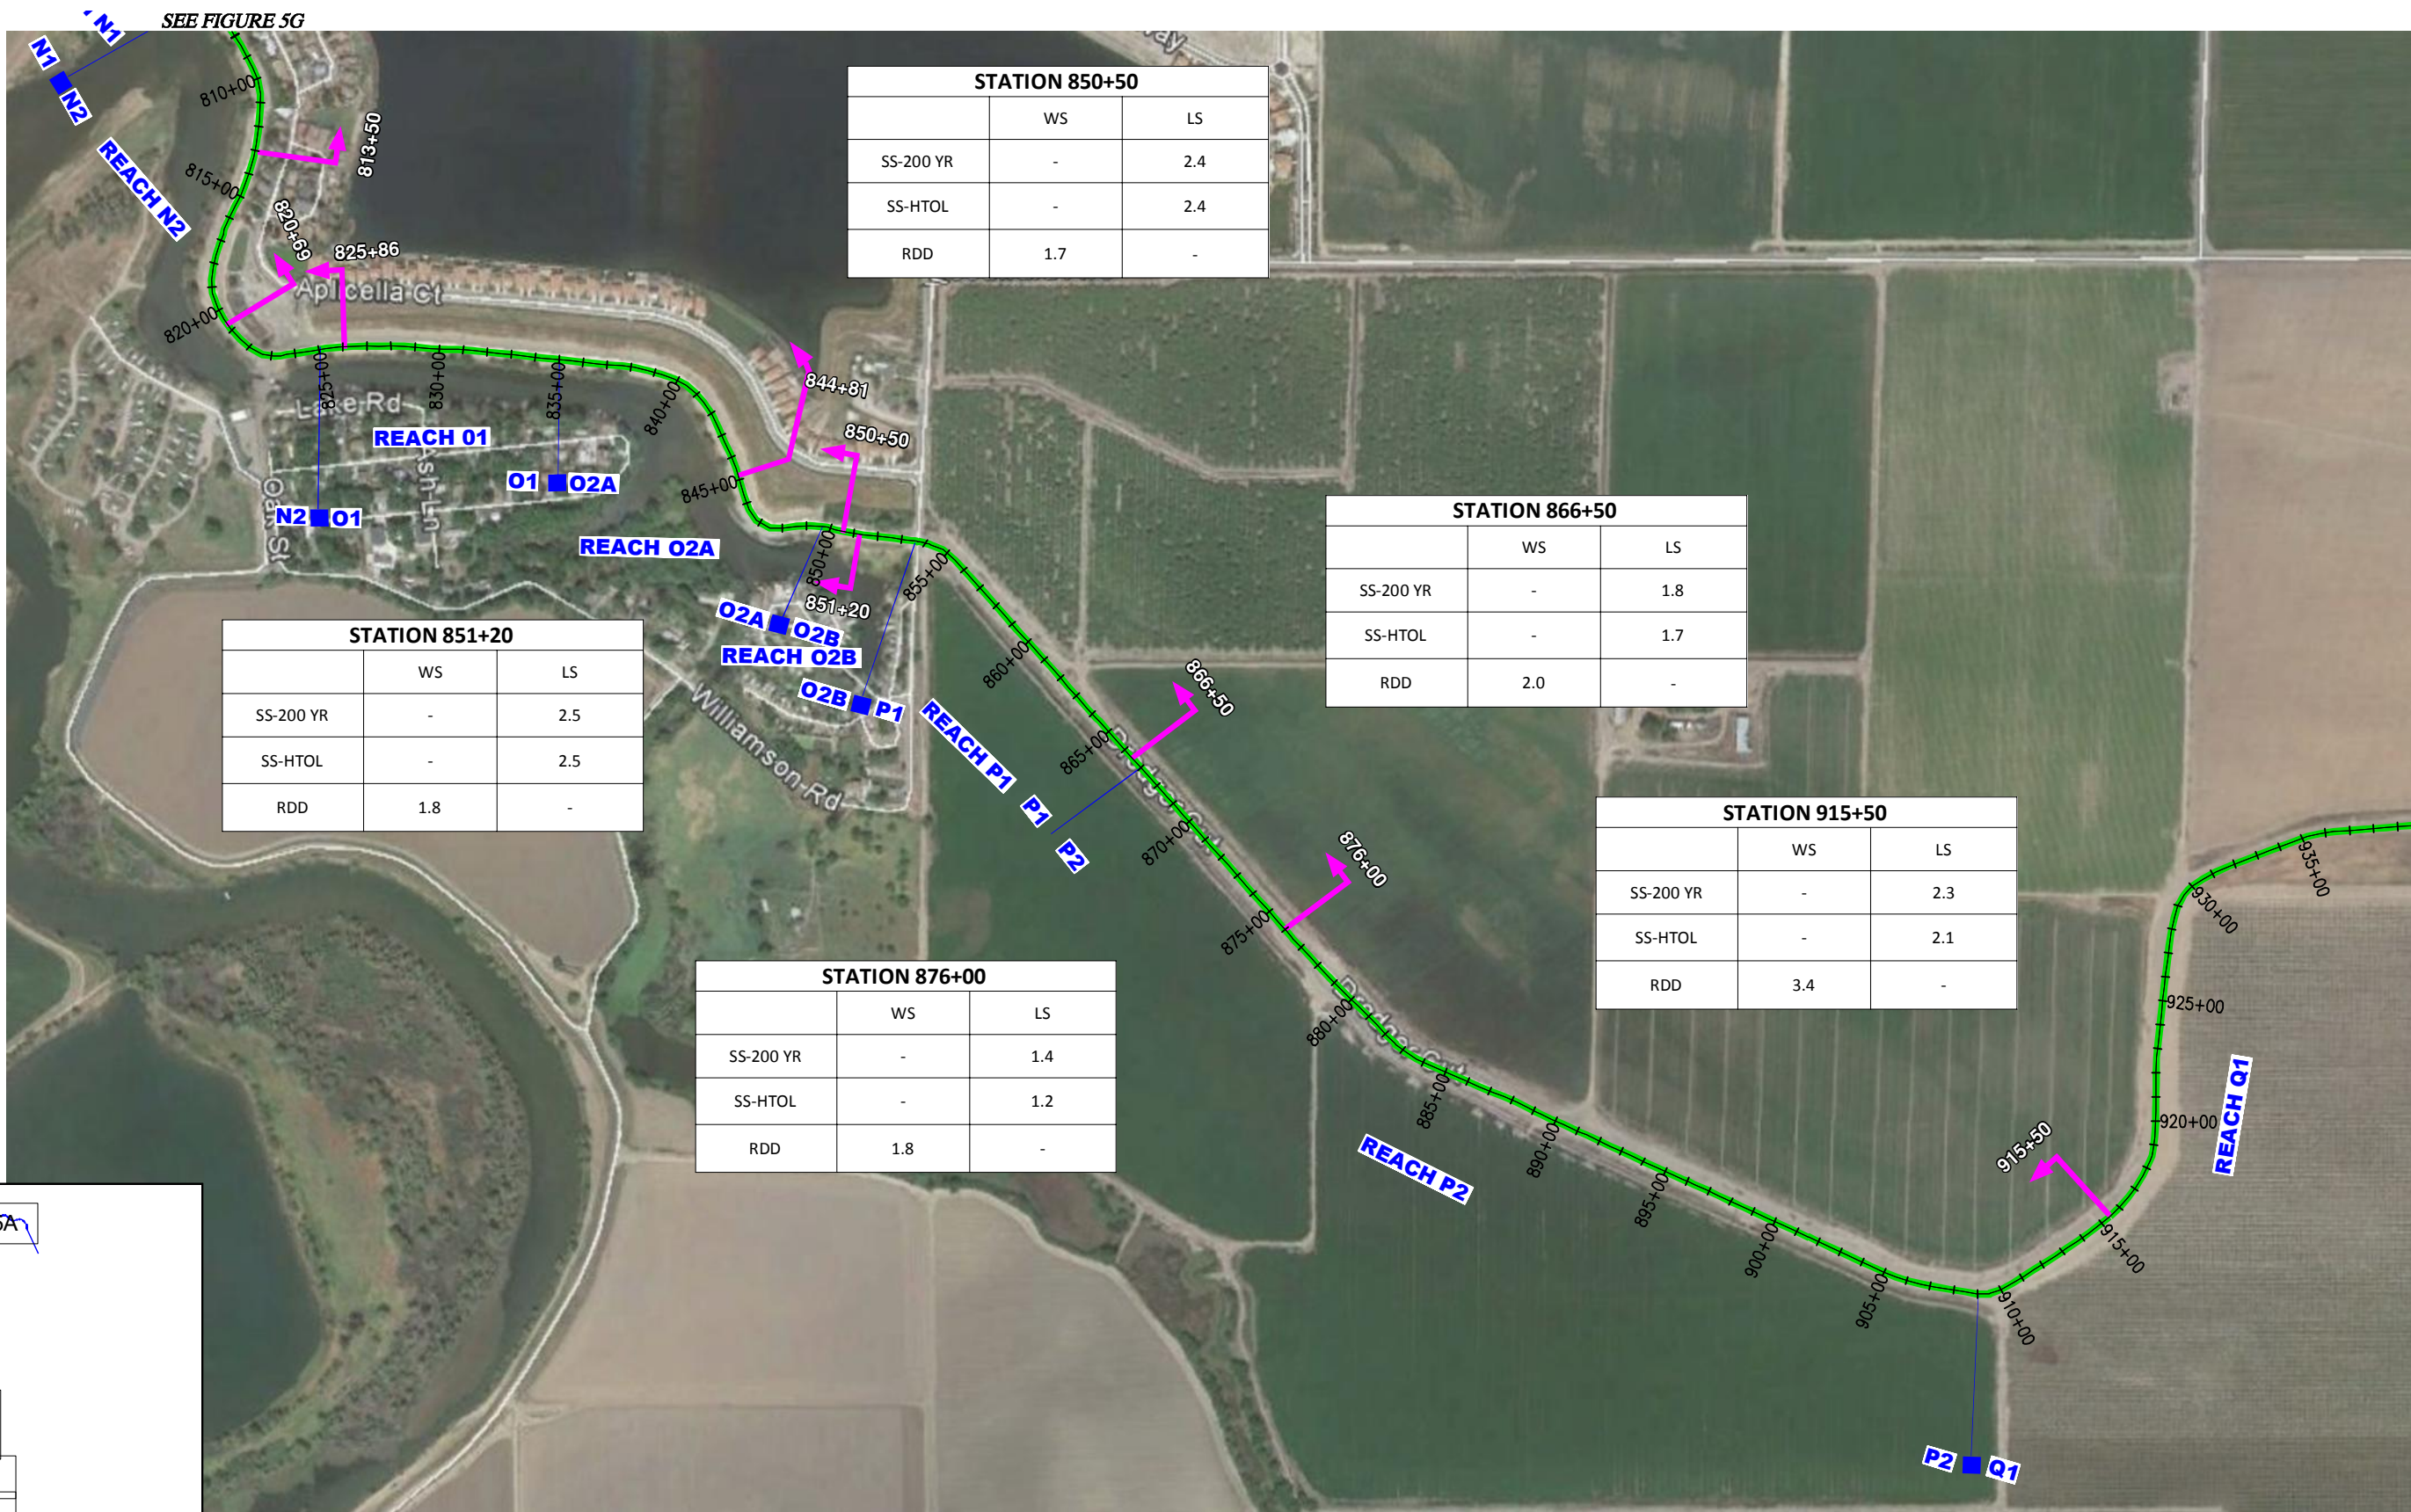
FIGURE NO.  
**5H**

WS	LS
SS-200 YR	-	2.5
SS-HTOL	-	2.5
RDD	1.8	-

WS	LS
SS-200 YR	-	1.4
SS-HTOL	-	1.2
RDD	1.8	-

WS	LS
SS-200 YR	-	1.8
SS-HTOL	-	1.7
RDD	2.0	-

WS	LS
SS-200 YR	-	2.3
SS-HTOL	-	2.1
RDD	3.4	-

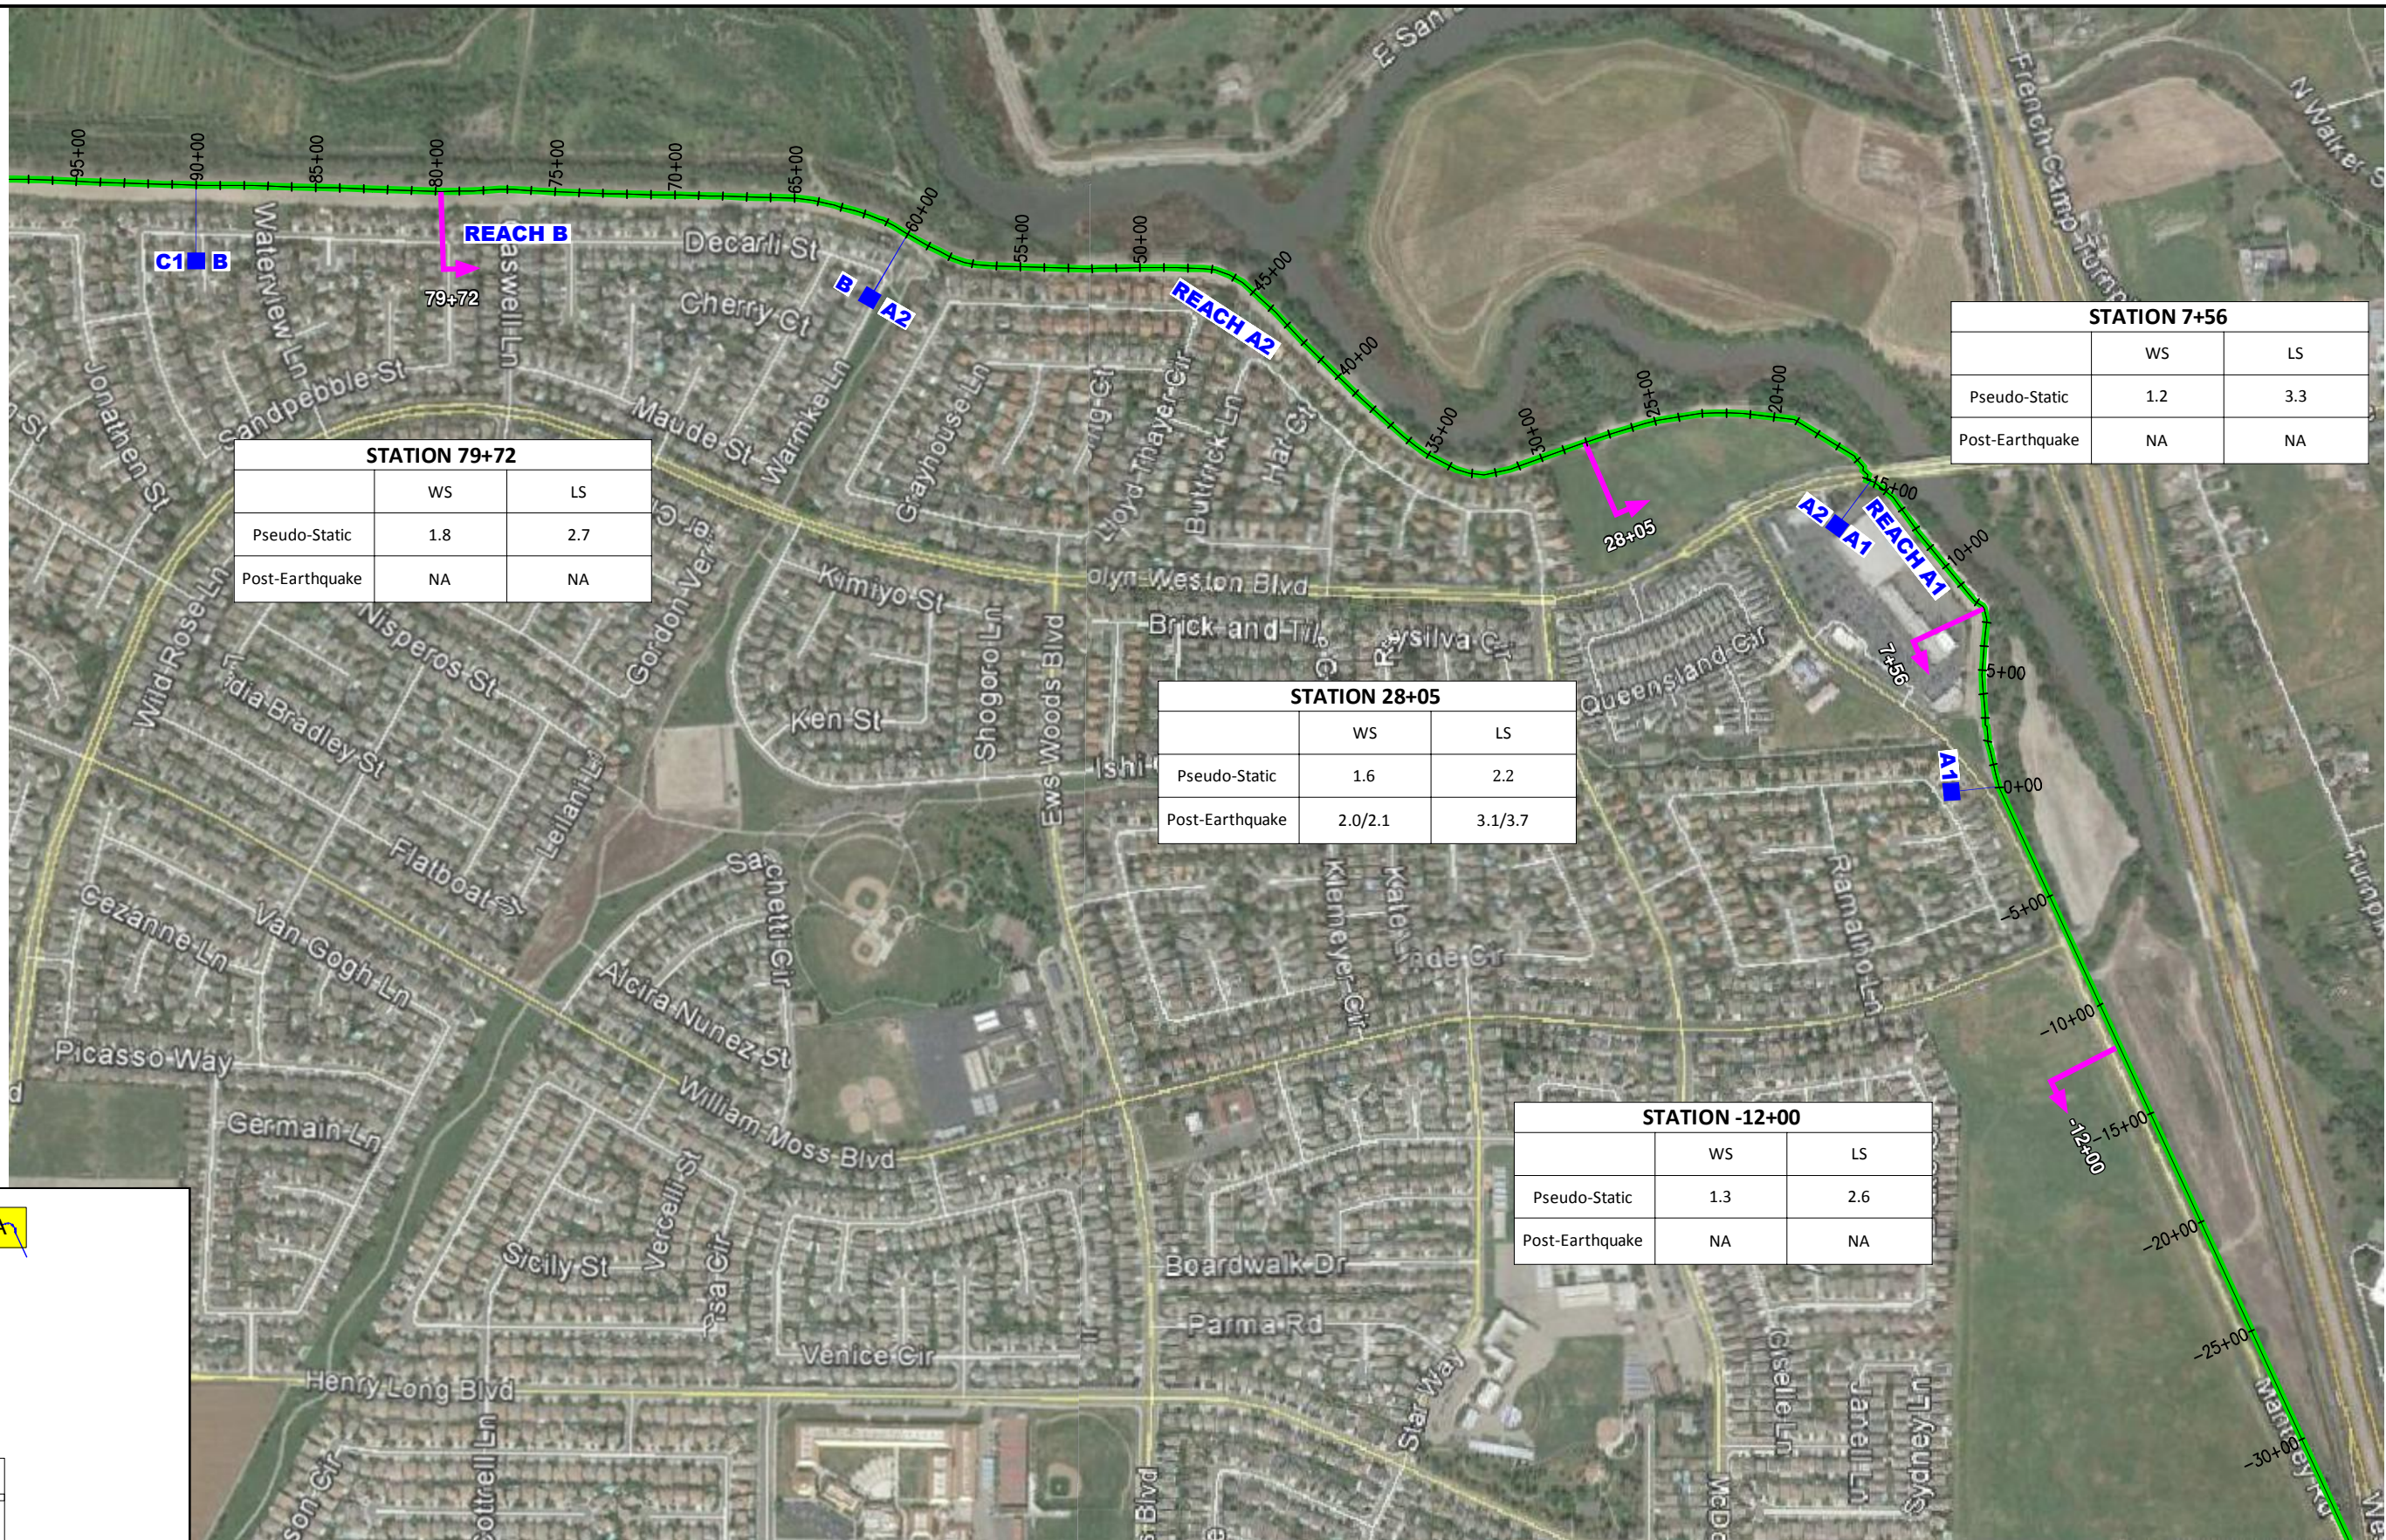
FIGURE NO.  
**6A**

STATION 79+72		
	WS	LS
Pseudo-Static	1.8	2.7
Post-Earthquake	NA	NA

STATION 7+56		
	WS	LS
Pseudo-Static	1.2	3.3
Post-Earthquake	NA	NA

STATION 28+05		
	WS	LS
Pseudo-Static	1.6	2.2
Post-Earthquake	2.0/2.1	3.1/3.7

STATION -12+00		
	WS	LS
Pseudo-Static	1.3	2.6
Post-Earthquake	NA	NA

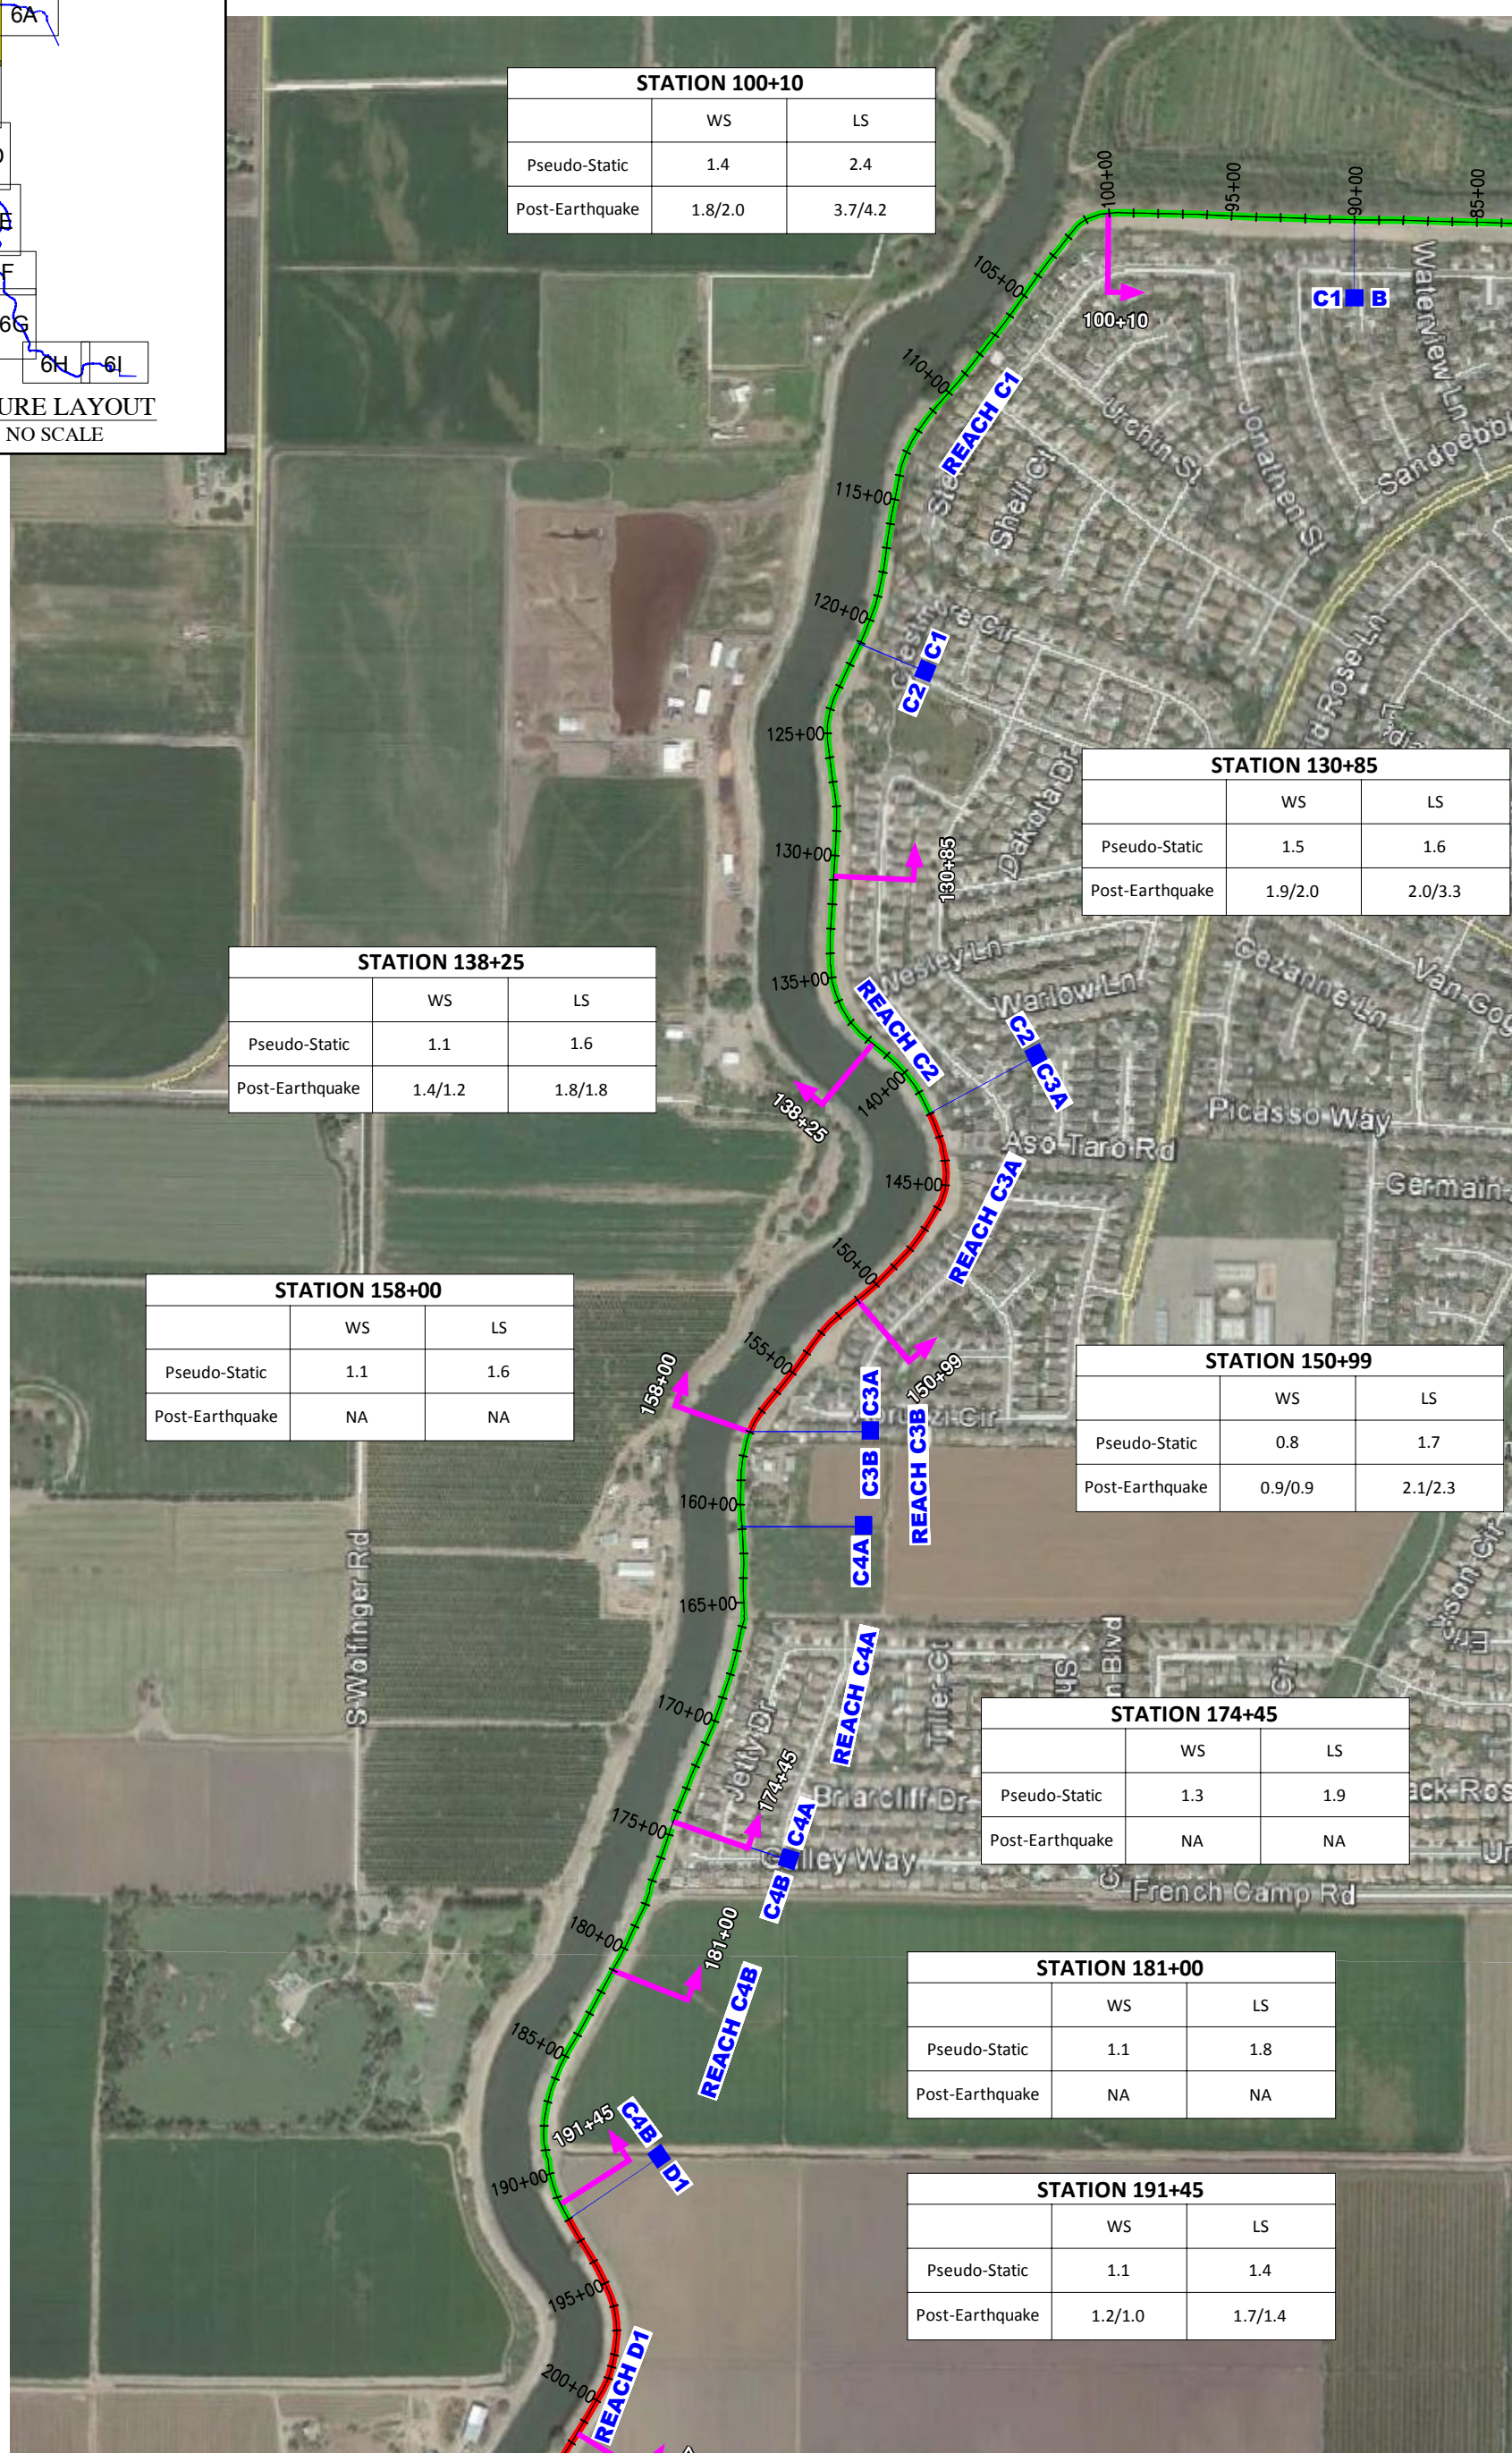
STATION 100+10		
	WS	LS
Pseudo-Static	1.4	2.4
Post-Earthquake	1.8/2.0	3.7/4.2

STATION 130+85		
	WS	LS
Pseudo-Static	1.5	1.6
Post-Earthquake	1.9/2.0	2.0/3.3

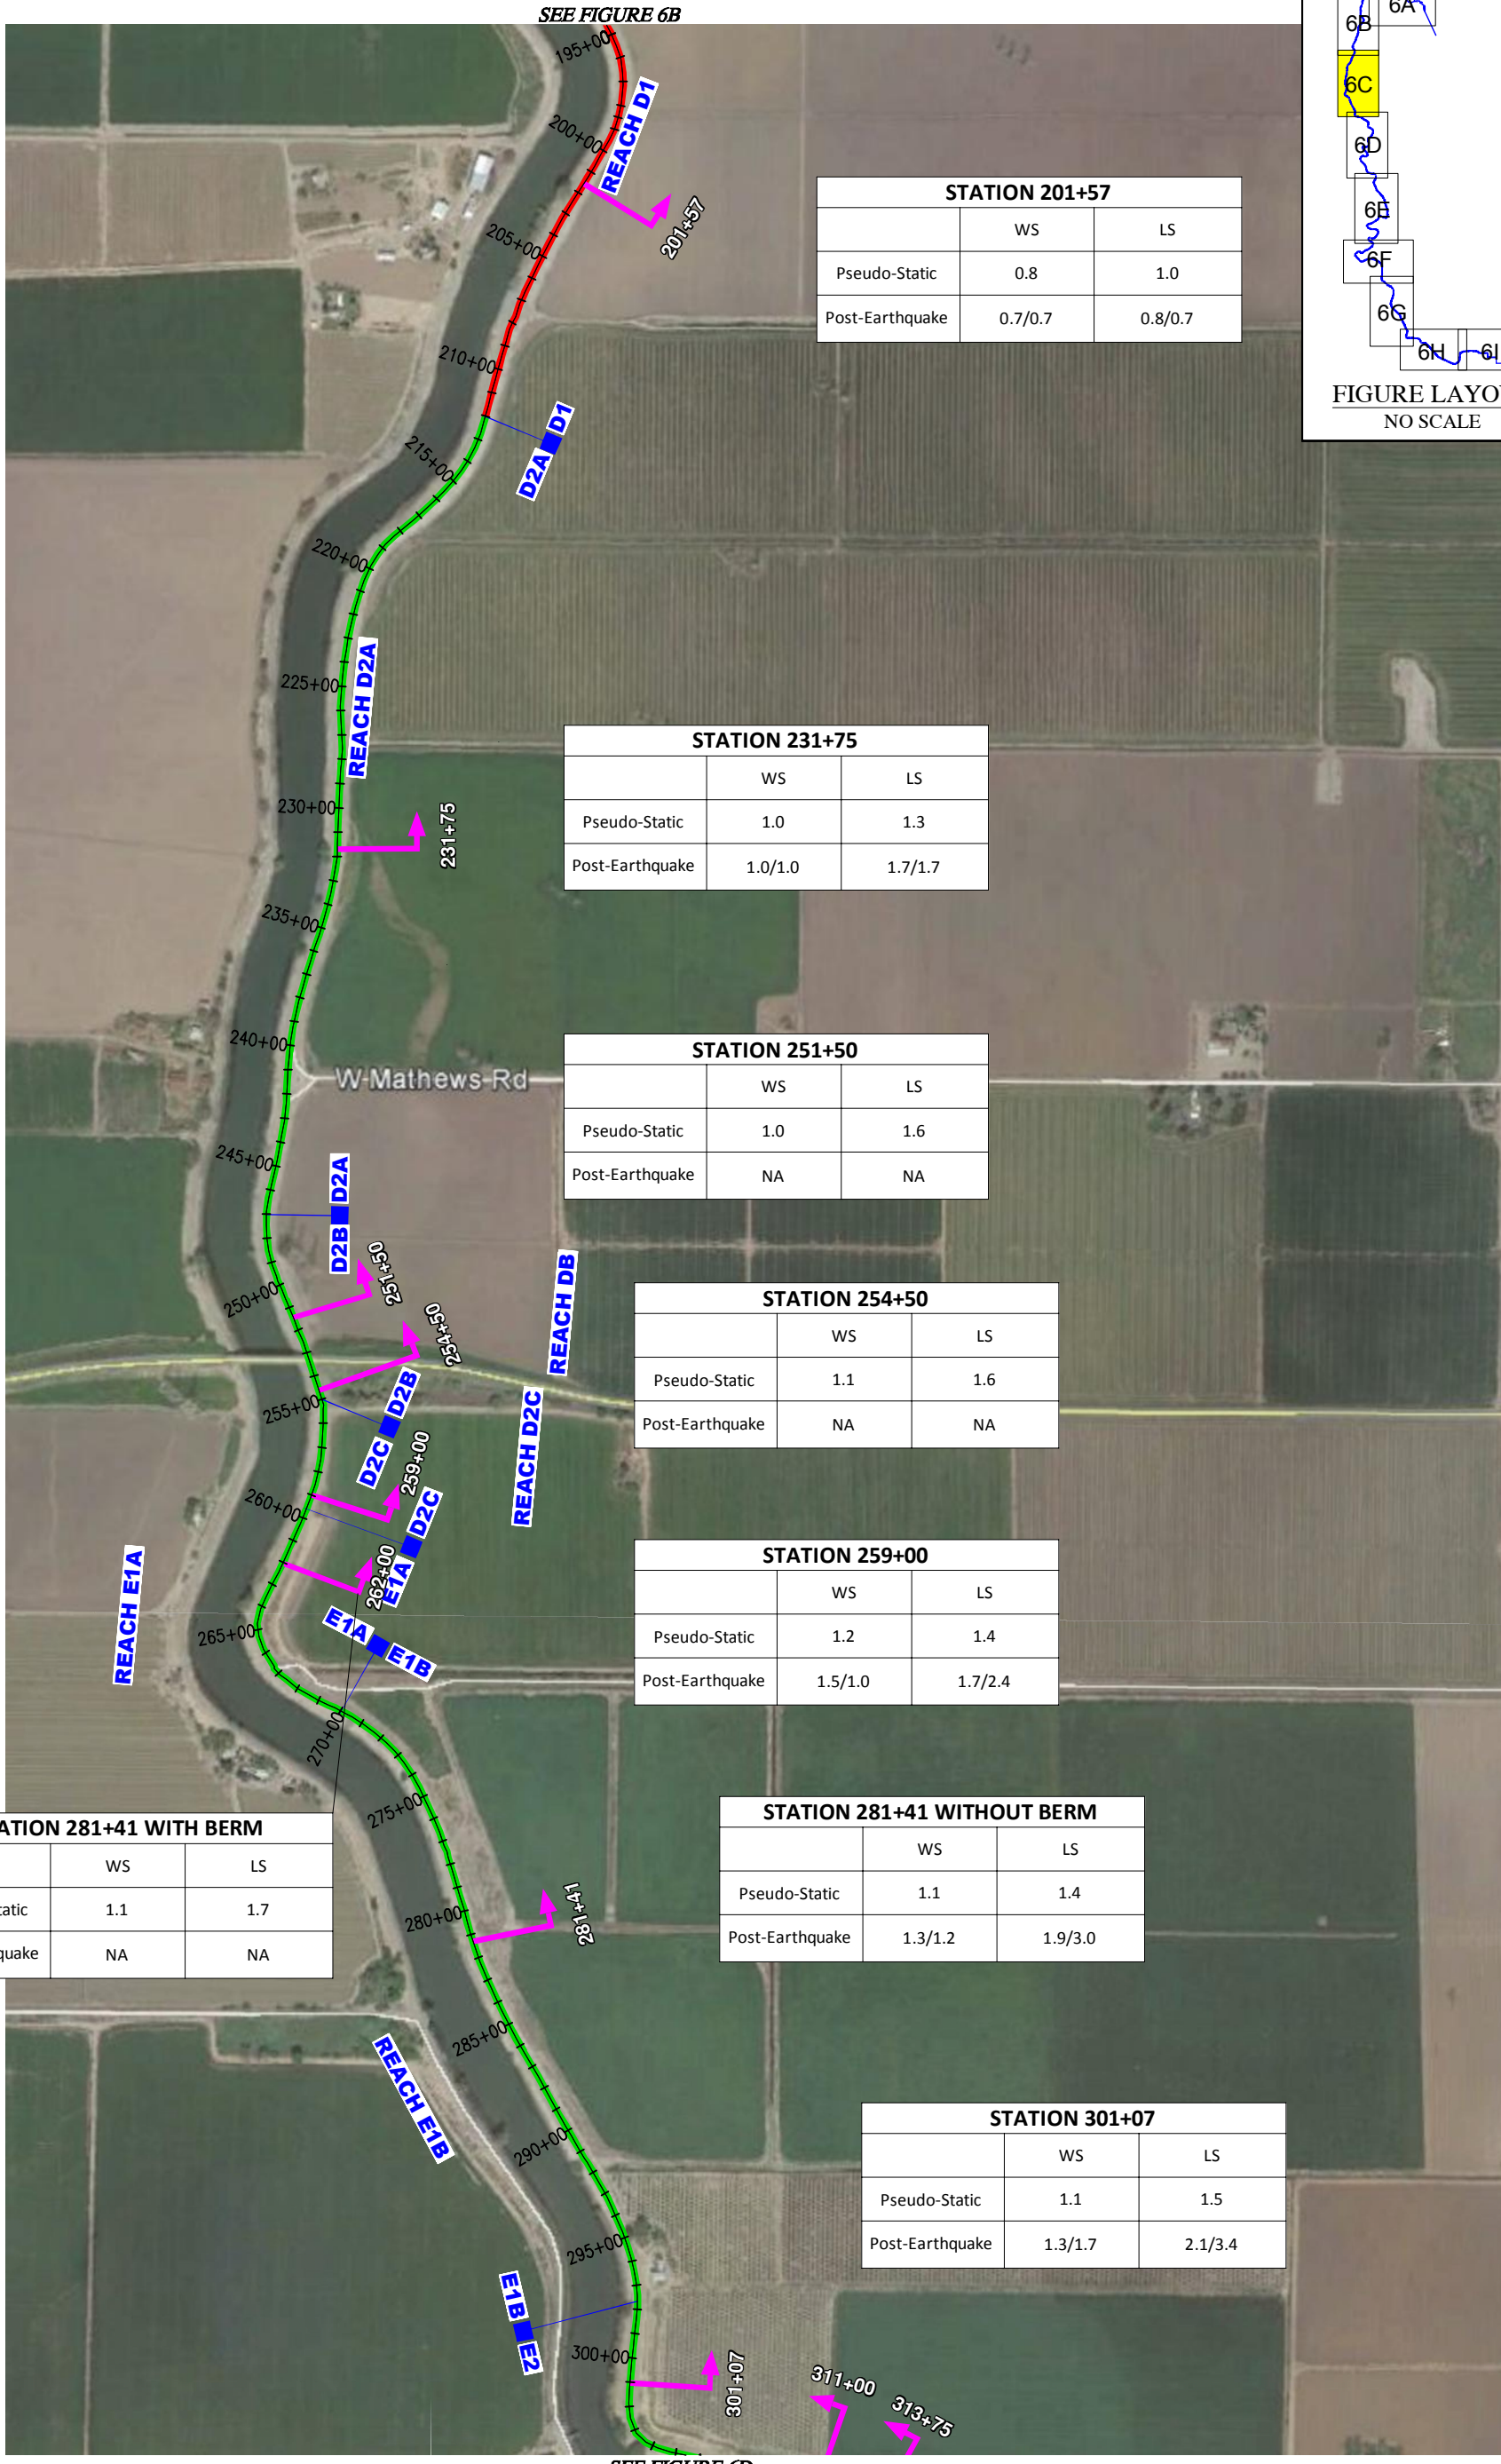
STATION 201+57		
	WS	LS
Pseudo-Static	0.8	1.0
Post-Earthquake	0.7/0.7	0.8/0.7

STATION 231+75		
	WS	LS
Pseudo-Static	1.0	1.3
Post-Earthquake	1.0/1.0	1.7/1.7

STATION 281+41 WITHOUT BERM		
	WS	LS
Pseudo-Static	1.1	1.4
Post-Earthquake	1.3/1.2	1.9/3.0

STATION 301+07		
	WS	LS
Pseudo-Static	1.1	1.5
Post-Earthquake	1.3/1.7	2.1/3.4
