# URBAN LEVEE DESIGN CRITERIA EVALUATION

MOSSDALE TRACT  
RECLAMATION DISTRICT NO. 17  
SAN JOAQUIN COUNTY, CALIFORNIA

Subject: Mossdale Tract  
Reclamation District No. 17  
San Joaquin County, California

## URBAN LEVEE DESIGN CRITERIA EVALUATION

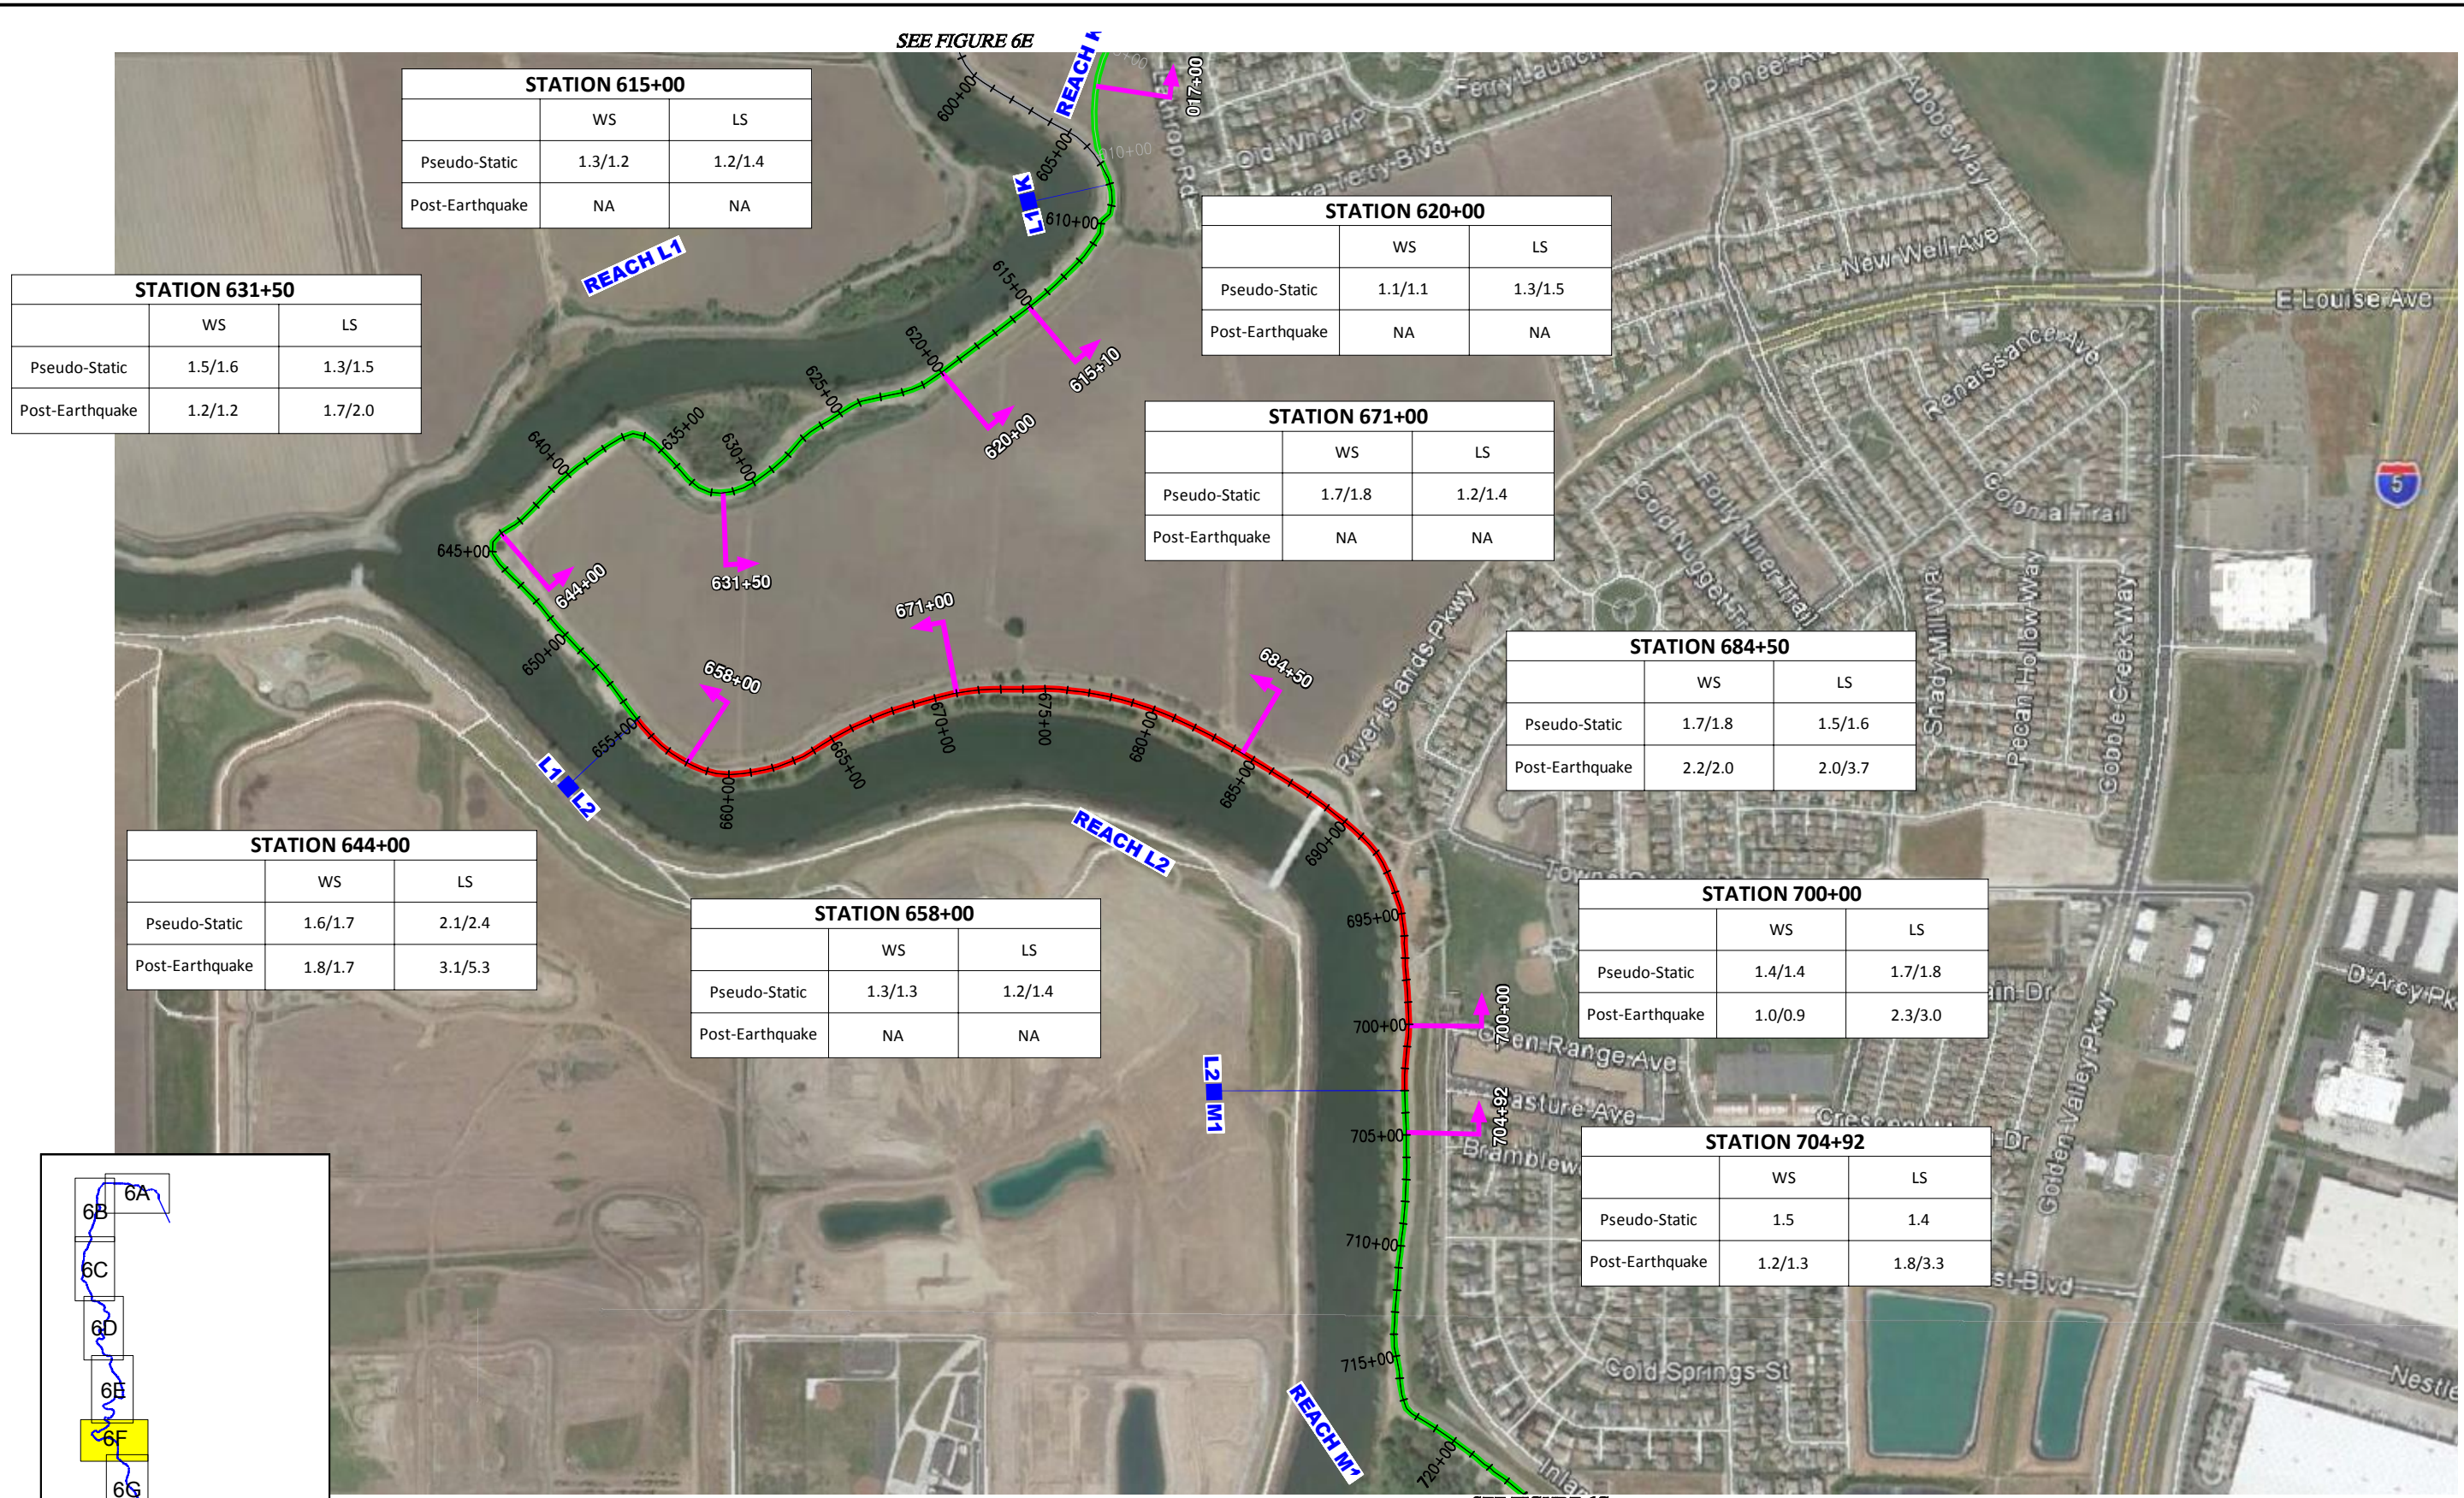
STATION 615+00		
	WS	LS
Pseudo-Static	1.3/1.2	1.2/1.4
Post-Earthquake	NA	NA

STATION 620+00		
	WS	LS
Pseudo-Static	1.1/1.1	1.3/1.5
Post-Earthquake	NA	NA

STATION 644+00		
	WS	LS
Pseudo-Static	1.6/1.7	2.1/2.4
Post-Earthquake	1.8/1.7	3.1/5.3

STATION 658+00		
	WS	LS
Pseudo-Static	1.3/1.3	1.2/1.4
Post-Earthquake	NA	NA

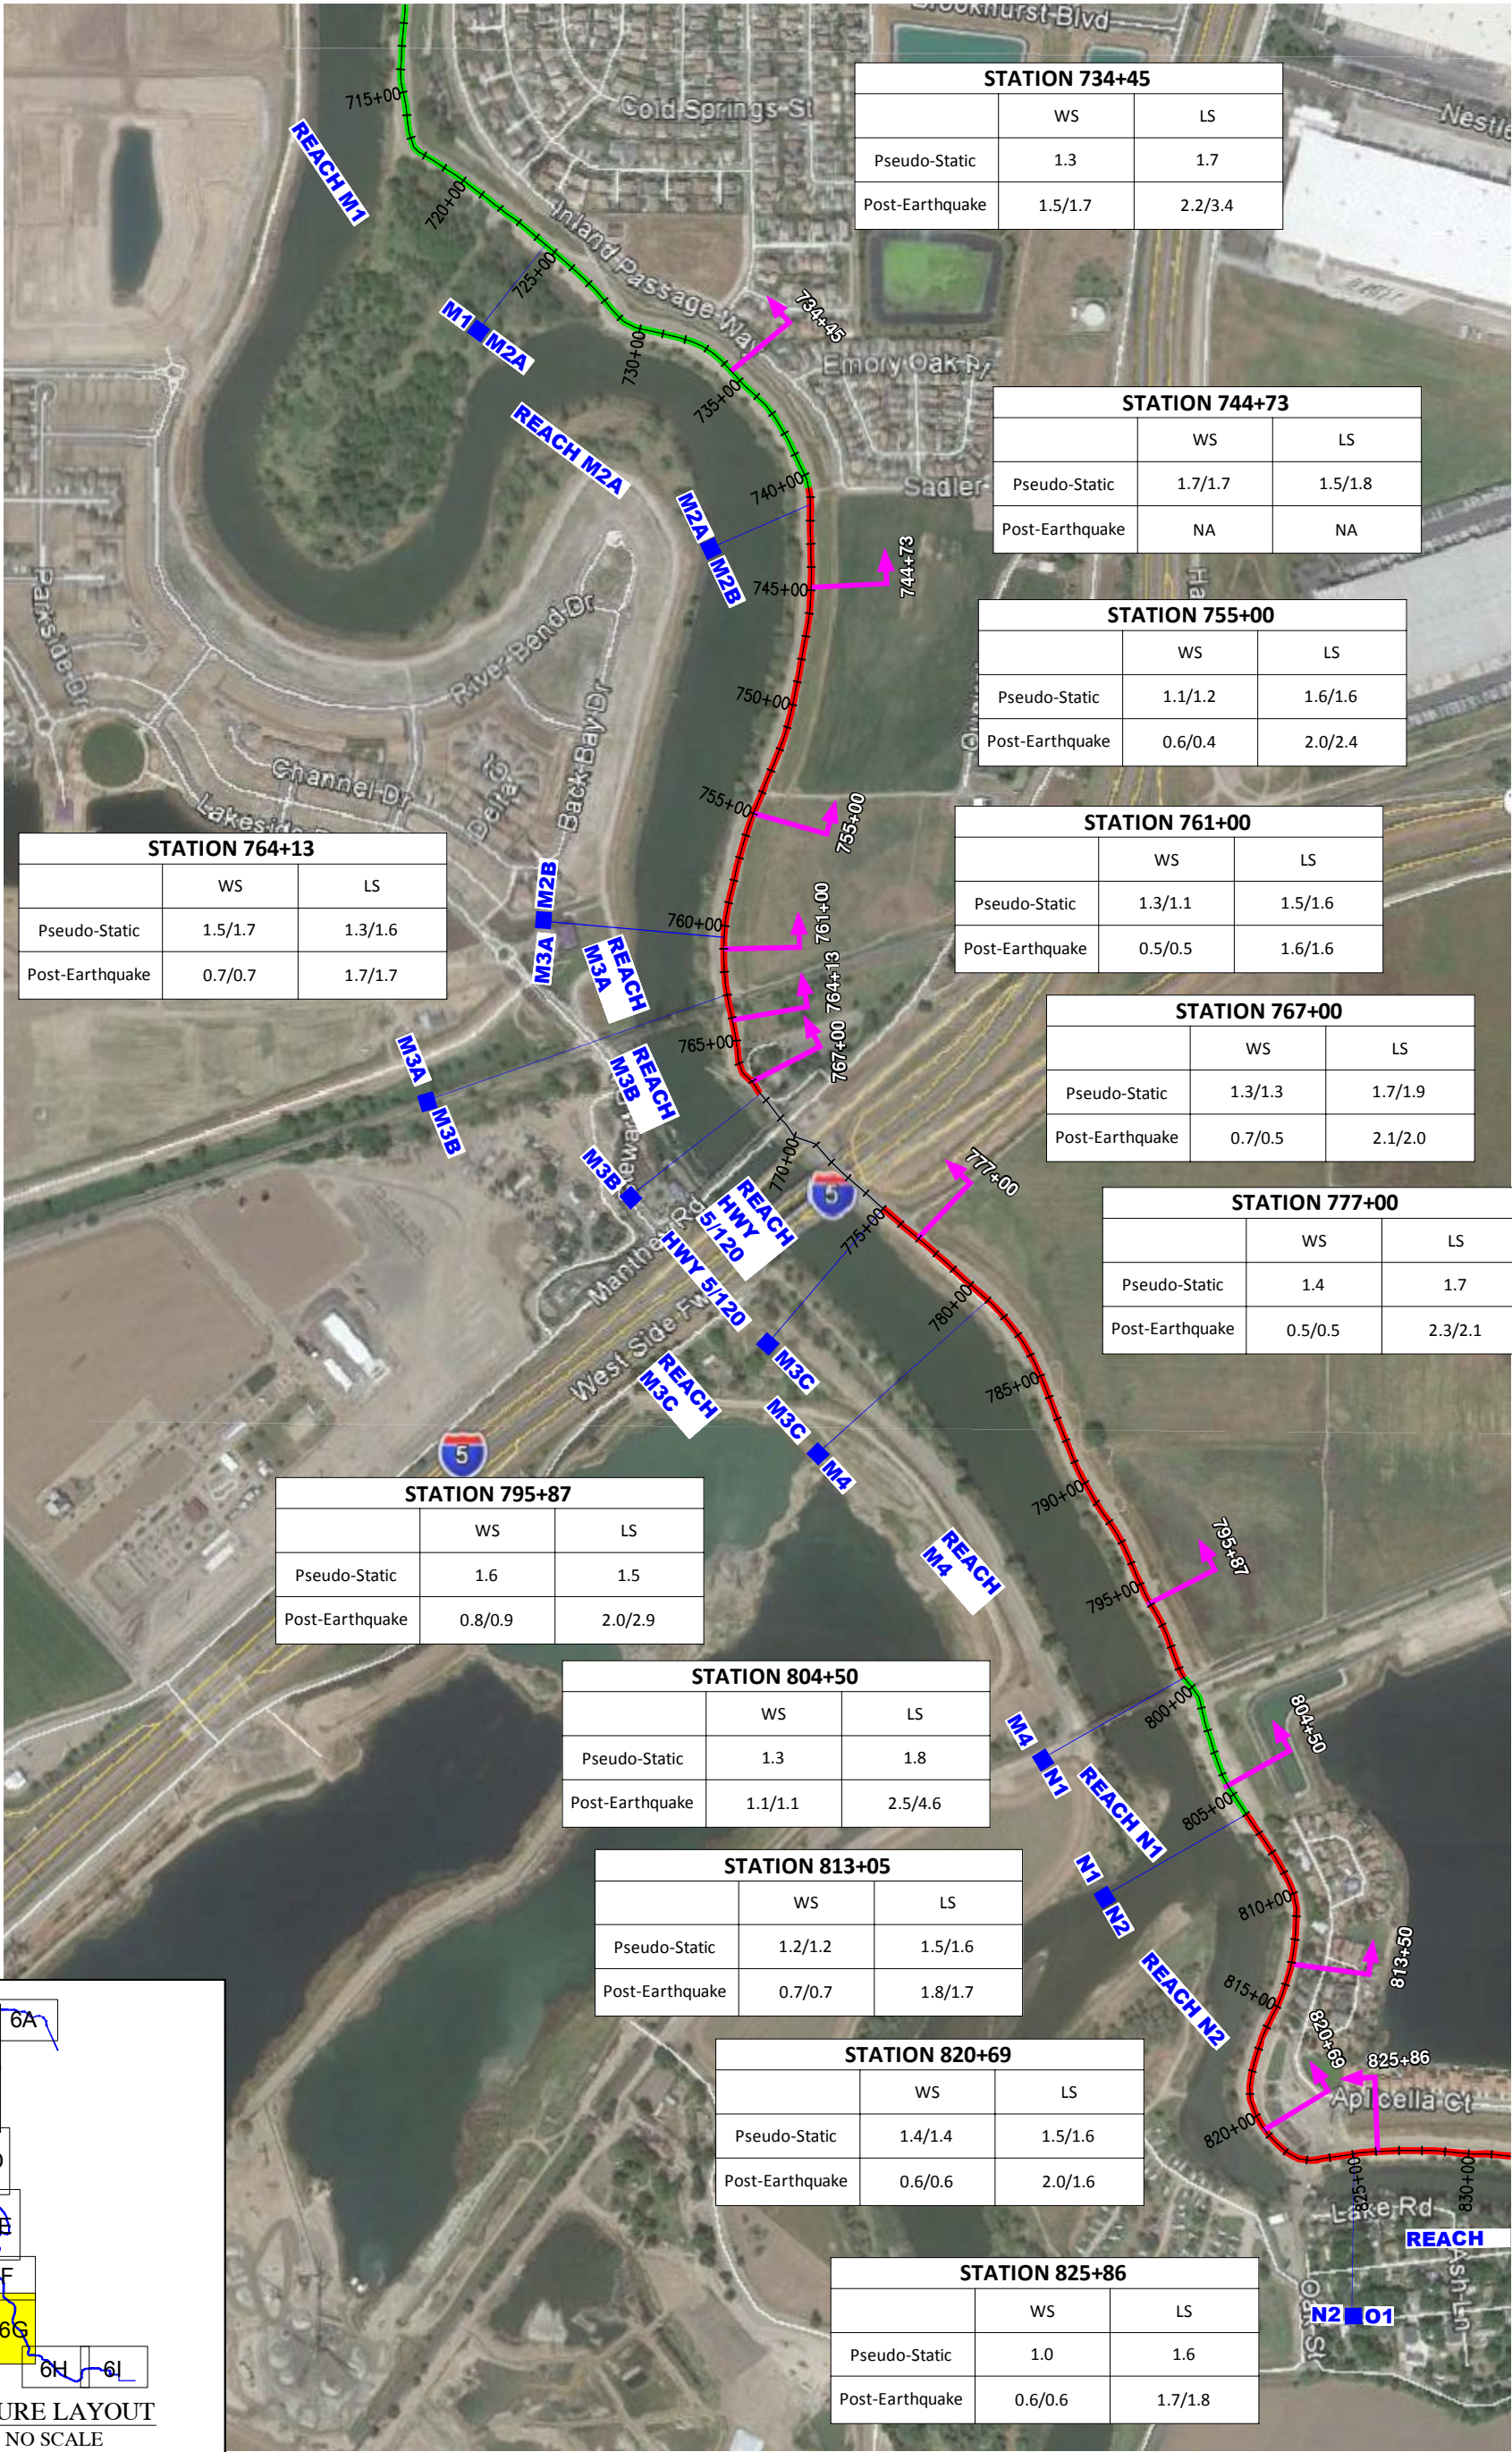
STATION 734+45		
	WS	LS
Pseudo-Static	1.3	1.7
Post-Earthquake	1.5/1.7	2.2/3.4

STATION 744+73		
	WS	LS
Pseudo-Static	1.7/1.7	1.5/1.8
Post-Earthquake	NA	NA

STATION 820+69		
	WS	LS
Pseudo-Static	1.4/1.4	1.5/1.6
Post-Earthquake	0.6/0.6	2.0/1.6

STATION 825+86		
	WS	LS
Pseudo-Static	1.0	1.6
Post-Earthquake	0.6/0.6	1.7/1.8

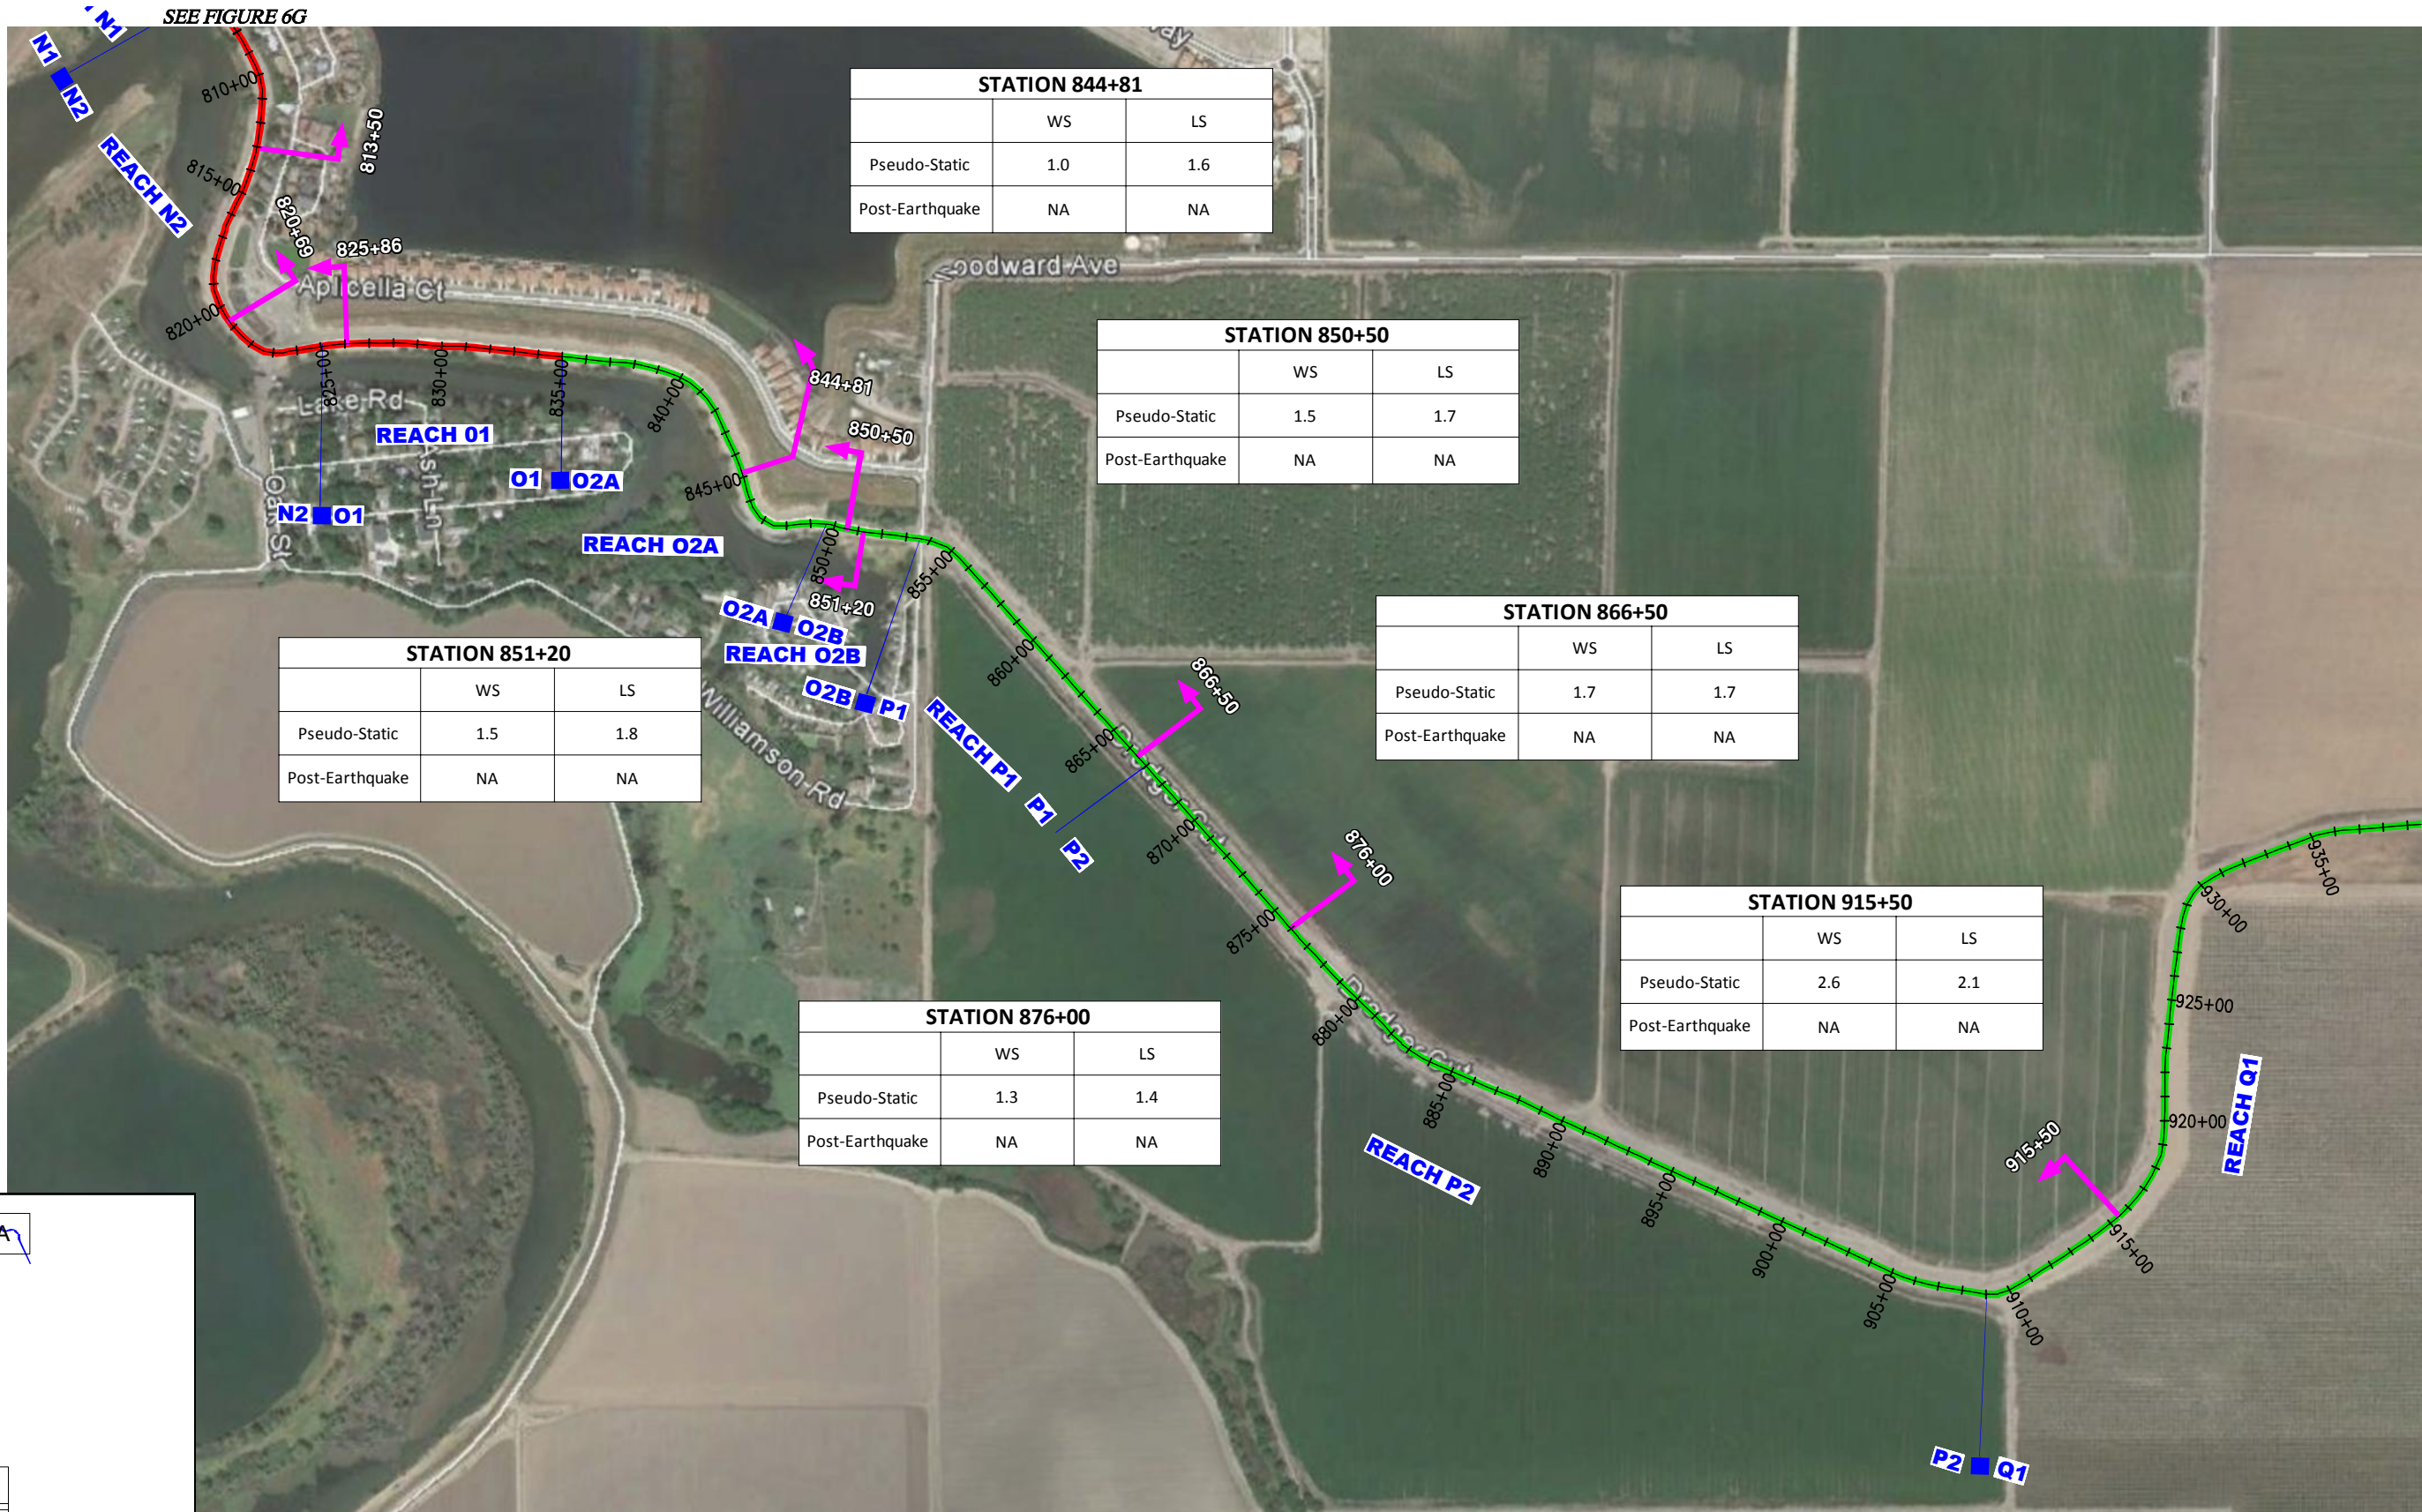
STATION 851+20		
	WS	LS
Pseudo-Static	1.5	1.8
Post-Earthquake	NA	NA

STATION 844+81		
	WS	LS
Pseudo-Static	1.0	1.6
Post-Earthquake	NA	NA

STATION 876+00		
	WS	LS
Pseudo-Static	1.3	1.4
Post-Earthquake	NA	NA

STATION 915+50		
	WS	LS
Pseudo-Static	2.6	2.1
Post-Earthquake	NA	NA

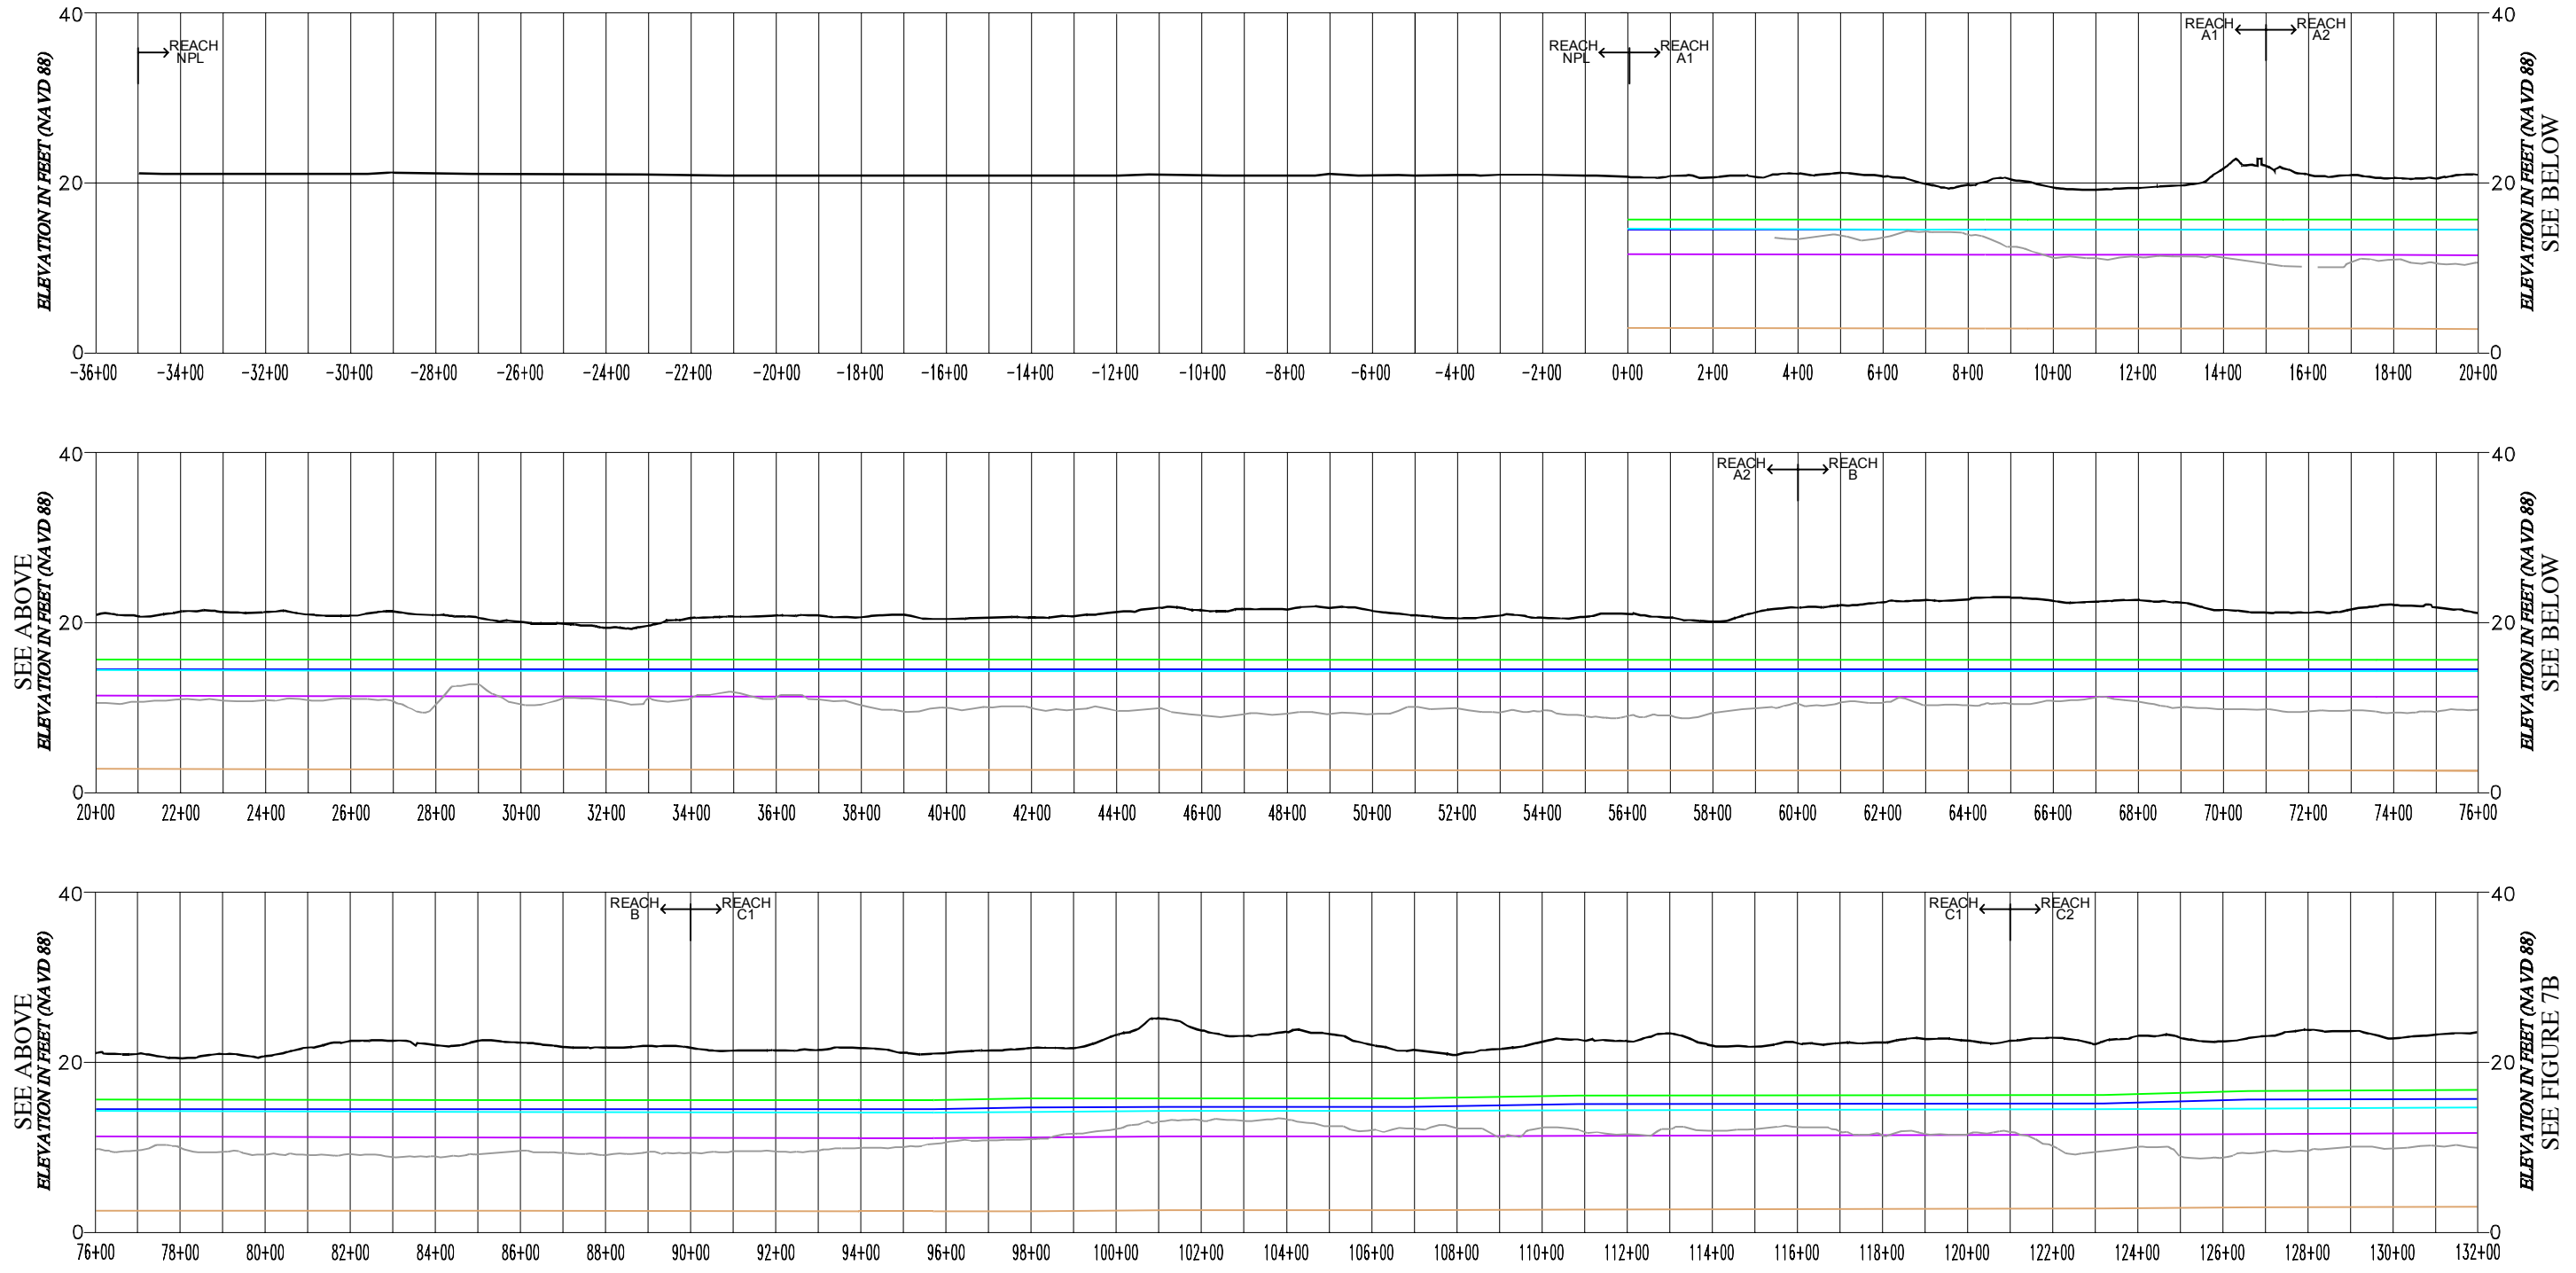
<b>WATER SURFACE PROFILES</b> ULDC EVALUATION - RECLAMATION DISTRICT NO. 17 SAN JOAQUIN COUNTY, CALIFORNIA		PROJECT NO.: 5747.005.000	<b>FIGURE NO.</b> <span style="font-size: 2em;">7A</span>
			SCALE: AS SHOWN	
	DRAWN BY: DLB	CHECKED BY: JJT

**EXPLANATION**  
 ALL LOCATIONS ARE APPROXIMATE

LEVEE CROWN	10 YEAR WSE + 3 FEET
HTOL	10 YEAR WSE
200 YEAR DWSE	LANDSIDE TOE
ESTIMATED VERTICAL DISPLACEMENT FROM 200 YEAR SEISMIC EVENT	SEISMIC WSE

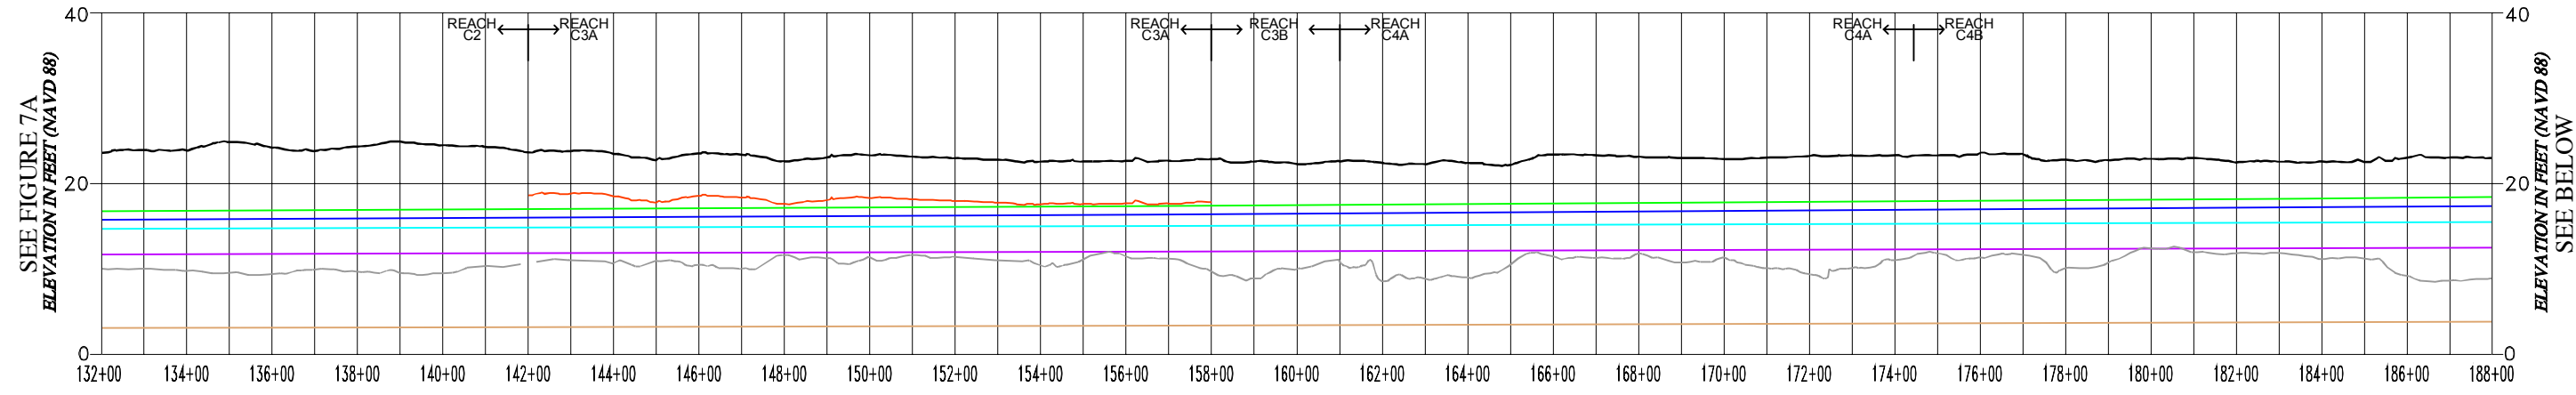
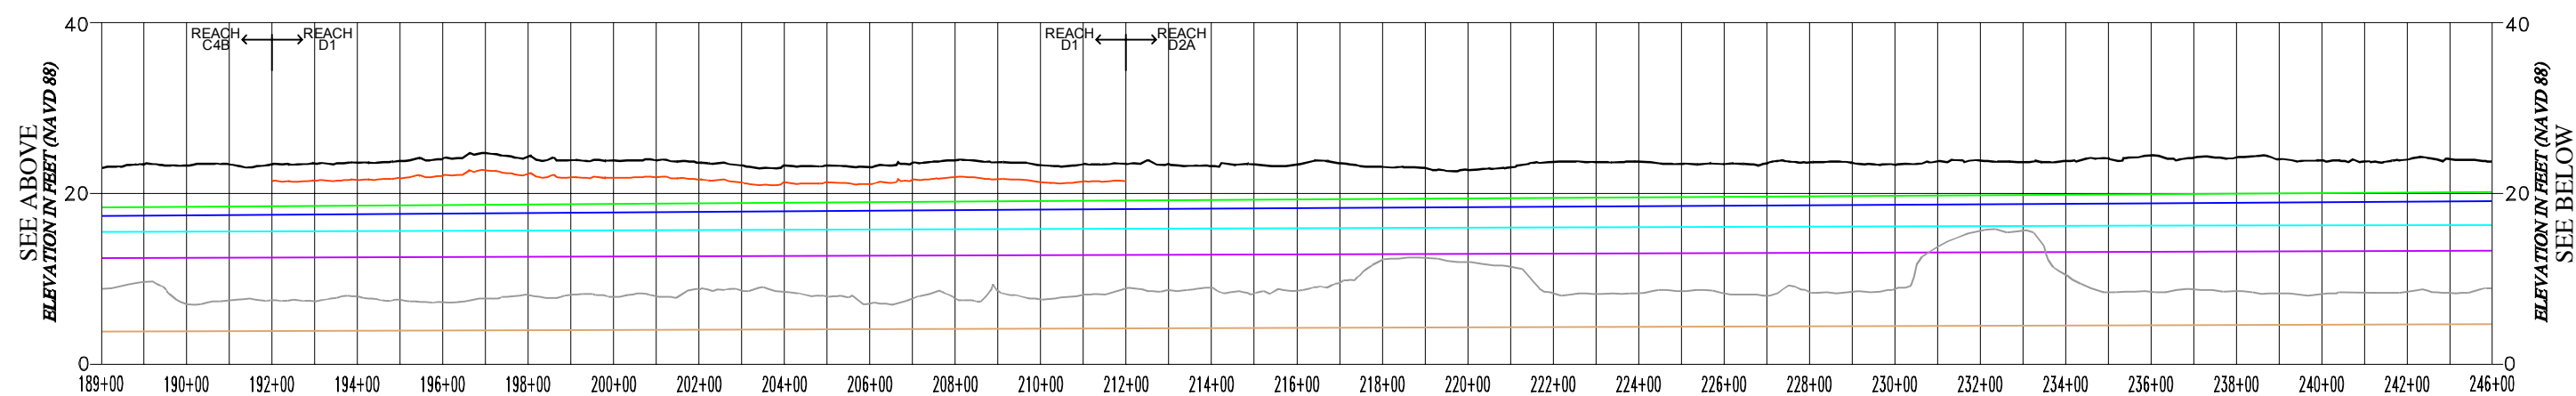
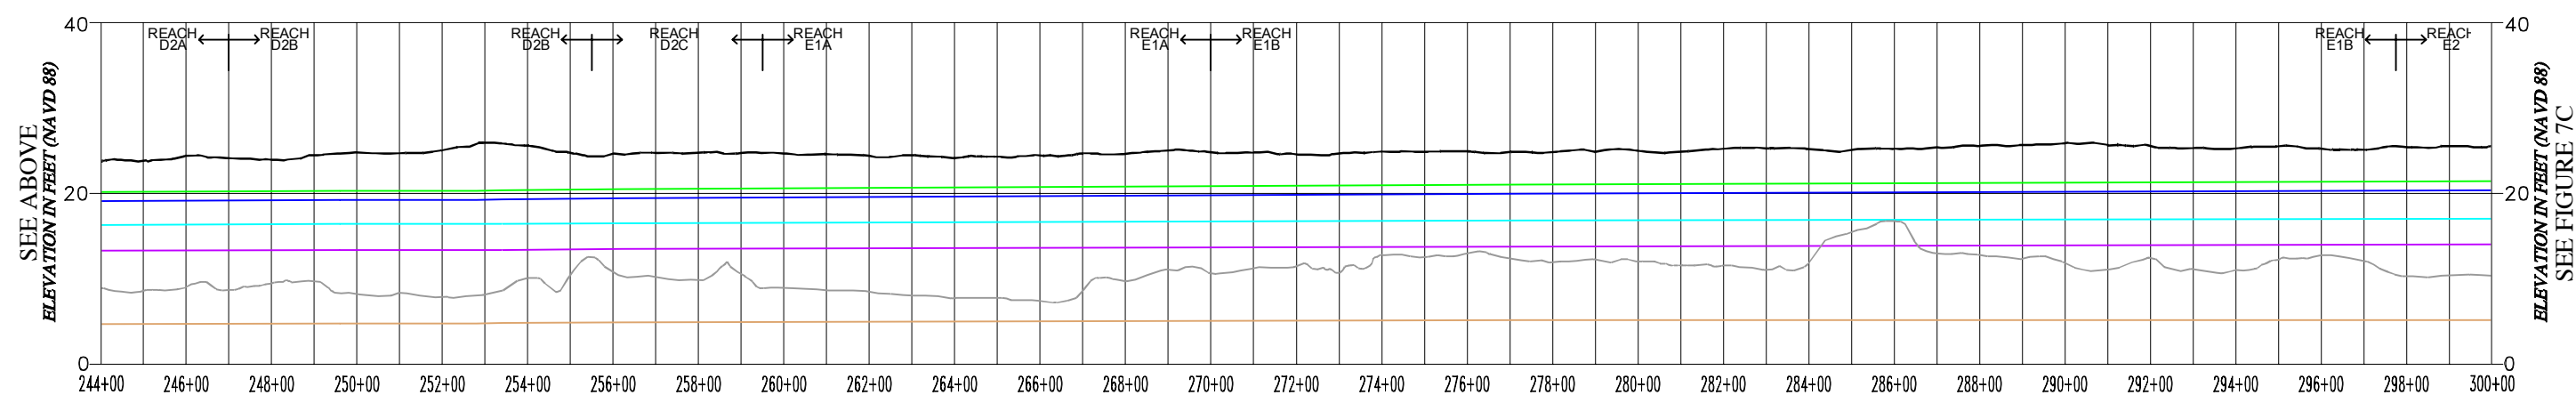
**EXPLANATION**  
ALL LOCATIONS ARE APPROXIMATE

— LEVEE CROWN	— 10 YEAR WSE + 3 FEET
— HTOL	— 10 YEAR WSE
— 200 YEAR DWSE	— LANDSIDE TOE
— ESTIMATED VERTICAL DISPLACEMENT FROM 200 YEAR SEISMIC EVENT	— SEISMIC WSE

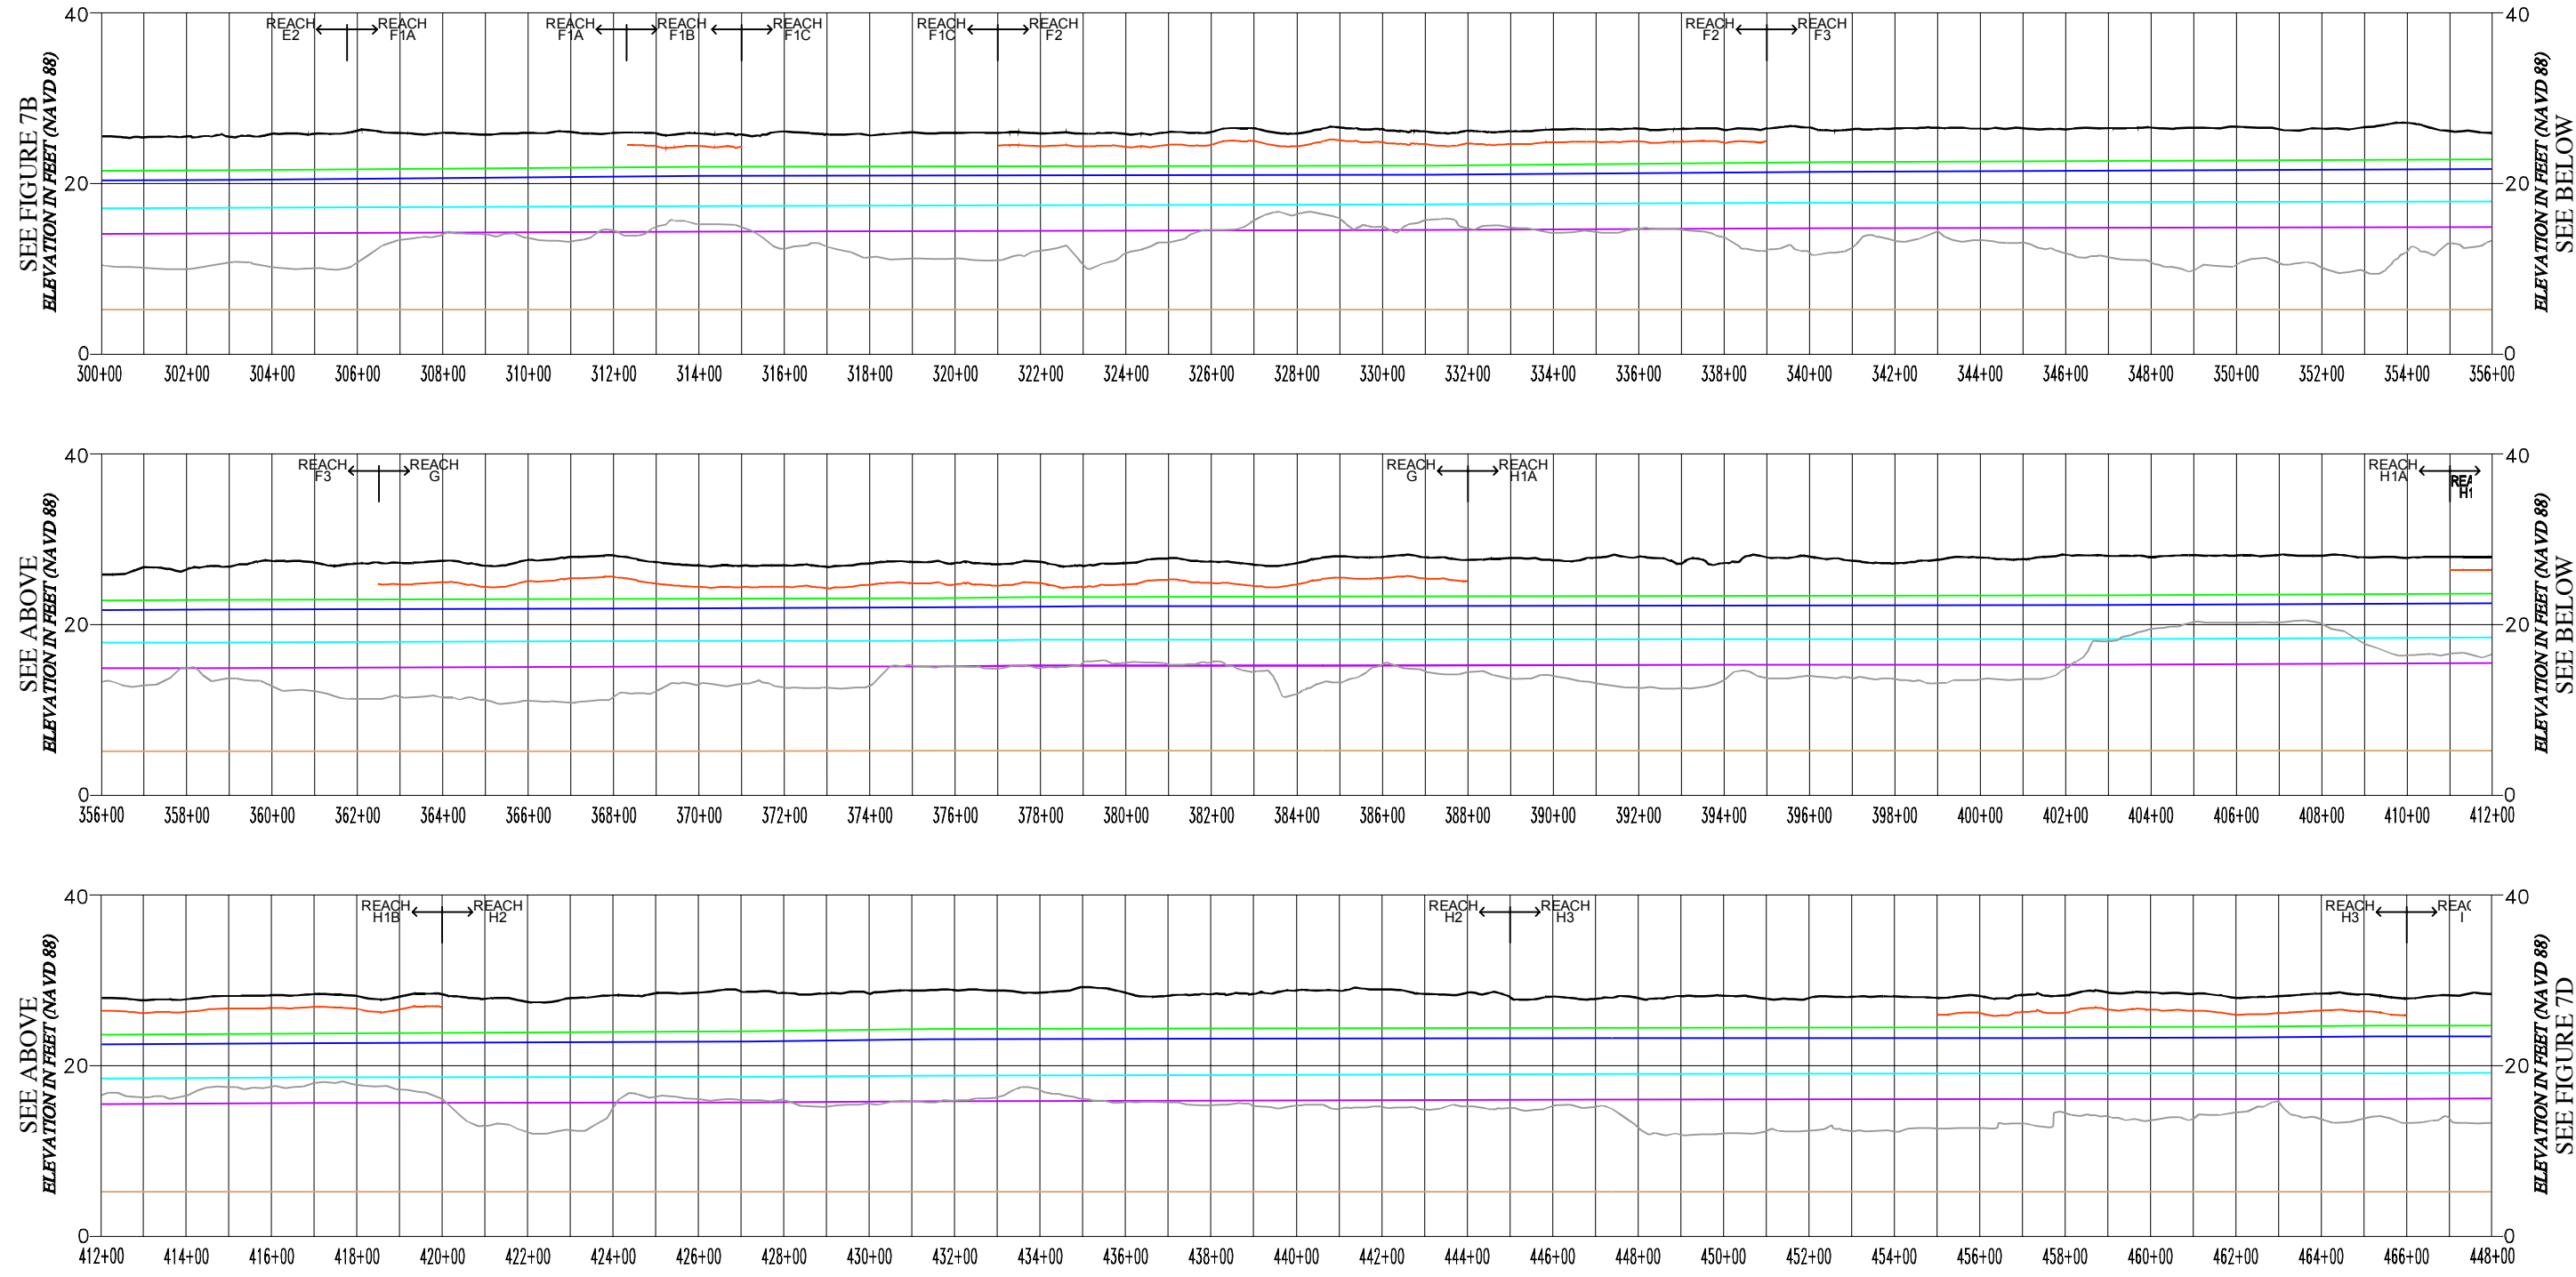
<b>WATER SURFACE PROFILES</b> ULDC EVALUATION - RECLAMATION DISTRICT NO. 17 SAN JOAQUIN COUNTY, CALIFORNIA		PROJECT NO.: 5747.005.000	<b>FIGURE NO.</b> <span style="font-size: 2em;">7C</span>
	DRAWN BY: DLB	CHECKED BY: JJT	SCALE: AS SHOWN

**EXPLANATION**  
ALL LOCATIONS ARE APPROXIMATE

— LEVEE CROWN	— 10 YEAR WSE + 3 FEET
— HTOL	— 10 YEAR WSE
— 200 YEAR DWSE	— LANDSIDE TOE
— ESTIMATED VERTICAL DISPLACEMENT FROM 200 YEAR SEISMIC EVENT	— SEISMIC WSE
