# URBAN LEVEE DESIGN CRITERIA EVALUATION

MOSSDALE TRACT  
RECLAMATION DISTRICT NO. 17  
SAN JOAQUIN COUNTY, CALIFORNIA

Subject: Mossdale Tract  
Reclamation District No. 17  
San Joaquin County, California

## URBAN LEVEE DESIGN CRITERIA EVALUATION

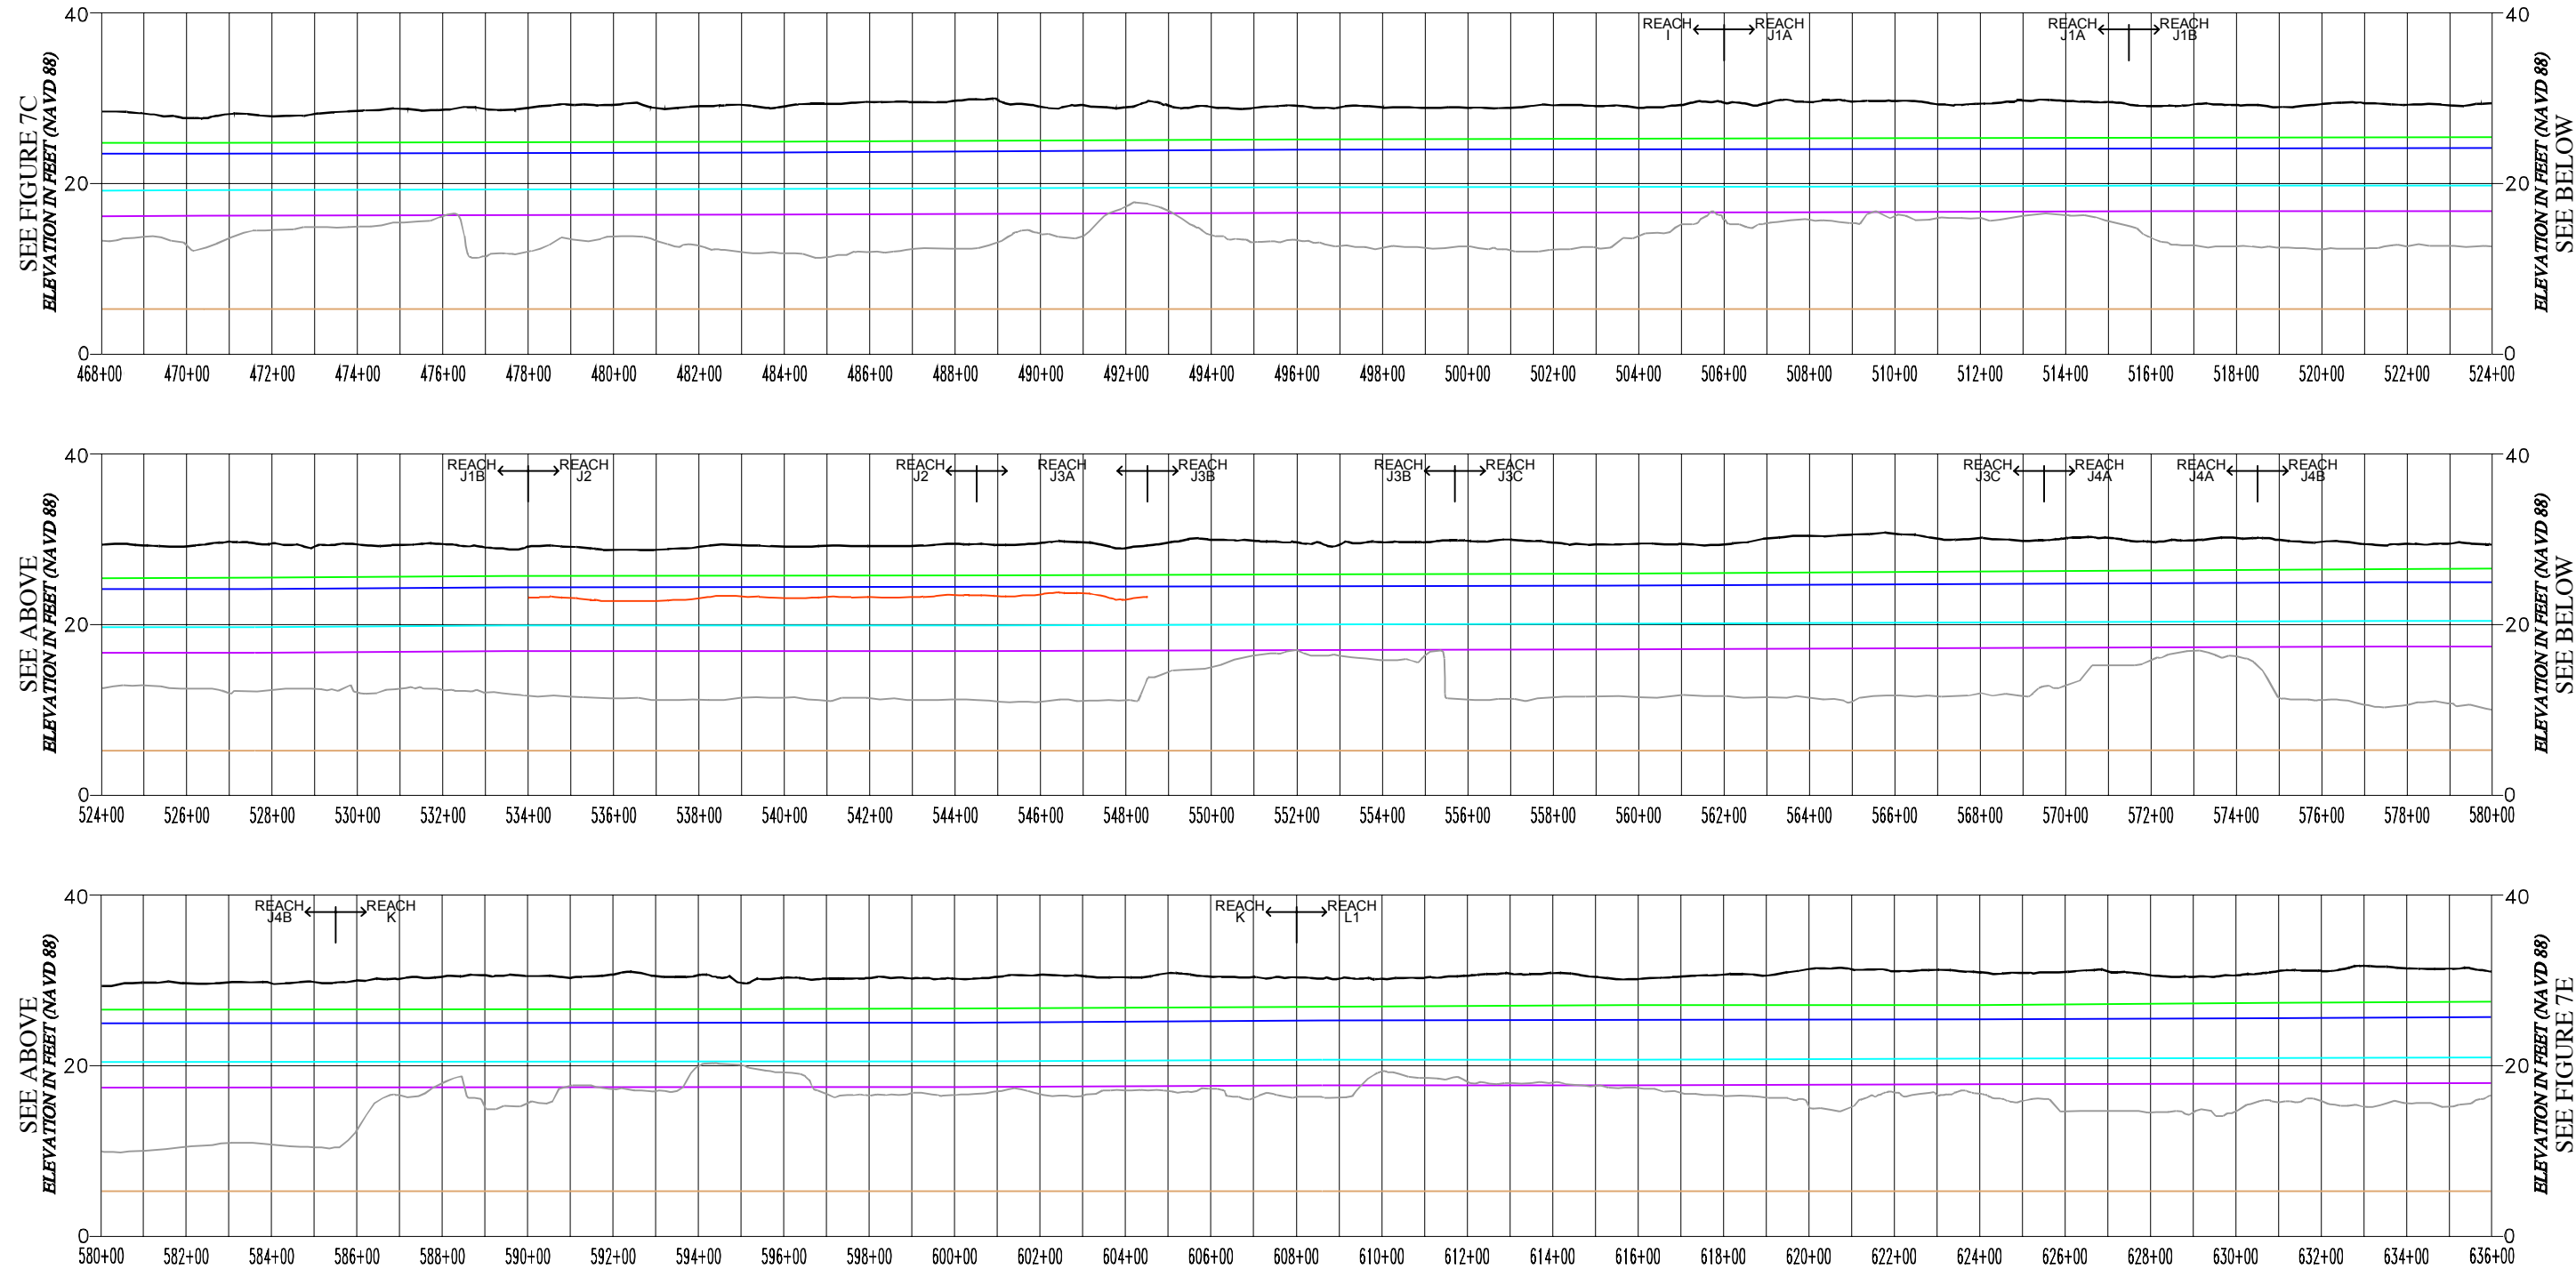
<b>WATER SURFACE PROFILES</b> ULDC EVALUATION - RECLAMATION DISTRICT NO. 17 SAN JOAQUIN COUNTY, CALIFORNIA		PROJECT NO.: 5747.005.000	<b>FIGURE NO.</b> <span style="font-size: 2em; font-weight: bold;">7D</span>
			SCALE: AS SHOWN	
	DRAWN BY: DLB	CHECKED BY: JJT

**EXPLANATION**  
ALL LOCATIONS ARE APPROXIMATE

— LEVEE CROWN	— 10 YEAR WSE + 3 FEET
— HTOL	— 10 YEAR WSE
— 200 YEAR DWSE	— LANDSIDE TOE
— ESTIMATED VERTICAL DISPLACEMENT FROM 200 YEAR SEISMIC EVENT	— SEISMIC WSE

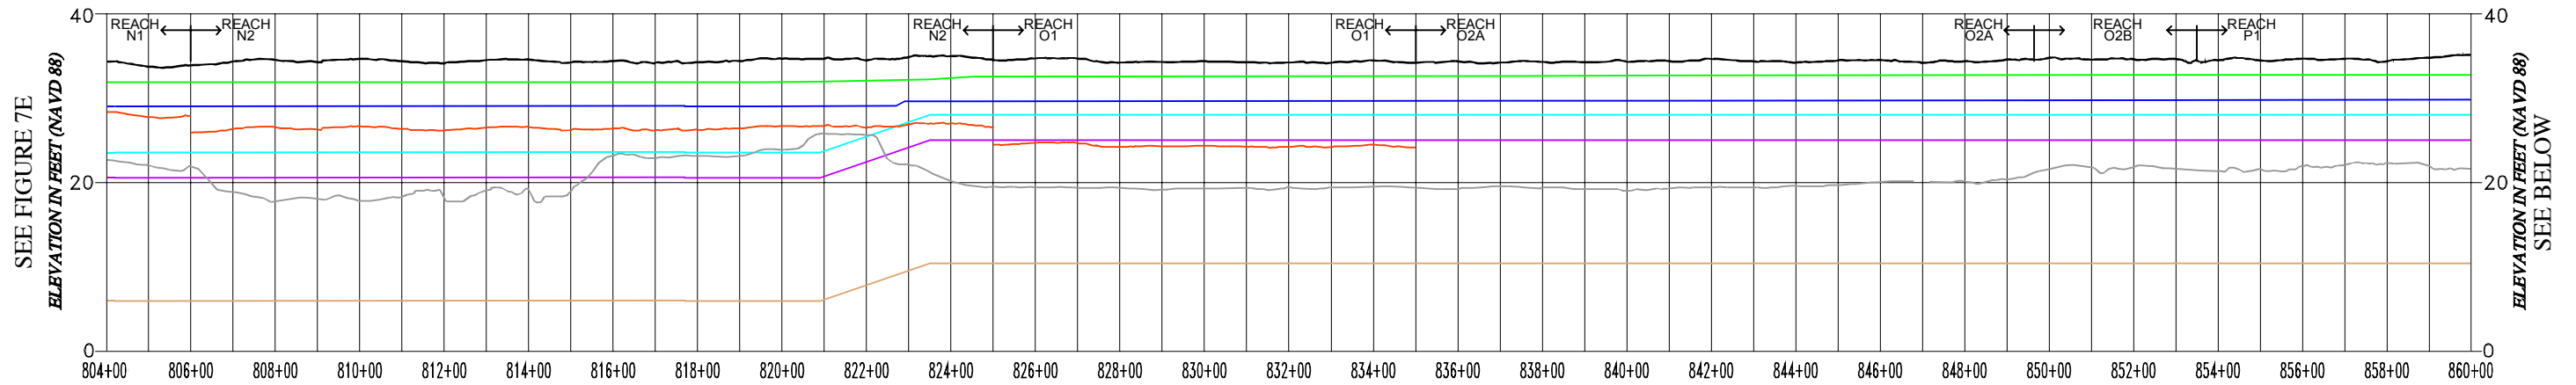
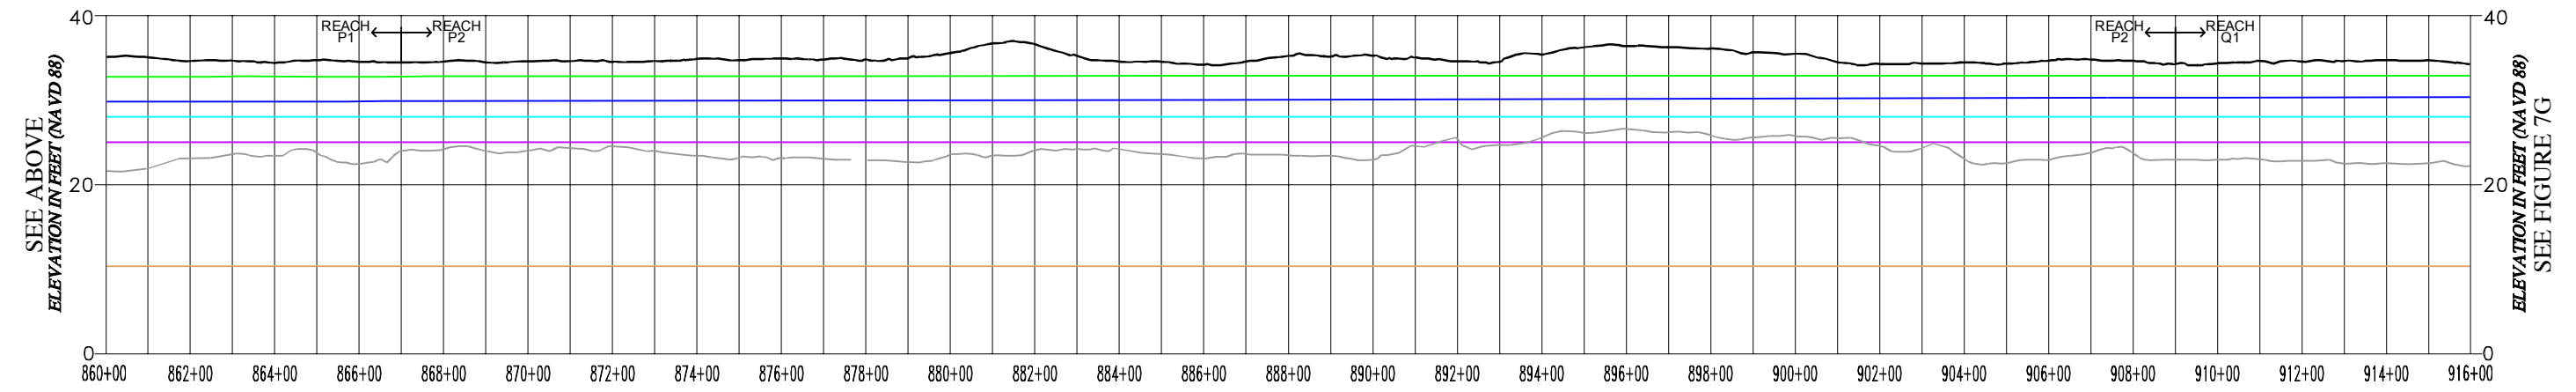
FIGURE NO.  
**7F**

**EXPLANATION**  
ALL LOCATIONS ARE APPROXIMATE

— LEVEE CROWN	— 10 YEAR WSE + 3 FEET
— HTOL	— 10 YEAR WSE
— 200 YEAR DWSE	— LANDSIDE TOE
— ESTIMATED VERTICAL DISPLACEMENT FROM 200 YEAR SEISMIC EVENT	— SEISMIC WSE
