URBAN LEVEE DESIGN CRITERIA EVALUATION

MOSSDALE TRACT
RECLAMATION DISTRICT NO. 17
SAN JOAQUIN COUNTY, CALIFORNIA

Project No:
5747.005.000

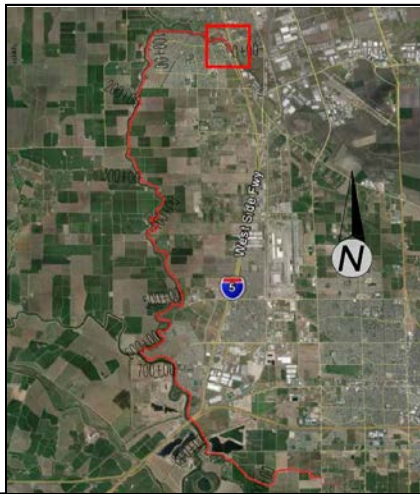
REACH A1 - STA 7+56																																																							
Based on our evaluation, this reach meets the ULDC Criteria.																																																							
Seepage Evaluation Summary				Slope Stability Evaluation Summary																																																			
200-Year DWSEL, Under Seepage:		Meets Criteria		Steady State Seepage 200-Year DWSEL, LS:		Meets Criteria																																																	
200-Year DWSEL, Through Seepage:		Meets Criteria		Steady State Seepage HTOL, LS:		Meets Criteria																																																	
HTOL, Under Seepage:		Meets Criteria		Rapid Drawdown, WS:		Meets Criteria																																																	
				Seismic Slope Stability, WS:		Meets Criteria																																																	
				Seismic Slope Stability, LS:		Meets Criteria

Reach Description				Reach Overview																																																			
Station Limits: 0+00 to 15+00 Feature(s) at Upstream Station Limit: South Manthey Road/dry land levee Feature(s) at Downstream Station Limit: Downing Ave Approx. Crown Elevation Range (feet, NAVD88): 19.5 to 22 Approx. Levee Height Range (feet): 8 to 10.5 Approx. Crown Width Range (feet): 17 to 47 Approx. Landside Slope (H:V) Range: 2:1 to 4.5:1 Approx. Waterside Slope (H:V) Range: 1.7:1 to 3:1 Waterside Constraint(s): Waterside bench between STA 0+00 and 8+00, overhead power lines Landside Constraint(s): STA 0+00 to 3+00 - agricultural land, STA 3+00 to 15+00 - commercial development Landside repairs associated with PL84-99: Levee raised in 1989 along French Camp Slough Improvements associated with LSRP P1: None Improvements associated with LSRP P2: None Proposed Improvements associated with LSRP P3: None

Generalized Subsurface Conditions Levee Prism Soils: SILT and Silty SAND Landside Surface Layer: Silty SAND, approx. 8 feet thick at levee toe Soils below surface layer: Approx. 10 to 15 feet of Silty SAND over Lean CLAY																																																							
Historic Performance No recorded events in ULE's 2014 SGDR Addendum																																																							
Liquefiable Soils Based on our liquefaction assessment, we are not considering liquefiable soils in our slope stability analyses.																																																							
Seepage Analysis Results <table border="1" style="width: 100%; border-collapse: collapse;"> <thead> <tr> <th rowspan="2">Station</th> <th rowspan="2">Water Surface</th> <th rowspan="2">Figure</th> <th colspan="3">Exit Gradient</th> <th rowspan="2">Through Seepage</th> <th rowspan="2">Breakout Height (ft)*</th> </tr> <tr> <th>Levee Toe</th> <th>Toe of Berm</th> <th>Field</th> </tr> </thead> <tbody> <tr> <td rowspan="2" style="text-align: center;">7+56</td> <td>200-Year</td> <td>E-2-B</td> <td>0.02</td> <td>---</td> <td>---</td> <td>Yes**</td> <td>0.2</td> </tr> <tr> <td>HTOL</td> <td>E-2-C</td> <td>0.03</td> <td>---</td> <td>---</td> <td>n/a</td> <td>n/a</td> </tr> </tbody> </table> <p>*Vertical distance from the toe of the levee (ground surface) to where the phreatic surface is calculated to daylight on the levee slope. Through seepage under HTOL conditions are not part of this evaluation. **Exits onto slope flatter than 5:1 (H:V), therefore we report "meets criteria" for through seepage.</p>								Station	Water Surface	Figure	Exit Gradient			Through Seepage	Breakout Height (ft)*	Levee Toe	Toe of Berm	Field	7+56	200-Year	E-2-B	0.02	---	---	Yes**	0.2	HTOL	E-2-C	0.03	---	---	n/a	n/a

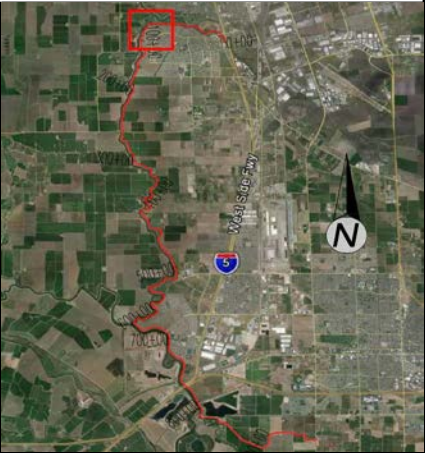
10.4 PROJECT REACH C1, STATION 100+10

REACH C1 - STA 100+10							
Based on our evaluation, this reach meets the ULDC Criteria.							
Seepage Evaluation Summary				Slope Stability Evaluation Summary			
200-Year DWSEL, Under Seepage:		Meets Criteria		Steady State Seepage 200-Year DWSEL, LS:		Meets Criteria	
200-Year DWSEL, Through Seepage:		Meets Criteria		Steady State Seepage HTOL, LS:		Meets Criteria	
HTOL, Under Seepage:		Meets Criteria		Rapid Drawdown, WS:		Meets Criteria	
				Seismic Slope Stability, WS:		Meets Criteria	
				Seismic Slope Stability, LS:		Meets Criteria	
Reach Description				Reach Overview			
Station Limits: 90+00 to 121+00 Feature(s) at Upstream Station Limit: Transition to thinner blanket, landside park area Feature(s) at Downstream Station Limit: Transition to thinner blanket in Reach B Approx. Crown Elevation Range (feet, NAVD88): 21 to 24 Approx. Levee Height Range (feet): 10 to 16 Approx. Crown Width Range (feet): 12 to 40 Approx. Landside Slope (H:V) Range: 1.6:1 to 6.9:1 Approx. Waterside Slope (H:V) Range: 1.7:1 to 4.2:1 Waterside Constraint(s): Waterside toe of slope at the waterway - no waterside bench. Landside Constraint(s): None - agricultural land. Landside repairs associated with PL84-99: None Improvements associated with LSRP P1: None Improvements associated with LSRP P2: None Proposed Improvements associated with LSRP P3: None

Generalized Subsurface Conditions							
Levee Prism Soils: Silty SAND to Lean Clay Landside Surface Layer: Lean CLAY, approx. 15 feet thick at toe of levee Soils below surface layer: Approx. 12 feet of Lean CLAY, over 4 feet of Silty SAND, over 50 feet of Lean CLAY							
Historic Performance							
No recorded events in ULE's 2014 SGDR Addendum							
Liquefiable Soils							
Based on our liquefaction assessment, we identified potentially liquefiable soils within this Reach (Refer to Appendix E and Appendix F)							
Seepage Analysis Results							
Station	Water Surface	Figure	Exit Gradient			Through Seepage	Breakout Height (ft)*
			Levee Toe	Toe of Berm	Field		
100+10	200-Year	E-5-B	0.03	---	0.02	Yes**	0.6
	HTOL	E-5-C	0.05	---	0.02	n/a	n/a
*Vertical distance from the toe of the levee (ground surface) to where the phreatic surface is calculated to daylight on the levee slope. Through seepage under HTOL conditions are not part of this evaluation. **Exits onto slope flatter than 5:1 (H:V), therefore we report "meets criteria" for through seepage.

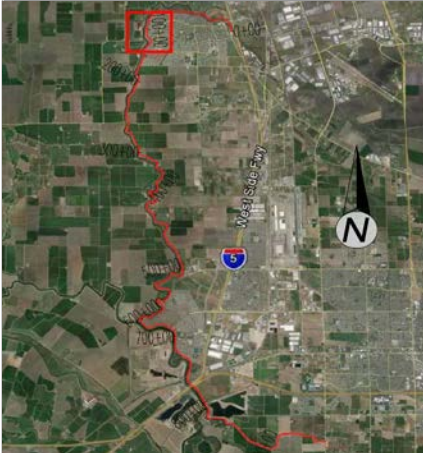
10.5 PROJECT REACH C2, STATION 130+85

REACH C2 - STA 130+85							
Based on our evaluation, this reach does not meet ULDC Criteria.							
Seepage Evaluation Summary				Slope Stability Evaluation Summary			
200-Year DWSEL, Under Seepage:		Meets Criteria		Steady State Seepage 200-Year DWSEL, LS:		Meets Criteria	
200-Year DWSEL, Through Seepage:		Fails Criteria		Steady State Seepage HTOL, LS:		Meets Criteria	
HTOL, Under Seepage:		Meets Criteria		Rapid Drawdown, WS:		Meets Criteria	
				Seismic Slope Stability, WS:		Meets Criteria	
				Seismic Slope Stability, LS:		Meets Criteria	
Reach Description				Reach Overview			
Station Limits: 121+00 to 142+00 Feature(s) at Upstream Station Limit: Pump Station levee penetrations Feature(s) at Downstream Station Limit: William Moss Boulevard Approx. Crown Elevation Range (feet, NAVD88): 23.3 to 25 Approx. Levee Height Range (feet): 12 to 20 Approx. Crown Width Range (feet): 11 to 46 Approx. Landside Slope (H:V) Range: 1.5:1 to 3:1 Approx. Waterside Slope (H:V) Range: 1.5:1 to 2.8:1 Waterside Constraint(s): Waterside toe of slope at the waterway - no waterside bench. Landside Constraint(s): Residential improvements, gravel trench drain Landside Repairs associated with PL84-99: Partial LS subdrain, 3 LS Berns Improvements associated with LSRP P1: None Improvements associated with LSRP P2: None Proposed Improvements associated with LSRP P3: None

Generalized Subsurface Conditions Levee Prism Soils: Poorly Graded SAND, SILT & Silty SAND transitioning to Lean Clay towards south Landside Surface Layer: Lean CLAY, approx. 10 to 40 feet thick at toe of levee Soils below surface layer: Interlayered Silty SAND and Lean CLAY							
Historic Performance Seepage, landside boils, and waterside erosion during 1997 flood event were reported in ULE's 2014 SGDR Addendum.							
Liquefiable Soils Based on our liquefaction assessment, we identified potentially liquefiable soils within this Reach (Refer to Appendix E and Appendix F)							
Seepage Analysis Results							
Station	Water Surface	Figure	Exit Gradient			Through Seepage	Breakout Height (ft)*
			Levee Toe	Toe of Berm	Field		
130+85	200-Year	E-6-B	0.0	---	0.06	Yes	1.7
	HTOL	E-6-C	0.01	---	0.06	n/a	n/a
*Vertical distance from the toe of the levee (ground surface) to where the phreatic surface is calculated to daylight on the levee slope. Through seepage under HTOL conditions are not part of this evaluation.

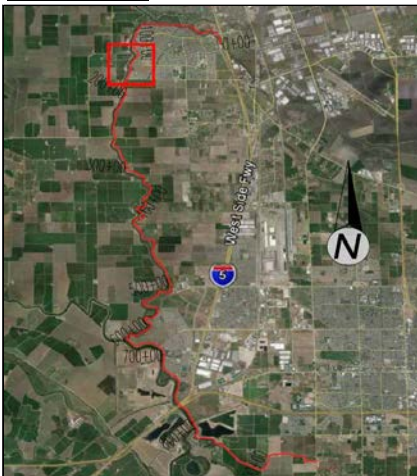
10.8 PROJECT REACH C3B, STATION 158+00

REACH C3B - STA 158+00							
Based on our evaluation, this reach meets ULDC criteria.							
Seepage Evaluation Summary				Slope Stability Evaluation Summary			
200-Year DWSEL, Under Seepage:		Meets Criteria		Steady State Seepage 200-Year DWSEL, LS:		Meets Criteria	
200-Year DWSEL, Through Seepage:		Meets Criteria		Steady State Seepage HTOL, LS:		Meets Criteria	
HTOL, Under Seepage:		Meets Criteria		Rapid Drawdown, WS:		Meets Criteria	
				Seismic Slope Stability, WS:		Meets Criteria	
				Seismic Slope Stability, LS:		Meets Criteria	
Reach Description				Reach Overview			
Station Limits: 158+00 to 161+00 Feature(s) at Upstream Station Limit: Transition to agricultural land on the landside Feature(s) at Downstream Station Limit: Transition to residential development approx. 100' south of Abruzzi Court Approx. Crown Elevation Range (feet, NAVD88): 22 to 23 Approx. Levee Height Range (feet): 13 to 15 Approx. Crown Width Range (feet): 15 to 30 Approx. Landside Slope (H:V) Range: 2:1 to 2:1 Approx. Waterside Slope (H:V) Range: 1.5:1 to 2:1 Waterside Constraint(s): Waterside toe of slope at the waterway - no waterside bench. Landside Constraint(s): Residential / Farm improvements Landside Repairs associated with PL84-99: None Improvements associated with LSRP P1: None Improvements associated with LSRP P2: None Proposed Improvements associated with LSRP P3: None

Generalized Subsurface Conditions							
Levee Prism Soils: Lean CLAY Landside Surface Layer: Lean CLAY, approx. 14 to 20 feet thick at toe of levee Soils below surface layer: Interlayered Silty SAND, Poorly Graded SAND and Lean CLAY							
Historic Performance							
No events were reported in ULE's 2014 SGDR Addendum.							
Liquefiable Soils							
Based on our liquefaction assessment, we are not considering liquefiable soils in our slope stability analyses.							
Seepage Analysis Results							
Station	Water Surface	Figure	Exit Gradient			Through Seepage	Breakout Height (ft)*
			Levee Toe	Toe of Berm	Field		
158+00	200-Year	E-9-B	0.20	---	---	Yes**	3
	HTOL	E-9-C	0.23	---	---	n/a	n/a
*Vertical distance from the toe of the levee (ground surface) to where the phreatic surface is calculated to daylight on the levee slope. Through seepage under HTOL conditions are not part of this evaluation. **Exits onto a fine grained slope flatter than 5:1 (H:V), therefore we report "meets criteria" for through seepage.

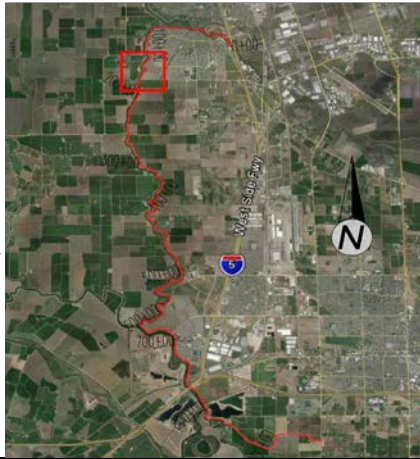
10.9 PROJECT REACH C4A, STATION 174+45

REACH C4A - STA 174+45							
Based on our evaluation, this reach meets the ULDC Criteria.							
Seepage Evaluation Summary				Slope Stability Evaluation Summary			
200-Year DWSEL, Under Seepage:		Meets Criteria		Steady State Seepage 200-Year DWSEL, LS:		Meets Criteria	
200-Year DWSEL, Through Seepage:		Meets Criteria		Steady State Seepage HTOL, LS:		Meets Criteria	
HTOL, Under Seepage:		Meets Criteria		Rapid Drawdown, WS:		Meets Criteria	
				Seismic Slope Stability, WS:		Meets Criteria	
				Seismic Slope Stability, LS:		Meets Criteria	
Reach Description				Reach Overview			
Station Limits: 161+00 to 174+45

Feature(s) at Upstream Station Limit: Levee access ramp from Galley Way							
Feature(s) at Downstream Station Limit: Transition to farm structures landside							
Approx. Crown Elevation Range (feet, NAVD88):		22 to 25					
Approx. Levee Height Range (feet):		12 to 20					
Approx. Crown Width Range (feet):		11 to 46

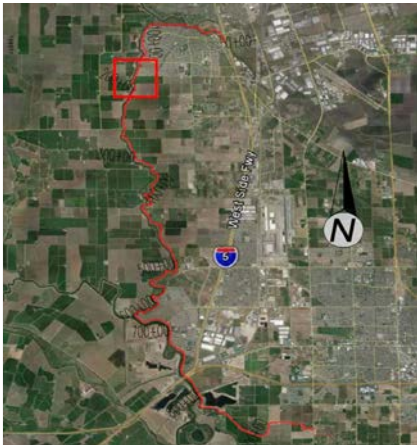
10.10 PROJECT REACH C4B, STATION 181+00

REACH C4B - STA 181+00							
Based on our evaluation, this reach fails to meet ULDC criteria based on the cross section at Sta 191+45.							
Seepage Evaluation Summary				Slope Stability Evaluation Summary			
200-Year DWSEL, Under Seepage:		Meets Criteria		Steady State Seepage 200-Year DWSEL, LS:		Meets Criteria	
200-Year DWSEL, Through Seepage:		Meets Criteria		Steady State Seepage HTOL, LS:		Meets Criteria	
HTOL, Under Seepage:		Meets Criteria		Rapid Drawdown, WS:		Meets Criteria	
				Seismic Slope Stability, WS:		Meets Criteria	
				Seismic Slope Stability, LS:		Meets Criteria	
Reach Description				Reach Overview			
Station Limits: 174+45 to 192+00 Feature(s) at Upstream Station Limit: Galley Way Feature(s) at Downstream Station Limit: Drainage Ditches (lined and unlined) Approx. Crown Elevation Range (feet, NAVD88): 22.5 to 23.5 Approx. Levee Height Range (feet): 11 to 14.5 Approx. Crown Width Range (feet): 20 to 46 Approx. Landside Slope (H:V) Range: 2:1 to 3:1 Approx. Waterside Slope (H:V) Range: 1.5:1 to 4:1 Waterside Constraint(s): Levee pipe penetrations at STA 179+50 and STA 189+00 Landside Constraint(s): Residential/agricultural land Landside Repairs associated with PL84-99: None Improvements associated with LSRP P1: None Improvements associated with LSRP P2: None Proposed Improvements associated with LSRP P3: None

Generalized Subsurface Conditions							
Levee Prism Soils: Lean CLAY with some Silty SAND Landside Surface Layer: Silty SAND and Lean CLAY (approx. 12 to 14 feet thick) Soils below surface layer: Lean CLAY with interlayered Poorly Graded SAND with SILT							
Historic Performance							
Waterside erosion, low to medium seepage and pin boils, and longitudinal cracking on waterside crown reported in ULE's 2014 SGDR Addendum.							
Liquefiable Soils							
Based on our liquefaction assessment, we are not considering liquefiable soils in our slope stability analyses.							
Seepage Analysis Results							
Station	Water Surface	Figure	Exit Gradient			Through Seepage	Breakout Height (ft)*
			Levee Toe	Toe of Berm	Field		
181+00	200-Year	E-11-B	0.27	---	0.55	No	n/a
	HTOL	E-11-C	0.32	---	0.60	n/a	n/a
*Vertical distance from the toe of the levee (ground surface) to where the phreatic surface is calculated to daylight on the levee slope. Through seepage under HTOL conditions are not part of this evaluation.

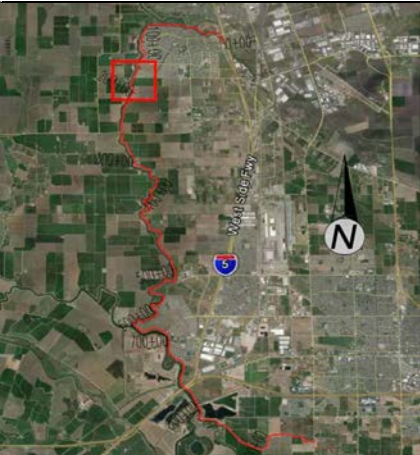
10.11 PROJECT REACH C4B, STATION 191+45

REACH C4B - STA 191+45							
Based on our evaluation, this reach does not meet ULDC Criteria.							
Seepage Evaluation Summary				Slope Stability Evaluation Summary			
200-Year DWSEL, Under Seepage:		Meets Criteria		Steady State Seepage 200-Year DWSEL, LS:		Meets Criteria	
200-Year DWSEL, Through Seepage:		Fails Criteria		Steady State Seepage HTOL, LS:		Meets Criteria	
HTOL, Under Seepage:		Meets Criteria		Rapid Drawdown, WS:		Meets Criteria	
				Seismic Slope Stability, WS:		Meets Criteria	
				Seismic Slope Stability, LS:		Meets Criteria	
Reach Description				Reach Overview			
Station Limits: 174+45 to 192+00 Feature(s) at Upstream Station Limit: Galley Way Feature(s) at Downstream Station Limit: Drainage Ditches (lined and unlined) Approx. Crown Elevation Range (feet, NAVD88): 22.5 to 23.5 Approx. Levee Height Range (feet): 11 to 14.5 Approx. Crown Width Range (feet): 20 to 46 Approx. Landside Slope (H:V) Range: 2:1 to 3:1 Approx. Waterside Slope (H:V) Range: 1.5:1 to 4:1 Waterside Constraint(s): Levee pipe penetrations at STA 179+50 and STA 189+00 Landside Constraint(s): Residential/agricultural land Landside Repairs associated with PL84-99: None Improvements associated with LSRP P1: None Improvements associated with LSRP P2: None Proposed Improvements associated with LSRP P3: None

Generalized Subsurface Conditions							
Levee Prism Soils: Lean CLAY with some Silty SAND Landside Surface Layer: Silty SAND and Lean CLAY (approx. 12 to 14 feet thick) Soils below surface layer: Lean CLAY with interlayered Poorly Graded SAND with SILT							
Historic Performance							
Waterside erosion, low to medium seepage and pin boils, and longitudinal cracking on waterside crown reported in ULE's 2014 SGDR Addendum.							
Liquefiable Soils							
Based on our liquefaction assessment, we identified potentially liquefiable soils within this Reach (Refer to Appendix E and Appendix F)							
Seepage Analysis Results							
Station	Water Surface	Figure	Exit Gradient			Through Seepage	Breakout Height (ft)*
			Levee Toe	Toe of Berm	Field		
191+45	200-Year	E-12-B	0.16	---	---	Yes	3
	HTOL	E-12-C	0.18	---	---	n/a	n/a
*Vertical distance from the toe of the levee (ground surface) to where the phreatic surface is calculated to daylight on the levee slope. Through seepage under HTOL conditions are not part of this evaluation.

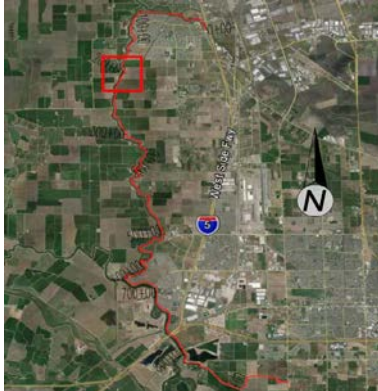
10.12 PROJECT REACH D1, STATION 201+57

REACH D1 - STA 201+57							
Based on our evaluation, this reach does not meet the ULDC Criteria. Seismic deformations are not anticipated to degrade below 10-Year WSE+3 feet.							
Seepage Evaluation Summary				Slope Stability Evaluation Summary			
200-Year DWSEL, Under Seepage:		Fails Criteria		Steady State Seepage 200-Year DWSEL, LS:		Fails Criteria	
200-Year DWSEL, Through Seepage:		Meets Criteria		Steady State Seepage HTOL, LS:		Fails Criteria	
HTOL, Under Seepage:		Fails Criteria		Rapid Drawdown, WS:		Meets Criteria	
				Seismic Slope Stability, WS:		Fails Criteria	
				Seismic Slope Stability, LS:		Fails Criteria	
Reach Description				Reach Overview			
Station Limits: 192+00 to 212+00 Feature(s) at Upstream Station Limit: Agricultural land Feature(s) at Downstream Station Limit: Agricultural land Approx. Crown Elevation Range (feet, NAVD88): 23 to 25 Approx. Levee Height Range (feet): 16 to 18 Approx. Crown Width Range (feet): 30 to 48 Approx. Landside Slope (H:V) Range: 1.6:1 to 2.3:1 Approx. Waterside Slope (H:V) Range: 1.4:1 to 2.1:1 Waterside Constraint(s): Levee penetration near STA 209+00 Landside Constraint(s): None - agricultural land Landside repairs associated with PL84-99: Yes, berms at STA 201+00 and STA 204+00 Improvements associated with LSRP P1: None Improvements associated with LSRP P2: None Proposed Improvements associated with LSRP P3: None

Generalized Subsurface Conditions							
Levee Prism Soils: Lean CLAY to SILT Landside Surface Layer: Lean CLAY, approx. 7 feet thick at toe of levee Soils below surface layer: Interbedded layers of silty SAND and poorly-graded SAND and CLAY							
Historic Performance							
Seepage and pin boils reported in ULE's 2014 SGDR Addendum.							
Liquefiable Soils							
Based on our liquefaction assessment, we identified potentially liquefiable soils within this Reach (Refer to Appendix E and Appendix F)							
Seepage Analysis Results							
Station	Water Surface	Figure	Exit Gradient			Through Seepage	Breakout Height (ft)*
			Levee Toe	Toe of Berm	Field		
201+57	200-Year	E-13-B	1.11	---	1.86	Yes**	4.5
	HTOL	E-13-C	1.24	---	2.03	n/a	n/a
*Vertical distance from the toe of the levee (ground surface) to where the phreatic surface is calculated to day light on the levee slope. Through seepage under HTOL conditions are not part of this evaluation. **Exits onto a fine grained slope, therefore we report "meets criteria" for through seepage.

Slope Stability Analysis Results							
Station	Case Analyzed	Water Surface	Figure	Factor of Safety (Circular)		Factor of Safety (Non-Circular)	
				Waterside	Landside	Waterside	Landside
201+57	SS - 200yr	17.8	E-13-D	---	0.7	n/a	n/a
	SS - HTOL	18.9	E-13-E	---	0.6	n/a	n/a
	RDD	12.7	E-13-D	1.3	---	n/a	n/a
	PS	4.1	E-13-F	0.8	1.0	n/a	n/a
	Post-EQ	4.1	E-133-GH	0.7	0.8	0.7	0.7
Post 200-Year Seismic Event Restoration Estimates							
Reach	Damage Length (feet)	Estimated Lateral Movement (feet)	Estimated Vertical Movement (feet)	Fill Volume (10 year WSE+3 feet Freeboard) (cubic yards)	Fill Volume (Fully Restored Levee Geometry) (cubic yards)		
D1	1,235	3.5	2	No Fill Anticipated	350

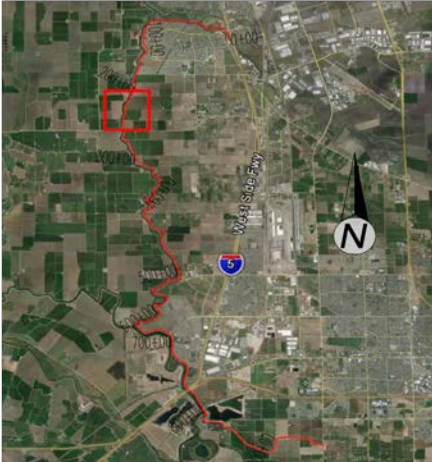
10.13 PROJECT REACH D2A, STATION 231+75

REACH D2A - STA 231+75							
Based on our evaluation, this reach does not meet the ULDC Criteria.							
Seepage Evaluation Summary				Slope Stability Evaluation Summary			
200-Year DWSEL, Under Seepage:		Fails Criteria		Steady State Seepage 200-Year DWSEL, LS:		Meets Criteria	
200-Year DWSEL, Through Seepage:		Fails Criteria		Steady State Seepage HTOL, LS:		Meets Criteria	
HTOL, Under Seepage:		Fails Criteria		Rapid Drawdown, WS:		Meets Criteria	
				Seismic Slope Stability, WS:		Meets Criteria	
				Seismic Slope Stability, LS:		Meets Criteria	
Reach Description				Reach Overview			
Station Limits: 212+00 to 247+00 Feature(s) at Upstream Station Limit: Just south of levee pipe penetration Feature(s) at Downstream Station Limit: Agricultural land Approx. Crown Elevation Range (feet, NAVD88): 23 to 25 Approx. Levee Height Range (feet): 14 to 18.5 Approx. Crown Width Range (feet): 11 to 34 Approx. Landside Slope (H:V) Range: 1.4:1 to 2.5:1 Approx. Waterside Slope (H:V) Range: 1.5:1 to 2.9:1 Waterside Constraint(s): Platform at STA 218+60, 241+00, and 246+30. Landside Constraint(s): None - agricultural land. Landside repairs associated with PL84-99: Yes, multiple berms constructed Improvements associated with LSRP P1: None Improvements associated with LSRP P2: None Proposed Improvements associated with LSRP P3: None

Generalized Subsurface Conditions							
Levee Prism Soils: Silty to Clayey SAND							
Landside Surface Layer: Lean CLAY, approx. 5 feet thick at toe of levee							
Soils below surface layer: Approx. 5 feet of Silty SAND underlain by interbedded layers of Lean CLAY and Poorly-graded SAND							
Historic Performance							
Landside seepage and pin boils reported in ULE's 2014 SGDR Addendum.							
Liquefiable Soils							
Based on our liquefaction assessment, we identified potentially liquefiable soils within this Reach (Refer to Appendix E and Appendix F)							
Seepage Analysis Results							
Station	Water Surface	Figure	Exit Gradient			Through Seepage	Breakout Height (ft)*
			Levee Toe	Toe of Berm	Field		
231+75	200-Year	E-14-B	0.54	---	0.83	Yes	3.5
	HTOL	E-14-C	0.62	---	0.86	n/a	n/a
*Vertical distance from the toe of the levee (ground surface) to where the phreatic surface is calculated to daylight on the levee slope. Through seepage under HTOL conditions are not part of this evaluation.

Slope Stability Analysis Results							
Station	Case Analyzed	Water Surface	Figure	Factor of Safety (Circular)		Factor of Safety (Non-Circular)	
				Waterside	Landside	Waterside	Landside
231+75	SS - 200yr	18.8	E-14-D	---	1.5	n/a	n/a
	SS - HTOL	19.9	E-14-E	---	1.4	n/a	n/a
	RDD	13.5	E-14-D	1.2	---	n/a	n/a
	PS	4.6	E-14-F	1.0	1.3	n/a	n/a
	Post-EQ	4.6	E-14-G/H	1.0	1.7	1.0	1.7

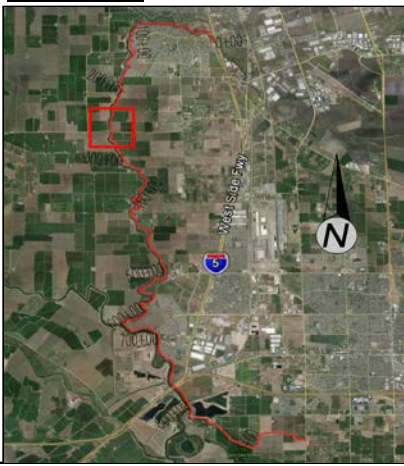
10.14 PROJECT REACH D2B, STATION 251+50

REACH D2B - STA 251+50							
Based on our evaluation, this reach meets the ULDC Criteria.							
Seepage Evaluation Summary				Slope Stability Evaluation Summary			
200-Year DWSEL, Under Seepage:		Meets Criteria		Steady State Seepage 200-Year DWSEL, LS:		Meets Criteria	
200-Year DWSEL, Through Seepage:		Meets Criteria		Steady State Seepage HTOL, LS:		Meets Criteria	
HTOL, Under Seepage:		Meets Criteria		Rapid Drawdown, WS:		Meets Criteria	
				Seismic Slope Stability, WS:		Meets Criteria	
				Seismic Slope Stability, LS:		Meets Criteria	
Reach Description				Reach Overview			
Station Limits: 247+00 to 255+50 Feature(s) at Upstream Station Limit: Levee access ramp from farm road Feature(s) at Downstream Station Limit: Just south of levee pipe penetration Approx. Crown Elevation Range (feet, NAVD88): 24 to 25 Approx. Levee Height Range (feet): 14 to 18.5 Approx. Crown Width Range (feet): 17 to 48 Approx. Landside Slope (H:V) Range: 1.4:1 to 2.5:1 Approx. Waterside Slope (H:V) Range: 1.5:1 to 2.9:1 Waterside Constraint(s): None Landside Constraint(s): High voltage towers STA 248+00 to 250+00 and Howard Road STA 253+00 Landside repairs associated with PL84-99: Yes, berms between STA 248+00 and 252+00 Improvements associated with LSRP P1: None Improvements associated with LSRP P2: None Proposed Improvements associated with LSRP P3: Drained seepage berm and chimney drain, fill low area south of Howard Rd

Generalized Subsurface Conditions							
Levee Prism Soils: Silty SAND to Clayey SAND Landside Surface Layer: Silty to Clayey SAND near levee toe, approx. 12 feet of CLAY near berm toe Soils below surface layer: Approx. 5 feet of Silty SAND underlain by interbedded layers of CLAY and Poorly-graded SAND							
Historic Performance							
Seepage and six to eight pin boils reported in ULE's 2014 SGDR Addendum.							
Liquefiable Soils							
Based on our liquefaction assessment, we are not considering liquefiable soils in our slope stability analyses.							
Seepage Analysis Results							
Station	Water Surface	Figure	Exit Gradient			Through Seepage	Breakout Height (ft)*
			Levee Toe	Toe of Berm	Field		
251+50	200-Year	E-15-B	No Positive Gradient	0.18	---	No	n/a
	HTOL	E-15-C	No Positive Gradient	0.20	---	n/a	n/a
*Vertical distance from the toe of the levee (ground surface) to where the phreatic surface is calculated to daylight on the levee slope. Through seepage under HTOL conditions are not part of this evaluation.

Slope Stability Analysis Results							
Station	Case Analyzed	Water Surface	Figure	Factor of Safety (Circular)		Factor of Safety (Non-Circular)	
				Waterside	Landside	Waterside	Landside
251+50	SS - 200yr	19.2	E-15-D	---	2.2	n/a	n/a
	SS - HTOL	20.3	E-15-E	---	2.2	n/a	n/a
	RDD	13.6	E-15-D	1.3	---	n/a	n/a
	PS	4.8	E-15-F	1.0	1.6	n/a	n/a
	Post-EQ	n/a	n/a	n/a	n/a	n/a	n/a

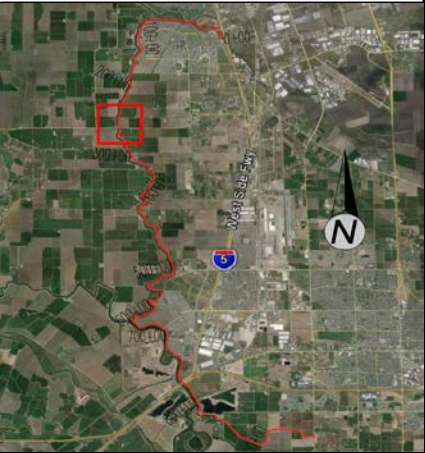
10.15 PROJECT REACH D2B, STATION 254+50

REACH D2B - STA 254+50							
Based on our evaluation, this reach meets the ULDC Criteria.							
Seepage Evaluation Summary				Slope Stability Evaluation Summary			
200-Year DWSEL, Under Seepage:	Meets Criteria			Steady State Seepage 200-Year DWSEL, LS:	Meets Criteria		
200-Year DWSEL, Through Seepage:	Meets Criteria			Steady State Seepage HTOL, LS:	Meets Criteria		
HTOL, Under Seepage:	Meets Criteria			Rapid Drawdown, WS:	Meets Criteria		
				Seismic Slope Stability, WS:	Meets Criteria		
				Seismic Slope Stability, LS:	Meets Criteria		
Reach Description				Reach Overview			
	Station Limits:	247+00	to	255+50

Feature(s) at Upstream Station Limit: Levee access ramp from farm road						
	Feature(s) at Downstream Station Limit: Just south of levee pipe penetration						
	Approx. Crown Elevation Range (feet, NAVD88):	24	to	25			
	Approx. Levee Height Range (feet):	14	to	18.5			
	Approx. Crown Width Range (feet):	17	to	48

Approx. Landside Slope (H:V) Range:	1.4:1	to	2.5:1			
	Approx. Waterside Slope (H:V) Range:	1.5:1	to	2.9:1			
	Waterside Constraint(s): None						
	Landside Constraint(s): High voltage towers (STA 248+00 to 250+00) and Howard Road (STA 253+00)						
	Landside repairs associated with PL84-99: Yes, berms between STA 248+00 and 252+00						
	Improvements associated with LSRP P1: None						
	Improvements associated with LSRP P2: None						
	Proposed Improvements associated with LSRP P3: Drained seepage berm and chimney						
Generalized Subsurface Conditions							
Levee Prism Soils: Silty to Clayey SAND							
Landside Surface Layer: Silty to Clayey SAND near levee toe, approx. 12 feet of CLAY near berm toe							
Soils below surface layer: Approx. 5 feet of Silty SAND underlain by interbedded layers of CLAY and Poorly-graded SAND							
Historic Performance							
Low to medium landside seepage and six to eight pin boils reported in ULE's 2014 SGDR Addendum.

Liquefiable Soils							
Based on our liquefaction assessment, we are not considering liquefiable soils in our slope stability analyses.							
Seepage Analysis Results							
Station	Water Surface	Figure	Exit Gradient			Through Seepage	Breakout Height (ft)*
			Levee Toe	Toe of Berm	Field		
254+50	200-Year	E-16-B	0.06	0.34	---	No	n/a
	HTOL	E-16-C	0.10	0.37	---	n/a	n/a
*Vertical distance from the toe of the levee (ground surface) to where the phreatic surface is calculated to daylight on the levee slope. Through seepage under HTOL conditions are not part of this evaluation.							
Slope Stability Analysis Results							
Station	Case Analyzed	Water Surface	Figure	Factor of Safety (Circular)		Factor of Safety (Non-Circular)	
				Waterside	Landside	Waterside	Landside
254+50	SS - 200yr	19.4	E-16-D	---	2.2	n/a	n/a
	SS - HTOL	20.5	E-16-E	---	2.1	n/a	n/a
	RDD	13.6	E-16-D	1.2	---	n/a	n/a
	PS	4.9	E-16-F	1.1	1.6	n/a	n/a

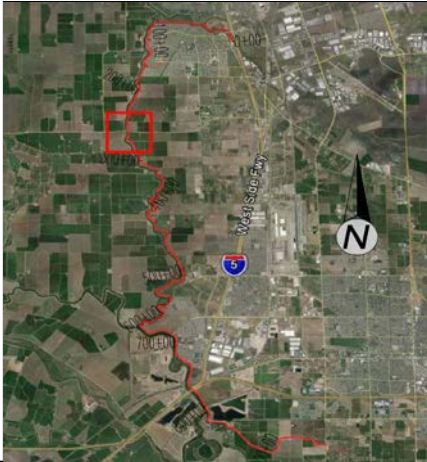
10.16 PROJECT REACH D2C, STATION 259+00

REACH D2C - STA 259+00							
Based on our evaluation, this reach does not meet the ULDC Criteria.							
Seepage Evaluation Summary				Slope Stability Evaluation Summary			
200-Year DWSEL, Under Seepage:		Fails Criteria		Steady State Seepage 200-Year DWSEL, LS:		Fails Criteria	
200-Year DWSEL, Through Seepage:		Fails Criteria		Steady State Seepage HTOL, LS:		Meets Criteria	
HTOL, Under Seepage:		Fails Criteria		Rapid Drawdown, WS:		Meets Criteria	
				Seismic Slope Stability, WS:		Meets Criteria	
				Seismic Slope Stability, LS:		Meets Criteria	
Reach Description				Reach Overview			
Station Limits: 255+50 to 259+50 Feature(s) at Upstream Station Limit: Transition to Phase II drained seepage berm associated with Rach EIA Feature(s) at Downstream Station Limit: Levee access ramp near Howard Road crossing Approx. Crown Elevation Range (feet, NAVD88): 23 to 25 Approx. Levee Height Range (feet): 14 to 18.5 Approx. Crown Width Range (feet): 17 to 21.5 Approx. Landside Slope (H:V) Range: 1.4:1 to 2.5:1 Approx. Waterside Slope (H:V) Range: 1.5:1 to 2.9:1 Waterside Constraint(s): Levee penetration at STA 259+00 Landside Constraint(s): Farm road/ramp at STA 255+50 Landside repairs associated with PL84-99: None Improvements associated with LSRP P1: None Improvements associated with LSRP P2: None Proposed Improvements associated with LSRP P3: None

Generalized Subsurface Conditions							
Levee Prism Soils: Silty to Clayey SAND Landside Surface Layer: Approx. 10 feet of CLAY near levee toe Soils below surface layer: Approx. 5 feet of Silty SAND underlain by interbedded layers of CLAY and Poorly-graded SAND							
Historic Performance							
No events reported in ULE's 2014 SGDR Addendum.							
Liquefiable Soils							
Based on our liquefaction assessment, we identified potentially liquefiable soils within this Reach (Refer to Appendix E and Appendix F)							
Seepage Analysis Results							
Station	Water Surface	Figure	Exit Gradient			Through Seepage	Breakout Height (ft)*
			Levee Toe	Toe of Berm	Field		
259+00	200-Year	E-17-B	0.54	---	---	Yes	3.7
	HTOL	E-17-C	0.61	---	---	n/a	n/a
*Vertical distance from the toe of the levee (ground surface) to where the phreatic surface is calculated to daylight on the levee slope. Through seepage under HTOL conditions are not part of this evaluation.

Slope Stability Analysis Results							
Station	Case Analyzed	Water Surface	Figure	Factor of Safety (Circular)		Factor of Safety (Non-Circular)	
				Waterside	Landside	Waterside	Landside
259+00	SS - 200yr	19.5	E-17-D	---	1.3	n/a	n/a
	SS - HTOL	20.7	E-17-E	---	1.3	n/a	n/a
	RDD	13.6	E-17-D	1.9	---	n/a	n/a
	PS	5.0	E-17-F	1.2	1.4	n/a	n/a
	Post-EQ	5.0	E-17-G/H	1.5	1.7	1.0	2.4

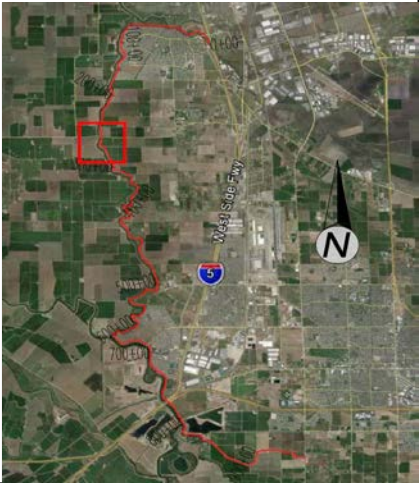
10.17 PROJECT REACH E1A, STATION 281+41 WITH BERM

REACH E1A - STA 281+41 WITH BERM							
Based on our evaluation, this reach meets the ULDC criteria.							
Seepage Evaluation Summary				Slope Stability Evaluation Summary			
200-Year DWSEL, Under Seepage:		Meets Criteria		Steady State Seepage 200-Year DWSEL, LS:		Meets Criteria	
200-Year DWSEL, Through Seepage:		Meets Criteria		Steady State Seepage HTOL, LS:		Meets Criteria	
HTOL, Under Seepage:		Meets Criteria		Rapid Drawdown, WS:		Meets Criteria	
				Seismic Slope Stability, WS:		Meets Criteria	
				Seismic Slope Stability, LS:		Meets Criteria	
Reach Description				Reach Overview			
Station Limits: 259+50 to 270+00 Feature(s) at Upstream Station Limit: End of Phase II drained berm for Reach E1A Feature(s) at Downstream Station Limit: Ends at raised grade or PL84-99 berm Approx. Crown Elevation Range (feet, NAVD88): 24 to 25 Approx. Levee Height Range (feet): 14 to 18 Approx. Crown Width Range (feet): 16 to 40 Approx. Landside Slope (H:V) Range: 2:1 to 3:1 Approx. Waterside Slope (H:V) Range: 1.2:1 to 2:1 Waterside Constraint(s): Waterside toe of slope at the waterway - no waterside bench. Landside Constraint(s): Agricultural fields/occasional overhead poles Landside Repairs associated with PL84-99: None Improvements associated with LSRP P1: None Improvements associated with LSRP P2: Drained Seepage Berm & Chimney Drain - STA 259+50 to 270+00 Proposed Improvements associated with LSRP P3: None

Generalized Subsurface Conditions							
Levee Prism Soils: Silty SAND and Clayey SAND Landside Surface Layer: Lean CLAY (10 to 30 feet thick) and Silty SAND Soils below surface layer: Lean CLAY and Silty SAND							
Historic Performance							
Landside seepage and pin boils reported during 1997 flood event in ULE's 2014 SGDR Addendum.							
Liquefiable Soils							
Based on our liquefaction assessment, we are not considering liquefiable soils in our slope stability analyses.							
Seepage Analysis Results							
Station	Water Surface	Figure	Exit Gradient**			Through Seepage	Breakout Height (ft)*
			Levee Toe	Toe of Berm	Field		
281+41	200-Year	E-18-B	No Positive Gradient	0.06	0.16	No	n/a
W/BERM	HTOL	E-18-C	No Positive Gradient	0.07	0.16	n/a	n/a
*Vertical distance from the toe of the levee (ground surface) to where the phreatic surface is calculated to daylight on the levee slope. Through seepage under HTOL conditions are not part of this evaluation. **Exit Gradient includes 3D effects

Slope Stability Analysis Results							
Station	Case Analyzed	Water Surface (feet)	Figure	Factor of Safety (Circular)		Factor of Safety (Non-Circular)	
				Waterside	Landside	Waterside	Landside
281+41 W/BERM	SS - 200yr	20.1	E-18-D	---	2.3	n/a	n/a
	SS - HTOL	21.2	E-18-E	---	2.2	n/a	n/a
	RDD	14.0	E-18-D	1.2	---	n/a	n/a
	PS	5.2	E-18-F	1.1	1.7	n/a	n/a
	Post-EQ	n/a	n/a	n/a	n/a	n/a	n/a

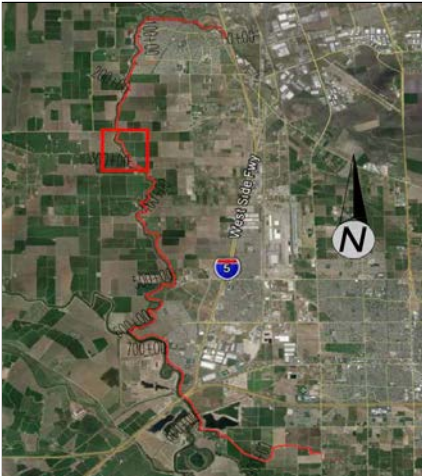
10.18 PROJECT REACH E1B, STATION 281+41 WITHOUT BERM

REACH E1B - STA 281+41 WITHOUT BERM							
Based on our evaluation, this reach does not meet the ULDC Criteria.							
Seepage Evaluation Summary				Slope Stability Evaluation Summary			
200-Year DWSEL, Under Seepage:	Meets Criteria			Steady State Seepage 200-Year DWSEL, LS:	Meets Criteria		
200-Year DWSEL, Through Seepage:	Fails Criteria			Steady State Seepage HTOL, LS:	Meets Criteria		
HTOL, Under Seepage:	Meets Criteria			Rapid Drawdown, WS:	Meets Criteria		
				Seismic Slope Stability, WS:	Meets Criteria		
				Seismic Slope Stability, LS:	Meets Criteria		
Reach Description				Reach Overview			
Station Limits: 270+00 to 297+75 Feature(s) at Upstream Station Limit: Begin Phase II drained seepage berm associated with Reach E2 Feature(s) at Downstream Station Limit: End of Phase II drained berm associated with Reach E1A Approx. Crown Elevation Range (feet, NAVD88): 24 to 25 Approx. Levee Height Range (feet): 14 to 18 Approx. Crown Width Range (feet): 16 to 40 Approx. Landside Slope (H:V) Range: 2:1 to 3:1 Approx. Waterside Slope (H:V) Range: 1.2:1 to 2:1 Waterside Constraint(s): Waterside toe of slope at the waterway - no waterside bench. Landside Constraint(s): Agricultural field Landside Repairs associated with PL84-99: None Improvements associated with LSRP P1: None Improvements associated with LSRP P2: None Proposed Improvements associated with LSRP P3: None

Generalized Subsurface Conditions							
Levee Prism Soils: Silty SAND and Lean CLAY Landside Surface Layer: Lean CLAY (10 to 30 feet thick) and Silty SAND Soils below surface layer: Lean CLAY and Silty SAND							
Historic Performance							
Low to medium landside seepage and pin boils reported during 1997 flood event in ULE's 2014 SGDR Addendum.							
Liquefiable Soils							
Based on our liquefaction assessment, we identified potentially liquefiable soils within this Reach (Refer to Appendix E and Appendix F)							
Seepage Analysis Results							
Station	Water Surface	Figure	Exit Gradient			Through Seepage	Breakout Height (ft)*
			Levee Toe	Toe of Berm	Field		
281+41 NO BERM	200-Year	E-19-B	0.18	---	---	Yes	2.0
	HTOL	E-19-C	0.20	---	---	n/a	n/a
*Vertical distance from the toe of the levee (ground surface) to where the phreatic surface is calculated to daylight on the levee slope. Through seepage under HTOL conditions are not part of this evaluation.

Slope Stability Analysis Results							
Station	Case Analyzed	Water Surface (feet)	Figure	Factor of Safety (Circular)		Factor of Safety (Non-Circular)	
				Waterside	Landside	Waterside	Landside
281+41 NO BERM	SS - 200yr	20.1	E-19-D	---	1.5	n/a	n/a
	SS - HTOL	21.2	E-19-E	---	1.4	n/a	n/a
	RDD	14	E-19-D	1.2	---	n/a	n/a
	PS	5.2	E-19-F	1.1	1.4	n/a	n/a
	Post-EQ	5.2	E-19-G/H	1.3	1.9	1.2	3.0

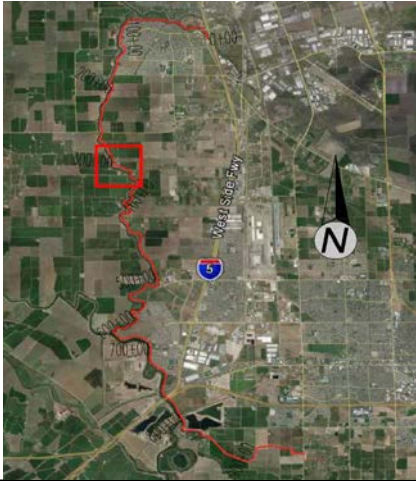
10.20 PROJECT REACH F1A, STATION 311+00

REACH F1A - STA 311+00							
Based on our evaluation, this reach meets the ULDC Criteria.							
Seepage Evaluation Summary				Slope Stability Evaluation Summary			
200-Year DWSEL, Under Seepage:		Meets Criteria		Steady State Seepage 200-Year DWSEL, LS:		Meets Criteria	
200-Year DWSEL, Through Seepage:		Meets Criteria		Steady State Seepage HTOL, LS:		Meets Criteria	
HTOL, Under Seepage:		Meets Criteria		Rapid Drawdown, WS:		Meets Criteria	
				Seismic Slope Stability, WS:		Meets Criteria	
				Seismic Slope Stability, LS:		Meets Criteria	
Reach Description				Reach Overview			
Station Limits: 305+75 to 312+30 Feature(s) at Upstream Station Limit: Transition to landside farm improvements Feature(s) at Downstream Station Limit: End of Phase II drained seepage berm associated with Reach E2 Approx. Crown Elevation Range (feet, NAVD88): 25 to 26 Approx. Levee Height Range (feet): 16 to 18 Approx. Crown Width (feet): 20 Approx. Landside Slope (H:V) Range: 2.5:1 to 3:1 Approx. Waterside Slope (H:V) Range: 2:1 to 2:1 Waterside Constraint(s): Waterside toe of slope at the waterway - no waterside bench. Landside Constraint(s): None - agricultural land Landside repairs associated with PL84-99: Yes, berms constructed between STA 305+75 and 307+00 Improvements associated with LSRP P1: None Improvements associated with LSRP P2: None Proposed Improvements associated with LSRP P3: Drained Seepage Berm

Generalized Subsurface Conditions							
Levee Prism Soils: Sandy CLAY to Silty SAND Landside Surface Layer: Lean CLAY, approx. 30 feet thick at toe of levee with thin seams of Silty SAND Soils below surface layer: Approx. 50 feet of interbedded layers of Silty SAND, SAND and Lean CLAY							
Historic Performance							
Landside seepage and pin boils reported during 1997 flood event in ULE's 2014 SGDR Addendum.							
Liquefiable Soils							
Based on our liquefaction assessment, we are not considering liquefiable soils in our slope stability analyses							
Seepage Analysis Results							
Station	Water Surface	Figure	Exit Gradient			Through Seepage	Breakout Height (ft)*
			Levee Toe	Toe of Berm	Field		
311+00	200-Year	E-21-B	No Positive Gradient	0.08	---	No	n/a
	HTOL	E-21-C	No Positive Gradient	0.10	---	n/a	n/a
*Vertical distance from the toe of the levee (ground surface) to where the phreatic surface is calculated to daylight on the levee slope. Through seepage under HTOL conditions are not part of this evaluation.

Slope Stability Analysis Results							
Station	Case Analyzed	Water Surface	Figure	Factor of Safety (Circular)		Factor of Safety (Non-Circular)	
				Waterside	Landside	Waterside	Landside
311+00	SS - 200yr	20.7	E-21-D	---	2.2	n/a	n/a
	SS - HTOL	21.9	E-21-E	---	2.2	n/a	n/a
	RDD	14.3	E-21-D	1.9	---	n/a	n/a
	PS	5.2	E-21-F	1.4	1.7	n/a	n/a
	Post-EQ	n/a	n/a	n/a	n/a	n/a	n/a

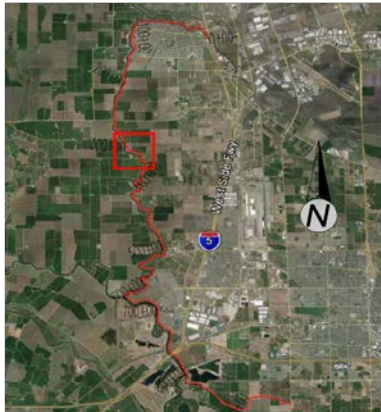
10.21 PROJECT REACH F1B, STATION 313+75

REACH F1B - STA 313+75							
Based on our evaluation, this reach does not meet the ULDC Criteria. Seismic deformations are not anticipated to degrade below 10-Year WSE+3 feet.							
Seepage Evaluation Summary				Slope Stability Evaluation Summary			
200-Year DWSEL, Under Seepage:		Meets Criteria		Steady State Seepage 200-Year DWSEL, LS:		Meets Criteria	
200-Year DWSEL, Through Seepage:		Fails Criteria		Steady State Seepage HTOL, LS:		Meets Criteria	
HTOL, Under Seepage:		Meets Criteria		Rapid Drawdown, WS:		Meets Criteria	
				Seismic Slope Stability, WS:		Fails Criteria	
				Seismic Slope Stability, LS:		Meets Criteria	
Reach Description				Reach Overview			
Station Limits: 312+30 to 315+00 Feature(s) at Upstream Station Limit: Bowman Road Feature(s) at Downstream Station Limit: Transition to Phase III Seepage berm Approx. Crown Elevation Range (feet, NAVD88): 25 to 26 Approx. Levee Height Range (feet): 12 to 13 Approx. Crown Width Range (feet): 12 to 30 Approx. Landside Slope (H:V) Range: 2:1 to 3.5:1 Approx. Waterside Slope (H:V) Range: 2:1 to 3:1 Waterside Constraint(s): Levee penetration near STA 314+50 Landside Constraint(s): Rural farm improvements, structures Landside repairs associated with PL84-99: Possibly, either berm or raised grades Improvements associated with LSRP P1: None Improvements associated with LSRP P2: None Proposed Improvements associated with LSRP P3: None

Generalized Subsurface Conditions Levee Prism Soils: Silty SAND to poorly graded SAND Landside Surface Layer: Silty SAND, approx. 6 feet thick at toe of levee Soils below surface layer: Approx. 20 feet of interbedded layers of Silty SAND and Lean CLAY, over 60 feet of Poorly Graded SAND							
Historic Performance Landside seepage and pin boils reported during 1997 flood event in ULE's 2014 SGDR Addendum							
Liquefiable Soils Based on our liquefaction assessment, we identified potentially liquefiable soils within this Reach (Refer to Appendix E and Appendix F)							
Seepage Analysis Results							
Station	Water Surface	Figure	Exit Gradient			Through Seepage	Breakout Height (ft)*
			Levee Toe	Toe of Berm	Field		
313+75	200-Year	E-22-B	0.26	---	0.14	Yes	2.5
	HTOL	E-22-C	0.27	---	0.14	n/a	n/a
*Vertical distance from the toe of the levee (ground surface) to where the phreatic surface is calculated to day light on the levee slope. Through seepage under HTOL conditions are not part of this evaluation.

Slope Stability Analysis Results							
Station	Case Analyzed	Water Surface	Figure	Factor of Safety (Circular)		Factor of Safety (Non-Circular)	
				Waterside	Landside	Waterside	Landside
313+75	SS - 200yr	20.9	E-22-D	---	1.7	n/a	n/a
	SS - HTOL	22.0	E-22-E	---	1.6	n/a	n/a
	RDD	14.5	E-22-D	1.7	---	n/a	n/a
	PS	5.2	E-22-F	1.1	1.7	n/a	n/a
	Post-EQ	5.2	E-22-G/H	0.9	2.1	0.9	2.0
Post 200-Year Seismic Event Restoration Estimates							
Reach	Damage Length (feet)	Estimated Lateral Movement (feet)	Estimated Vertical Movement (feet)	Fill Volume (10 year WSE+3 feet Freeboard) (cubic yards)	Fill Volume (Fully Restored Levee Geometry) (cubic yards)		
F1B	650	2	1.5	No Fill Anticipated	100

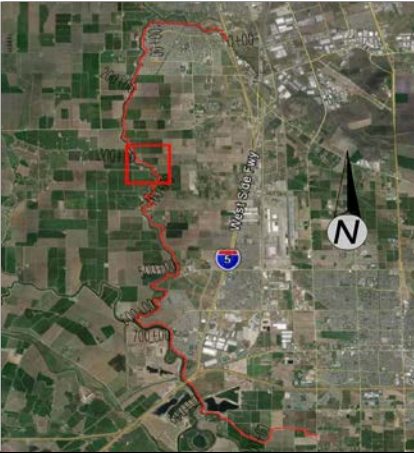
10.22 PROJECT REACH F1C, STATION 320+65

REACH F1C - STA 320+65							
Based on our evaluation, this reach does not meet the ULDC Criteria.							
Seepage Evaluation Summary				Slope Stability Evaluation Summary			
200-Year DWSEL, Under Seepage:	Fails Criteria			Steady State Seepage 200-Year DWSEL, LS:	Fails Criteria		
200-Year DWSEL, Through Seepage:	Fails Criteria			Steady State Seepage HTOL, LS:	Fails Criteria		
HTOL, Under Seepage:	Fails Criteria			Rapid Drawdown, WS:	Meets Criteria		
				Seismic Slope Stability, WS:	Meets Criteria		
				Seismic Slope Stability, LS:	Meets Criteria		
Reach Description				Reach Overview			
Station Limits: 315+00 to 321+00 Feature(s) at Upstream Station Limit: Gate on levee near mill Feature(s) at Downstream Station Limit: Bowman Road Approx. Crown Elevation Range (feet, NAVD88): 25 to 26 Approx. Levee Height Range (feet): 19 to 20 Approx. Crown Width Range (feet): 20 to 35 Approx. Landside Slope (H:V) Range: 2:1 to 2.2:1 Approx. Waterside Slope (H:V) Range: 1.5:1 to 2.4:1 Waterside Constraint(s): None Landside Constraint(s): None - open land Landside repairs associated with PL84-99: Yes, berms constructed between STA Improvements associated with LSRP P1: None Improvements associated with LSRP P2: None Proposed Improvements associated with LSRP P3: None

Generalized Subsurface Conditions							
Levee Prism Soils: Silty SAND to Lean CLAY Landside Surface Layer: Lean CLAY, approx. 15 feet thick at toe of levee Soils below surface layer: Approx. 8 feet of Silty SAND, over 18 feet Lean CLAY, over 40 feet of SAND							
Historic Performance							
Landside seepage and pin boils reported during 1997 flood event in ULE's 2014 SGDR Addendum.							
Liquefiable Soils							
Based on our liquefaction assessment, we are not considering liquefiable soils in our slope stability analyses.							
Seepage Analysis Results							
Station	Water Surface	Figure	Exit Gradient			Through Seepage	Breakout Height (ft)*
			Levee Toe	Toe of Berm	Field		
320+65	200-Year	E-23-B	1.2	---	0.42	Yes	6.8
	HTOL	E-23-C	1.3	---	0.46	n/a	n/a
*Vertical distance from the toe of the levee (ground surface) to where the phreatic surface is calculated to daylight on the levee slope. Through seepage under HTOL conditions are not part of this evaluation.

Slope Stability Analysis Results							
Station	Case Analyzed	Water Surface	Figure	Factor of Safety (Circular)		Factor of Safety (Non-Circular)	
				Waterside	Landside	Waterside	Landside
320+65	SS - 200yr	21.9	E-23-D	---	1.1	n/a	n/a
	SS - HTOL	22.1	E-23-E	---	1.0	n/a	n/a
	RDD	14.4	E-23-D	1.5	---	n/a	n/a
	PS	5.2	E-23-F	1.1	1.2	n/a	n/a
	Post-EQ	n/a	n/a	n/a	n/a	n/a	n/a

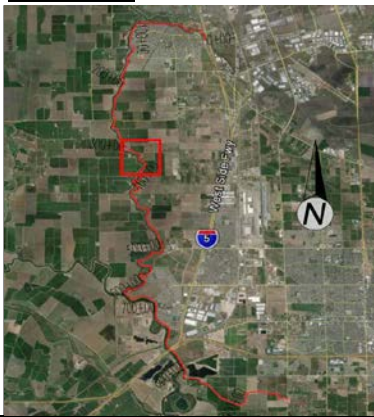
10.23 PROJECT REACH F2, STATION 329+00

REACH F2 - STA 329+00							
Based on our evaluation, this reach does not meet the ULDC Criteria. Seismic deformations are not anticipated to degrade below 10-Year WSE+3 feet.							
Seepage Evaluation Summary				Slope Stability Evaluation Summary			
200-Year DWSEL Under Seepage:		Fails Criteria		Steady State Seepage 200-Year DWSEL, LS:		Meets Criteria	
200-Year DWSEL Through Seepage:		Fails Criteria		Steady State Seepage HTOL, LS:		Meets Criteria	
HTOL Under Seepage:		Fails Criteria		Rapid Drawdown, WS:		Meets Criteria	
				Seismic Slope Stability, WS:		Fails Criteria	
				Seismic Slope Stability, LS:		Meets Criteria	
Reach Description				Reach Overview			
Station Limits: 321+00 to 339+00 Feature(s) at Upstream Station Limit: Between two levee access ramps Feature(s) at Downstream Station Limit: Gate on levee crown Approx. Crown Elevation Range (feet, NAVD88): 25 to 26 Approx. Levee Height Range (feet): 11 to 19.5 Approx. Crown Width Range (feet): 12 to 22.5 Approx. Landside Slope (H:V) Range: 2.1:1 to 3.8:1 Approx. Waterside Slope (H:V) Range: 1.5:1 to 3.1:1 Waterside Constraint(s): Platform (STA 331+80) Landside Constraint(s): Existing structures (STA 322+00 to 329+00), small structure (STA 331+80) Landside repairs associated with PL84-99: Seepage berm repairs between STA Improvements associated with LSRP P1: None Improvements associated with LSRP P2: None Proposed Improvements associated with LSRP P3: None

Generalized Subsurface Conditions							
Levee Prism Soils: Silty SAND Landside Surface Layer: Lean CLAY, approx. 5 feet thick at toe of levee with silty SAND lens Soils below surface layer: Interbedded layers of silty SAND, Lean CLAY, and Poorly Graded SAND with Silt							
Historic Performance							
Landside seepage and pin boils reported in ULE's 2014 SGDR Addendum.							
Liquefiable Soils							
Based on our liquefaction assessment, we identified potentially liquefiable soils within this Reach (Refer to Appendix E and Appendix F)							
Seepage Analysis Results							
Station	Water Surface	Figure	Exit Gradient**			Through Seepage	Breakout Height (ft)*
			Levee Toe	Toe of Berm	Field		
329+00	200-Year	E-24-B	1.19	---	0.34	Yes	1
	HTOL	E-24-C	1.33	---	0.38	n/a	n/a
*Vertical distance from the toe of the levee (ground surface) to where the phreatic surface is calculated to day light on the levee slope. Through seepage under HTOL conditions are not part of this evaluation. **Exit Gradient includes 3D effects

Slope Stability Analysis Results							
Station	Case Analyzed	Water Surface	Figure	Factor of Safety (Circular)		Factor of Safety (Non-Circular)	
				Waterside	Landside	Waterside	Landside
329+00	SS - 200yr	21.0	E-24-D	---	1.6	n/a	n/a
	SS - HTOL	22.1	E-24-E	---	1.5	n/a	n/a
	RDD	14.4	E-24-D	1.7	---	n/a	n/a
	PS	5.3	E-24-F	1.3	1.5	n/a	n/a
	Post-EQ	5.3	E-24-G/H	0.8	2.1	0.7	2.0
Post 200-Year Seismic Event Restoration Estimates							
Reach	Damage Length (feet)	Estimated Lateral Movement (feet)	Estimated Vertical Movement (feet)	Fill Volume (10 year WSE+3 feet Freeboard) (cubic yards)	Fill Volume (Fully Restored Levee Geometry) (cubic yards)		
F2	750	2	1.5	No Fill Anticipated	100

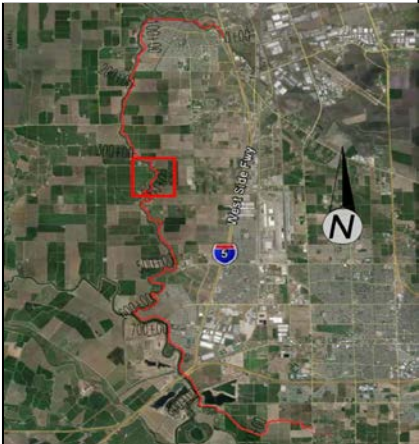
10.24 PROJECT REACH F3, STATION 350+00

REACH F3 - STA 350+00							
Based on our evaluation, this reach does not meet the ULDC Criteria.							
Seepage Evaluation Summary				Slope Stability Evaluation Summary			
200-Year DWSEL, Under Seepage:		Fails Criteria		Steady State Seepage 200-Year DWSEL, LS:		Fails Criteria	
200-Year DWSEL, Through Seepage:		Fails Criteria		Steady State Seepage HTOL, LS:		Meets Criteria	
HTOL, Under Seepage:		Fails Criteria		Rapid Drawdown, WS:		Meets Criteria	
				Seismic Slope Stability, WS:		Meets Criteria	
				Seismic Slope Stability, LS:		Meets Criteria	
Reach Description				Reach Overview			
Station Limits: 339+00 to 362+50 Feature(s) at Upstream Station Limit: Transition to Phase III cutoff wall Feature(s) at Downstream Station Limit: Near levee access ramp from farm road Approx. Crown Elevation Range (feet, NAVD88): 26 to 27.5 Approx. Levee Height Range (feet): 11 to 19.5 Approx. Crown Width Range (feet): 13 to 25 Approx. Landside Slope (H:V) Range: 2:1 to 3.8:1 Approx. Waterside Slope (H:V) Range: 1.5:1 to 3.1:1 Waterside Constraint(s): Levee penetration (STA 354+00) Landside Constraint(s): None - agricultural land Landside repairs associated with PL84-99: None Improvements associated with LSRP P1: None Improvements associated with LSRP P2: None Proposed Improvements associated with LSRP P3: None

Generalized Subsurface Conditions							
Levee Prism Soils: Silty SAND Landside Surface Layer: Lean CLAY, approx. 15 feet thick at toe of levee Soils below surface layer: Interbedded layers of Silty SAND, Clayey SAND, Lean CLAY, and Poorly Graded SAND							
Historic Performance							
No observations reported in ULE's 2014 SGDR Addendum.							
Liquefiable Soils							
Based on our liquefaction assessment, we are not considering liquefiable soils in our slope stability analyses							
Seepage Analysis Results							
Station	Water Surface	Figure	Exit Gradient**			Through Seepage	Breakout Height (ft)*
			Levee Toe	Toe of Berm	Field		
350+00	200-Year	E-25-B	0.81	---	0.78	Yes	2
	HTOL	E-25-C	0.91	---	0.86	n/a	n/a
*Vertical distance from the toe of the levee (ground surface) to where the phreatic surface is calculated to daylight on the levee slope. Through seepage under HTOL conditions are not part of this evaluation. **Exit Gradient includes 3D effects

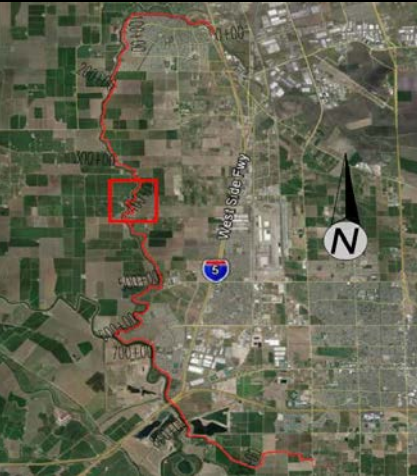
10.25 PROJECT REACH G, STATION 375+50

REACH G - STA 375+50							
Based on our evaluation, this reach meets the ULDC Criteria.							
Seepage Evaluation Summary				Slope Stability Evaluation Summary			
200-Year DWSEL, Under Seepage:		Meets Criteria		Steady State Seepage 200-Year DWSEL, LS:		Meets Criteria	
200-Year DWSEL, Through Seepage Seepage:		Meets Criteria		Steady State Seepage HTOL, LS:		Meets Criteria	
HTOL, Under Seepage:		Meets Criteria		Rapid Drawdown, WS:		Meets Criteria	
				Seismic Slope Stability, WS:		Meets Criteria	
				Seismic Slope Stability, LS:		Meets Criteria	
Reach Description				Reach Overview			
Station Limits: 362+50 to 388+00 Feature(s) at Upstream Station Limit: Waterside mobile home park/waterside Feature(s) at Downstream Station Limit: Near levee access ramp from farm road Approx. Crown Elevation Range (feet, NAVD88): 27 to 28 Approx. Levee Height Range (feet): 13.5 to 21 Approx. Crown Width Range (feet): 17 to 37 Approx. Landside Slope (H:V) Range: 1.8:1 to 2.7:1 Approx. Waterside Slope (H:V) Range: 1.7:1 to 3.2:1 Waterside Constraint(s): Waterside toe of slope at the waterway - waterside bench begins at STA 377+75 Landside Constraint(s): Lake and equestrian arena Landside repairs associated with PL84-99: Yes, berm constructed from STA 374+50 to 382+00 Improvements associated with LSRP P1: None Improvements associated with LSRP P2: None Proposed Improvements associated with LSRP P3: Fully penetrating cutoff wall STA 362+50 to 388+00

Generalized Subsurface Conditions							
Levee Prism Soils: Clayey SAND to Silty SAND Landside Surface Layer: Lean CLAY approx. 6 feet thick at levee toe Soils below surface layer: Approx. 4 feet of Silty SAND, over 4 feet of Lean Clay, over 23 feet of Silty SAND							
Historic Performance							
Seepage and boils reported in ULE's 2014 SGDR Addendum.							
Liquefiable Soils							
Based on our liquefaction assessment, we are not considering liquefiable soils in our slope stability analyses.							
Seepage Analysis Results							
Station	Water Surface	Figure	Exit Gradient			Through Seepage	Breakout Height (ft)*
			Levee Toe	Toe of Berm	Field		
375+50	200-Year	E-26-B	No Positive Gradient	---	---	No	n/a
	HTOL	E-26-C	No Positive Gradient	---	---	n/a	n/a
*Vertical distance from the toe of the levee (ground surface) to where the phreatic surface is calculated to daylight on the levee slope. Through seepage under HTOL conditions are not part of this evaluation.

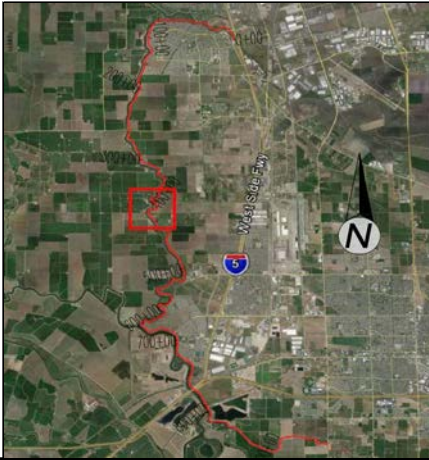
10.27 PROJECT REACH H1A, STATION 408+00

REACH H1A - STA 408+00							
Based on our evaluation, this reach does not meet the ULDC Criteria.							
Seepage Evaluation Summary				Slope Stability Evaluation Summary			
200-Year DWSEL, Under Seepage:		Fails Criteria		Steady State Seepage 200-Year DWSEL, LS:		Fails Criteria	
200-Year DWSEL, Through Seepage:		Fails Criteria		Steady State Seepage HTOL, LS:		Fails Criteria	
HTOL, Under Seepage:		Fails Criteria		Rapid Drawdown, WS:		Meets Criteria	
				Seismic Slope Stability, WS:		Meets Criteria	
				Seismic Slope Stability, LS:		Meets Criteria	
Reach Description				Reach Overview			
Station Limits: 388+00 to 411+00 Feature(s) at Upstream Station Limit: End of PL84-99 berm within Reach H1B Feature(s) at Downstream Station Limit: Terminous of LSRP Phase III cutoff wall in Reach G Approx. Crown Elevation Range (feet, NAVD88): 27 to 28 Approx. Levee Height Range (feet): 11 to 17 Approx. Crown Width Range (feet): 14 to 30 Approx. Landside Slope (H:V) Range: 1.8:1 to 2.5:1 Approx. Waterside Slope (H:V) Range: 1.7:1 to 3.2:1 Waterside Constraint(s): Waterside residential improvements Landside Constraint(s): None - Agricultural/undeveloped land Landside repairs associated with PL84-99: Yes, berm constructed between STA 402+00 and 411+00 Improvements associated with LSRP P1: None Improvements associated with LSRP P2: None Proposed Improvements associated with LSRP P3: None

Generalized Subsurface Conditions							
Levee Prism Soils: Silty SAND with Lean CLAY lenses Landside Surface Layer: Lean CLAY to Fat CLAY, approx. 5 feet thick at toe of levee Soils below surface layer: 7 feet of Silty SAND, over 12 feet of Poorly Graded SAND, over interbedded layers of Lean CLAY and Silty SAND							
Historic Performance							
Seepage and boils reported in ULE's 2014 SGDR Addendum.							
Liquefiable Soils							
Based on our liquefaction assessment, we identified potentially liquefiable soils within this Reach (Refer to Appendix E and Appendix F)							
Seepage Analysis Results							
Station	Water Surface	Figure	Exit Gradient			Through Seepage	Breakout Height (ft)*
			Levee Toe	Toe of Berm	Field		
408+00	200-Year	E-28-B	0.99	---	1.06	Yes	1.5
	HTOL	E-28-B	1.13	---	1.21	n/a	n/a
*Vertical distance from the toe of the levee (ground surface) to where the phreatic surface is calculated to daylight on the levee slope. Through seepage under HTOL conditions are not part of this evaluation.

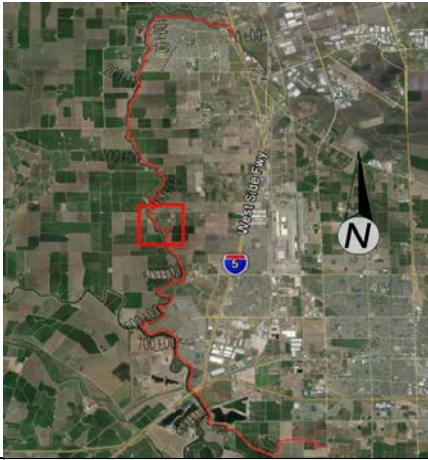
10.29 PROJECT REACH H2, STATION 437+26

REACH H2 - STA 437+26							
Based on our evaluation, this reach does not meet the ULDC Criteria.							
Seepage Evaluation Summary				Slope Stability Evaluation Summary			
200-Year DWSEL, Under Seepage:		Fails Criteria		Steady State Seepage 200-Year DWSEL, LS:		Fails Criteria	
200-Year DWSEL, Through Seepage:		Fails Criteria		Steady State Seepage HTOL, LS:		Fails Criteria	
HTOL, Under Seepage:		Fails Criteria		Rapid Drawdown, WS:		Meets Criteria	
				Seismic Slope Stability, WS:		Meets Criteria	
				Seismic Slope Stability, LS:		Meets Criteria	
Reach Description				Reach Overview			
Station Limits: 420+00 to 445+00 Feature(s) at Upstream Station Limit: 250 feet north of levee access ramp Feature(s) at Downstream Station Limit: End of PL84-99 berm within Reach H1B Approx. Crown Elevation Range (feet, NAVD88): 28 to 29 Approx. Levee Height Range (feet): 16 to 18 Approx. Crown Width Range (feet): 15 to 40 Approx. Landside Slope (H:V) Range: 1.9:1 to 2.5:1 Approx. Waterside Slope (H:V) Range: 1.7:1 to 7.5:1 Waterside Constraint(s): Waterside bench/residence from STA 438+00 to 445+00 Landside Constraint(s): Pond approx. 300 feet from levee centerline from STA 423+00 to 443+00 Landside repairs associated with PL84-99: None Improvements associated with LSRP P1: None Improvements associated with LSRP P2: None Proposed Improvements associated with LSRP P3: None

Generalized Subsurface Conditions							
Levee Prism Soils: Interbedded Silty SAND and Lean CLAY Landside Surface Layer: Lean CLAY, approx. 3 feet thick at toe of levee Soils below surface layer: Approx. 20 feet of Silty SAND to Poorly Graded Sand with Silt, over 30 feet of Lean CLAY							
Historic Performance							
No data reported in ULE's 2014 SGDR Addendum.							
Liquefiable Soils							
Based on our liquefaction assessment, we identified potentially liquefiable soils within this Reach (Refer to Appendix E and Appendix F)							
Seepage Analysis Results							
Station	Water Surface	Figure	Exit Gradient			Through Seepage	Breakout Height (ft)*
			Levee Toe	Toe of Berm	Field		
437+26	200-Year	E-30-B	1.62	---	2.12	Yes	6
	HTOL	E-30-C	1.81	---	2.35	n/a	n/a
*Vertical distance from the toe of the levee (ground surface) to where the phreatic surface is calculated to daylight on the levee slope. Through seepage under HTOL conditions are not part of this evaluation.

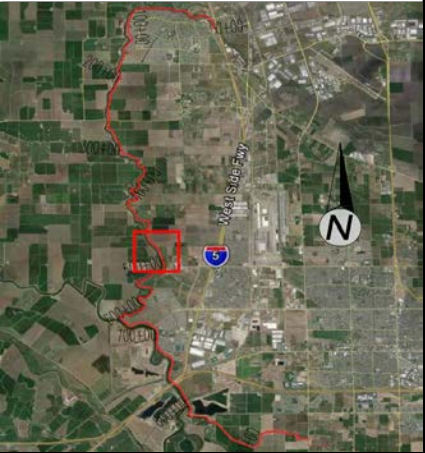
10.31 PROJECT REACH I, STATION 476+00

REACH I - STA 476+00							
Based on our evaluation, this reach does not meet ULDC Criteria.							
Seepage Evaluation Summary				Slope Stability Evaluation Summary			
200-Year DWSEL, Under Seepage:		Fails Criteria		Steady State Seepage 200-Year DWSEL, LS:		Fails Criteria	
200-Year DWSEL, Through Seepage:		Fails Criteria		Steady State Seepage HTOL, LS:		Meets Criteria	
HTOL, Under Seepage:		Fails Criteria		Rapid Drawdown, WS:		Meets Criteria	
				Seismic Slope Stability, WS:		Meets Criteria	
				Seismic Slope Stability, LS:		Meets Criteria	
Reach Description				Reach Overview			
Station Limits: 466+00 to 506+00 Feature(s) at Upstream Station Limit: Lathrop High School Improvements Feature(s) at Downstream Station Limit: 500 feet north of De Lima Road Approx. Crown Elevation Range (feet, NAVD88): 28 to 30 Approx. Levee Height Range (feet): 15.5 to 18 Approx. Crown Width Range (feet): 15 to 42 Approx. Landside Slope (H:V) Range: 1.7:1 to 3.8:1 Approx. Waterside Slope (H:V) Range: 1.6:1 to 4.6:1 Waterside Constraint(s): Penetration near STA 478+50 and Landside Constraint(s): Dos Reis Rd. and parking lot from STA 483+00 to 493+00 Landside Repairs associated with PL84-99: Yes, berm constructed from STA 472+00 to 477+00 Improvements associated with LSRP P1: None Improvements associated with LSRP P2: None Proposed Improvements associated with LSRP P3: Drained seepage berm with chimney

Generalized Subsurface Conditions							
Levee Prism Soils: Silty SAND Landside Surface Layer: Lean CLAY approx. 2 ft thick at toe of levee Soils below surface layer: Alternating layers of Silty SAND and Lean CLAY							
Historic Performance							
Seepage, landside boils, and waterside erosion during 1997 flood event were reported in ULE's 2014 SGDR Addendum.							
Liquefiable Soils							
Based on our liquefaction assessment, we are not considering liquefiable soils in our slope stability analyses.							
Seepage Analysis Results							
Station	Water Surface	Figure	Exit Gradient			Through Seepage	Breakout Height (ft)*
			Levee Toe	Toe of Berm	Field		
476+00	200-Year	E-32-B	1.61	---	---	Yes	6
	HTOL	E-32-C	1.75	---	---	n/a	n/a
*Vertical distance from the toe of the levee (ground surface) to where the phreatic surface is calculated to daylight on the levee slope. Through seepage under HTOL conditions are not part of this evaluation.
