URBAN LEVEE DESIGN CRITERIA EVALUATION

MOSSDALE TRACT
RECLAMATION DISTRICT NO. 17
SAN JOAQUIN COUNTY, CALIFORNIA

Project No:
5747.005.000

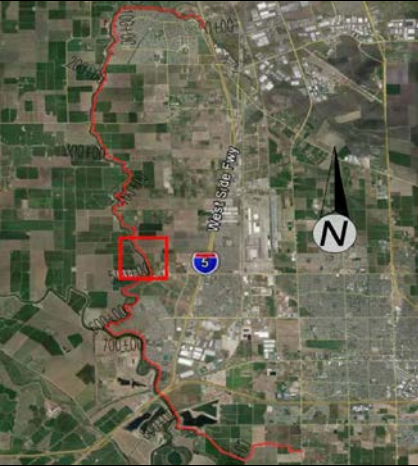
10.32 PROJECT REACH I, STATION 496+28

REACH I - STA 496+28							
Based on our evaluation, this reach does not meet ULDC criteria.							
Seepage Evaluation Summary				Slope Stability Evaluation Summary			
200-Year DWSEL, Under Seepage:	Fails Criteria			Steady State Seepage 200-Year DWSEL, LS:	Meets Criteria		
200-Year DWSEL, Through Seepage:	Fails Criteria			Steady State Seepage HTOL, LS:	Meets Criteria		
HTOL, Under Seepage:	Fails Criteria			Rapid Drawdown, WS:	Meets Criteria		
				Seismic Slope Stability, WS:	Meets Criteria		
				Seismic Slope Stability, LS:	Meets Criteria		
Reach Description				Reach Overview			
Station Limits: 466+00 to 506+00 Feature(s) at Upstream Station Limit: Lathrop High School Improvements Feature(s) at Downstream Station Limit: 500 feet north of De Lima Road Approx. Crown Elevation Range (feet, NAVD88): 28 to 30 Approx. Levee Height Range (feet): 15.5 to 18 Approx. Crown Width Range (feet): 15 to 42 Approx. Landside Slope (H:V) Range: 1.7:1 to 3.8:1 Approx. Waterside Slope (H:V) Range: 1.6:1 to 4.6:1 Waterside Constraint(s): Penetration near STA 478+50 and dock/boat ramp near STA 491+00 Landside Constraint(s): Dos Reis Rd. and parking lot from STA 483+00 to 493+00 Landside Repairs associated with PL84-99: Yes, berm constructed from STA 472+00 to 477+00 Improvements associated with LSRP P1: None Improvements associated with LSRP P2: None Proposed Improvements associated with LSRP P3: Drained seepage berm with chimney

Generalized Subsurface Conditions Levee Prism Soils: Clayey SAND and Poorly Graded SAND with Silt Landside Surface Layer: Lean CLAY, approx. 10 ft thick at toe of levee Soils below surface layer: Alternating layers of Poorly Graded SAND to Silty SAND and Lean CLAY							
Historic Performance Seepage, landside boils, and waterside erosion during 1997 flood event were reported in ULE's 2014 SGDR Addendum.							
Liquefiable Soils Based on our liquefaction assessment, we are not considering liquefiable soils in our slope stability analyses.							
Seepage Analysis Results							
Station	Water Surface	Figure	Exit Gradient			Through Seepage	Breakout Height (ft)*
			Levee Toe	Toe of Berm	Field		
496+28	200-Year	E-33-B	0.97	---	---	Yes	4
	HTOL	E-33-C	1.08	---	---	n/a	n/a
*Vertical distance from the toe of the levee (ground surface) to where the phreatic surface is calculated to daylight on the levee slope. Through seepage under HTOL conditions are not part of this evaluation.

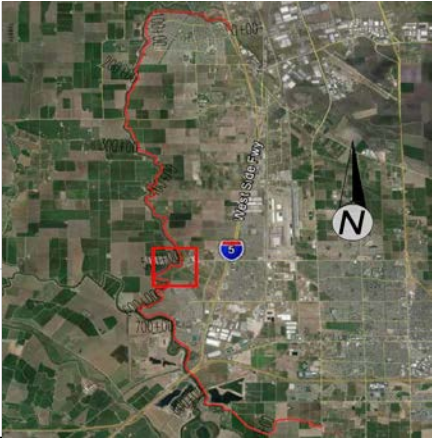
10.34 PROJECT REACH J1B, STATION 516+00

REACH J1B - STA 516+00							
Based on our evaluation, this reach meets the ULDC Criteria.							
Seepage Evaluation Summary				Slope Stability Evaluation Summary			
200-Year DWSEL, Under Seepage:		Meets Criteria		Steady State Seepage 200-Year DWSEL, LS:		Meets Criteria	
200-Year DWSEL, Through Seepage:		Meets Criteria		Steady State Seepage HTOL, LS:		Meets Criteria	
HTOL, Under Seepage:		Meets Criteria		Rapid Drawdown, WS:		Meets Criteria	
				Seismic Slope Stability, WS:		Meets Criteria	
				Seismic Slope Stability, LS:		Meets Criteria	
Reach Description				Reach Overview			
Station Limits: 515+50 to 534+00 Feature(s) at Upstream Station Limit: Landside agricultural land Feature(s) at Downstream Station Limit: Levee access ramp Approx. Crown Elevation Range (feet, NAVD88): 29 to 30 Approx. Levee Height Range (feet): 14.5 to 18.5 Approx. Crown Width Range (feet): 15 to 35 Approx. Landside Slope (H:V) Range: 1.9:1 to 2.5:1 Approx. Waterside Slope (H:V) Range: 1.5:1 to 3.1:1 Waterside Constraint(s): Bench between STA 515+00 to 529+00 Landside Constraint(s): None - agricultural land Landside Repairs associated with PL84-99: None Improvements associated with LSRP P1: Drained seepage berm from STA 151+50 to 534+00 - the reach limits Improvements associated with LSRP P2: None Proposed Improvements associated with LSRP P3: Chimney Drain

Generalized Subsurface Conditions							
Levee Prism Soils: Silty to Clayey SAND and Lean CLAY Landside Surface Layer: Silty SAND, approx. 20 feet thick at levee toe Soils below surface layer: Alternating layers of Lean CLAY and Poorly Graded SAND with Silt							
Historic Performance							
No records of documented seepage, slope stability, or erosion events according to ULE's 2015 GER Volume 1.							
Liquefiable Soils							
Based on our liquefaction assessment, we are not considering liquefiable soils in our slope stability analyses							
Seepage Analysis Results							
Station	Water Surface	Figure	Exit Gradient			Through Seepage	Breakout Height (ft)*
			Levee Toe	Toe of Berm	Field		
516+00	200-Year	E-35-B	No Positive Gradient	0.14	---	No	n/a
	HTOL	E-35-C	No Positive Gradient	0.14	---	n/a	n/a
*Vertical distance from the toe of the levee (ground surface) to where the phreatic surface is calculated to daylight on the levee slope. Through seepage under HTOL conditions are not part of this evaluation.

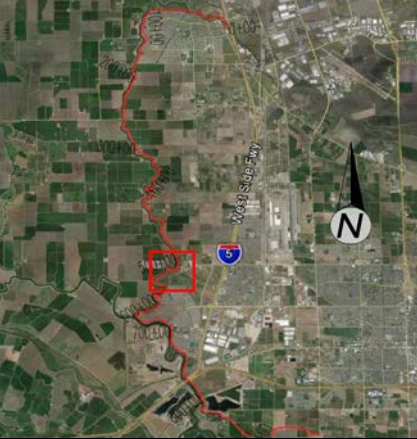
10.35 PROJECT REACH J1B, STATION 528+45

REACH J1B - STA 528+45							
Based on our evaluation, this reach meets the ULDC criteria.							
Seepage Evaluation Summary				Slope Stability Evaluation Summary			
200-Year DWSEL, Under Seepage:		Meets Criteria		Steady State Seepage 200-Year DWSEL, LS:		Meets Criteria	
200-Year DWSEL, Through Seepage:		Meets Criteria		Steady State Seepage HTOL, LS:		Meets Criteria	
HTOL, Under Seepage:		Meets Criteria		Rapid Drawdown, WS:		Meets Criteria	
				Seismic Slope Stability, WS:		Meets Criteria	
				Seismic Slope Stability, LS:		Meets Criteria	
Reach Description				Reach Overview			
Station Limits:		515+50 to 534+00

Feature(s) at Upstream Station Limit: Landside agricultural land							
Feature(s) at Downstream Station Limit: Levee access ramp							
Approx. Crown Elevation Range (feet, NAVD88):		29 to 30					
Approx. Levee Height Range (feet):		14.5 to 18.5					
Approx. Crown Width Range (feet):		15 to 35

Approx. Landside Slope (H:V) Range:		1.9:1 to 2.5:1					
Approx. Waterside Slope (H:V) Range:		1.5:1 to 3.1:1					
Waterside Constraint(s): Bench between STA 515+00 to 529+00							
Landside Constraint(s): None - agricultural land							
Landside Repairs associated with PL84-99: None							
Improvements associated with LSRP P1: Drained seepage berm from STA 151+50 to 534+00 - the reach limits							
Improvements associated with LSRP P2: None							
Proposed Improvements associated with LSRP P3: Chimney Drain							
Generalized Subsurface Conditions							
Levee Prism Soils: Silty to Clayey SAND and Lean CLAY							
Landside Surface Layer: Silty SAND, approx. 20 feet thick at levee toe							
Soils below surface layer: Alternating layers of Lean CLAY and Poorly Graded SAND with Silt							
Historic Performance							
No records of documented seepage, slope stability, or erosion events according to ULE's 2015 GER Volume 1.

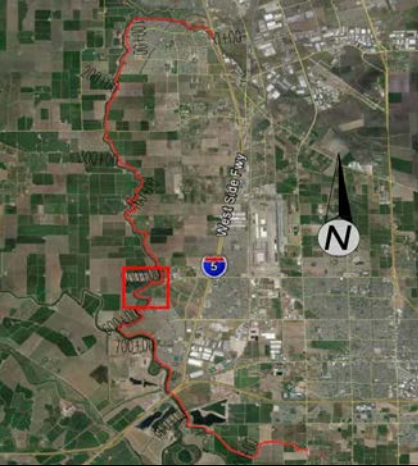
10.36 PROJECT REACH J2, STATION 544+33

REACH J2 - STA 544+33							
Based on our evaluation, this reach meets the ULDC Criteria.							
Seepage Evaluation Summary				Slope Stability Evaluation Summary			
200-Year DWSEL, Under Seepage:	Meets Criteria			Steady State Seepage 200-Year DWSEL, LS:	Meets Criteria		
200-Year DWSEL, Through Seepage:	Meets Criteria			Steady State Seepage HTOL, LS:	Meets Criteria		
HTOL, Under Seepage:	Meets Criteria			Rapid Drawdown, WS:	Meets Criteria		
				Seismic Slope Stability, WS:	Meets Criteria		
				Seismic Slope Stability, LS:	Meets Criteria		
Reach Description				Reach Overview			
Station Limits: 534+00 to 544+50 Feature(s) at Upstream Station Limit: Adjoining Phase 1 LSRP drained seepage berm - Reach J3A Feature(s) at Downstream Station Limit: Adjoining Phase 1 LSRP drained seepage berm - Reach J1B Approx. Crown Elevation Range (feet, NAVD88): 29 to 30 Approx. Levee Height Range (feet): 18 to 19 Approx. Crown Width Range (feet): 16 to 27 Approx. Landside Slope (H:V) Range: 3:1 to 3:1 Approx. Waterside Slope (H:V) Range: 1.5:1 to 3:1 Waterside Constraint(s): Waterside toe of slope at the waterway Landside Constraint(s): Existing seepage berm and agricultural land. Landside repairs associated with PL84-99: None Improvements associated with LSRP P1: Drained Seepage Berm Improvements associated with LSRP P2: None Proposed Improvements associated with LSRP P3: Chimney Drain

Generalized Subsurface Conditions							
Levee Prism Soils: Silty SAND to Clayey SAND Landside Surface Layer: Lean CLAY, approx. 15 feet thick at toe of levee Soils below surface layer: Approx. 30 feet of interlayered Silty SAND, SAND and Silty CLAY, over 30 feet of Lean CLAY							
Historic Performance							
Seepage and landside boils were reported in ULE's 2014 SGDR Addendum.							
Liquefiable Soils							
Based on our liquefaction assessment, we are not considering liquefiable soils in our slope stability analyses.							
Seepage Analysis Results							
Station	Water Surface	Figure	Exit Gradient			Through Seepage	Breakout Height (ft)*
			Levee Toe	Toe of Berm	Field		
544+33	200-Year	E-37-B	0.11	0.45	0.47	No	n/a
	HTOL	E-37-C	0.16	0.50	0.53	n/a	n/a
*Vertical distance from the toe of the levee (ground surface) to where the phreatic surface is calculated to daylight on the levee slope. Through seepage under HTOL conditions are not part of this evaluation.

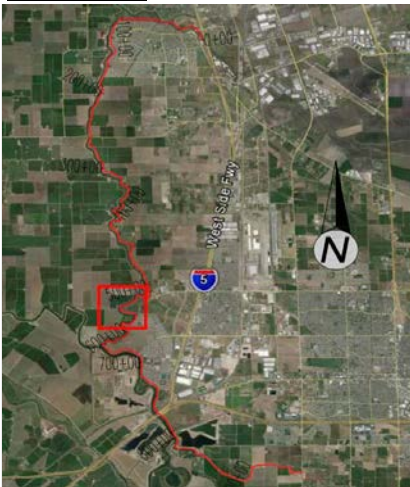
REACH J3B - STA 553+71							
Based on our evaluation, this reach meets the ULDC Criteria.							
<u>Seepage Evaluation Summary</u>				<u>Slope Stability Evaluation Summary</u>			
200-Year DWSEL, Under Seepage:		Meets Criteria		Steady State Seepage 200-Year DWSEL, LS:		Meets Criteria	
200-Year DWSEL, Through Seepage:		Meets Criteria		Steady State Seepage HTOL, LS:		Meets Criteria	
HTOL, Under Seepage:		Meets Criteria		Rapid Drawdown, WS:		Meets Criteria	
				Seismic Slope Stability, WS:		Meets Criteria	
				Seismic Slope Stability, LS:		Meets Criteria	
<u>Reach Description</u>				<u>Reach Overview</u>			
Station Limits: 548+50 to 555+70 Feature(s) at Upstream Station Limit: Northern end Phase 1 LSRP drained seepage berm - Reach J3C Feature(s) at Downstream Station Limit: Southern end Phase 1 LSRP drained seepage berm - Reach J3A Approx. Crown Elevation Range (feet, NAVD88): 29 to 31 Approx. Levee Height Range (feet): 15 to 18 Approx. Crown Width Range (feet): 18 to 20 Approx. Landside Slope (H:V) Range: 3:1 to 3:1 Approx. Waterside Slope (H:V) Range: 1.5:1 to 3:1 Waterside Constraint(s): Waterside toe of slope at the waterway - no waterside bench. Landside Constraint(s): Oak Trees Landside repairs associated with PL84-99: None definitively documented Improvements associated with LSRP P1: None Improvements associated with LSRP P2: None Proposed Improvements associated with LSRP P3: Drained seepage berm with chimney drain

<u>Generalized Subsurface Conditions</u>							
Levee Prism Soils: Sandy SILT to Silty SAND Landside Surface Layer: Silty SAND, approx. 3 feet thick at toe of levee Soils below surface layer: Approx. 15 feet of Silty SAND, over 10 feet of Lean CLAY, over interbedded Silty SAND, SAND and Lean CLAY							
<u>Historic Performance</u>							
Extensive seepage, landside boils and erosion were reported in ULE's 2014 SGDR Addendum.							
<u>Liquefiable Soils</u>							
Based on our liquefaction assessment, we identified potentially liquefiable soils within this Reach (Refer to Appendix E and Appendix F)							
<u>Seepage Analysis Results</u>							
Station	Water Surface	Figure	Exit Gradient**			Through Seepage	Breakout Height (ft)*
			Levee Toe	Toe of Berm	Field		
553+71	200-Year	E-38-B	No Positive Gradient	0.46	---	No	n/a
	HTOL	E-38-C	No Positive Gradient	0.50	---	n/a	n/a
*Vertical distance from the toe of the levee (ground surface) to where the phreatic surface is calculated to daylight on the levee slope. Through seepage under HTOL conditions are not part of this evaluation. **Exit Gradient includes 3D effects

<u>Slope Stability Analysis Results</u>							
Station	Case Analyzed	Water Surface (ft)	Figure	Factor of Safety (Circular)		Factor of Safety (Non-Circular)	
				Waterside	Landside	Waterside	Landside
553+71	SS - 200yr	24.5	E-38-D	---	2.1	n/a	n/a
	SS - HTOL	26.0	E-38-E	---	2.1	n/a	n/a
	RDD	15.5	E-38-D	1.6	---	n/a	n/a
	PS	5.3	E-38-F	1.1	1.5	n/a	n/a
	Post-EQ	5.3	E-38-G/H	1.3	1.9	1.3	3.0

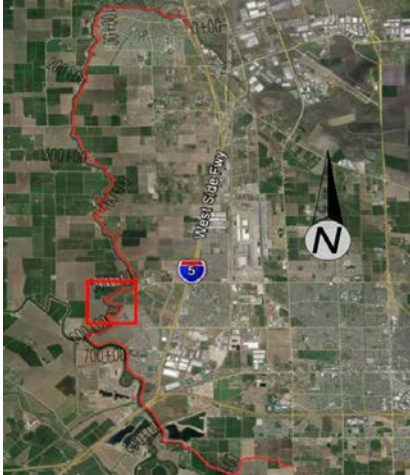
REACH J3C - STA 564+00							
Based on our evaluation, this reach meets the ULDC Criteria.							
Seepage Evaluation Summary				Slope Stability Evaluation Summary			
200-Year DWSEL, Under Seepage:		Meets Criteria		Steady State Seepage 200-Year DWSEL, LS:		Meets Criteria	
200-Year DWSEL, Through Seepage:		Meets Criteria		Steady State Seepage HTOL, LS:		Meets Criteria	
HTOL, Under Seepage:		Meets Criteria		Rapid Drawdown, WS:		Meets Criteria	
				Seismic Slope Stability, WS:		Meets Criteria	
				Seismic Slope Stability, LS:		Meets Criteria	
Reach Description				Reach Overview			
Station Limits: 555+70 to 569+50 Feature(s) at Upstream Station Limit: Southern end of Phase 1 LSRP drained seepage berm (at oak trees) Feature(s) at Downstream Station Limit: Northern end of Phase 1 LSRP drained seepage berm (at oak trees) Approx. Crown Elevation Range (feet, NAVD88): 29 to 30 Approx. Levee Height Range (feet): 18 to 19 Approx. Crown Width Range (feet): 16 to 27 Approx. Landside Slope (H:V) Range: 3:1 to 3:1 Approx. Waterside Slope (H:V) Range: 1.5:1 to 3:1 Waterside Constraint(s): Waterside bench from STA 565+00 to 569+50 Landside Constraint(s): None - agricultural land Landside repairs associated with PL84-99: Yes, berm constructed from STA 555+70 to 564+00 Improvements associated with LSRP P1: Drained Seepage Berm Improvements associated with LSRP P2: None Proposed Improvements associated with LSRP P3: Chimney Drain

Generalized Subsurface Conditions							
Levee Prism Soils: Clayey SILT to SAND Landside Surface Layer: Silty SAND, approx. 2 feet thick at toe of levee Soils below surface layer: Approx. 21 feet of Lean CLAY, over interbedded layers of Silty SAND, Lean CLAY and SAND							
Historic Performance							
Extensive seepage and landside boils were reported in ULE's 2014 SGDR Addendum. An approximate 400 foot wide levee breach was reported between STA 560+00 to 564+00 associated with the 1950 flood event. Waterside erosion was reported at two locations during the 1997 event.							
Liquefiable Soils							
Based on our liquefaction assessment, we are not considering liquefiable soils in our slope stability analyses.							
Seepage Analysis Results							
Station	Water Surface	Figure	Exit Gradient**			Through Seepage	Breakout Height (ft)*
			Levee Toe	Toe of Berm	Field		
564+00	200-Year	E-40-B	No Positive Gradient	0.32	---	No	n/a

HTOL	E-40-C	No Positive Gradient	0.36	---	n/a	n/a
*Vertical distance from the toe of the levee (ground surface) to where the phreatic surface is calculated to day light on the levee slope. Through seepage under HTOL conditions are not part of this evaluation. **Exit Gradient includes 3D effects							
Slope Stability Analysis Results							
Station	Case Analyzed	Water Surface (ft)	Figure	Factor of Safety (Circular)		Factor of Safety (Non-Circular)	
				Waterside	Landside	Waterside	Landside
564+00	SS - 200yr	24.7	E-40-D	---	2.1	n/a	n/a
	SS - HTOL	26.2	E-40-E	---	2.1	n/a	n/a
	RDD	15.6	E-40-D	1.5	---	n/a	n/a
	PS	5.3	E-40-F	1.3	1.6	n/a	n/a
	Post-EQ	n/a	n/a	n/a	n/a	n/a	n/a

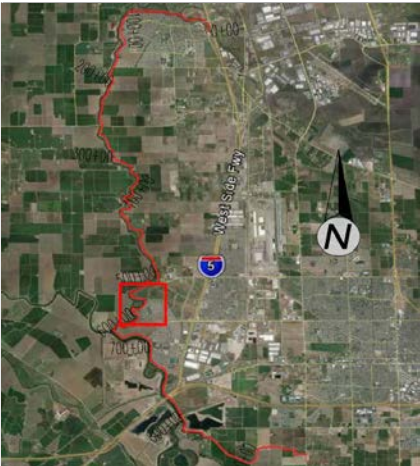
REACH J4B - STA 579+70							
Based on our evaluation, this reach meets the ULDC Criteria.							
Seepage Evaluation Summary				Slope Stability Evaluation Summary			
200-Year DWSEL, Under Seepage:		Meets Criteria		Steady State Seepage 200-Year DWSEL, LS:		Meets Criteria	
200-Year DWSEL, Through Seepage:		Meets Criteria		Steady State Seepage HTOL, LS:		Meets Criteria	
HTOL, Under Seepage:		Meets Criteria		Rapid Drawdown, WS:		Meets Criteria	
				Seismic Slope Stability, WS:		Meets Criteria	
				Seismic Slope Stability, LS:		Meets Criteria	
Reach Description				Reach Overview			
Station Limits: 574+50 to 585+50 Feature(s) at Upstream Station Limit: Landside park/begin waterside bench Feature(s) at Downstream Station Limit: Levee access ramp, Begin north end of Phase II landside berm/trench for J4B Approx. Crown Elevation Range (feet, NAVD88): 30 to 30.5 Approx. Levee Height Range (feet): 17 to 22 Approx. Crown Width Range (feet): 26 to 32 Approx. Landside Slope (H:V) Range: 2.1:1 to 3:1 Approx. Waterside Slope (H:V) Range: 1.8:1 to 2.8:1 Waterside Constraint(s): None Landside Constraint(s): Lathrop Road and residential improvements Landside repairs associated with PL84-99: None Improvements associated with LSRP P1: None Improvements associated with LSRP P2: Drainage trench, drained seepage berm, Proposed Improvements associated with LSRP P3: None

Generalized Subsurface Conditions							
Levee Prism Soils: SILT to Silty SAND Landside Surface Layer: Lean CLAY and SILT, approx. 15 feet thick at toe of seepage berm Soils below surface layer: Interbedded layers of Silty SAND and Lean CLAY							
Historic Performance							
No events were reported in ULE's 2014 SGDR Addendum.							
Liquefiable Soils							
Based on our liquefaction assessment, we are not considering liquefiable soils in our slope stability analyses							
Seepage Analysis Results							
Station	Water Surface	Figure	Exit Gradient			Through Seepage	Breakout Height (ft)*
			Levee Toe	Toe of Berm	Field		
579+70	200-Year	E-42-B	No Positive Gradient	0.30	---	No	n/a
	HTOL	E-42-C	No Positive Gradient	0.34	---	n/a	n/a
*Vertical distance from the toe of the levee (ground surface) to where the phreatic surface is calculated to daylight on the levee slope. Through seepage under HTOL conditions are not part of this evaluation.

Slope Stability Analysis Results							
Station	Case Analyzed	Water Surface	Figure	Factor of Safety (Circular)		Factor of Safety (Non-Circular)	
				Waterside	Landside	Waterside	Landside
579+70	SS - 200yr	25.0	E-42-D	---	2.2	n/a	n/a
	SS - HTOL	26.6	E-42-E	---	2.1	n/a	n/a
	RDD	15.9	E-42-D	1.7	---	n/a	n/a
	PS	5.3	E-42-F	1.2	1.5	n/a	n/a
	Post-EQ	n/a	n/a	n/a	n/a	n/a	n/a

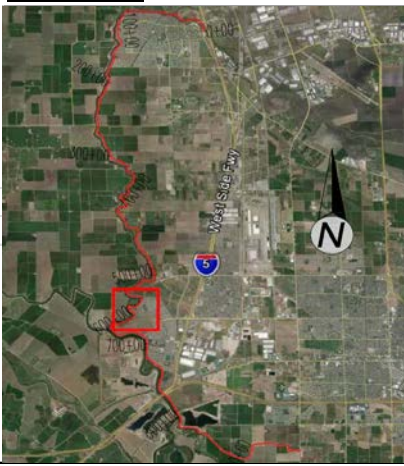
Reach K - STA 017+00 {600+00}							
Based on our evaluation, this reach meets the ULDC Criteria.							
Seepage Evaluation Summary				Slope Stability Evaluation Summary			
200-Year DWSEL, Under Seepage:		Meets Criteria		Steady State Seepage 200-Year DWSEL, LS:		Meets Criteria	
200-Year DWSEL, Through Seepage:		Meets Criteria		Steady State Seepage HTOL, LS:		Meets Criteria	
HTOL, Under Seepage:		Meets Criteria		Rapid Drawdown, WS:		Meets Criteria	
				Siesmic Slope Stability, WS:		Meets Criteria	
				Seismic Slope Stability, LS:		Meets Criteria	
Reach Description				Reach Overview			
Station Limits: 585+50 to 608+00 Feature(s) at Upstream Station Limit: Approx. 400 ft west of Old Wharf Court Feature(s) at Downstream Station Limit: Seepage berm, drainage trench, and chimney drain, Approx. 200 ft northwest Approx. Crown Elevation Range (feet, NAVD88): 30 to 30.5 Approx. Levee Height Range (feet): 16 to 18 Approx. Crown Width Range (feet): 20 to 20 Approx. Landside Slope (H:V) Range: 3:1 to 3:1 Approx. Waterside Slope (H:V) Range: 3:1 to 3:1 Waterside Constraint(s): Agricultural land between existing levee and setback levee Landside Constraint(s): None - agricultural land. Landside repairs associated with PL84-99: Drained seepage berm from STA 591+00 Improvements associated with LSRP P1: None Improvements associated with LSRP P2: None Proposed Improvements associated with LSRP P3: Setback levee with cutoff wall

Generalized Subsurface Conditions							
Levee Prism Soils: Engineered Levee Fill Landside Surface Layer: Lean CLAY at setback levee toe, approx. 2 feet thick Soils below surface layer: Clayey SAND over Lean CLAY and Poorly Graded SAND with SILT							
Historic Performance							
Heavy seepage and landside boils adjacent to existing levee during 1997 flood event were reported in ULE's 2014 SGDR Addendum.							
Liquefiable Soils							
Based on our liquefaction assessment, we are not considering liquefiable soils in our slope stability analyses.							
Seepage Analysis Results							
Station	Water Surface	Figure	Exit Gradient			Through Seepage	Breakout Height (ft)*
			Levee Toe	Toe of Berm	Field		
017+00	200-Year	E-43-B	0.30	---	---	Yes**	1.5
600+00	HTOL	E-43-C	0.35	---	---	n/a	n/a
*Vertical distance from the toe of the levee (ground surface) to where the phreatic surface is calculated to daylight on the levee slope. Through seepage under HTOL conditions are not part of this evaluation. **Exits onto engineered fine grained setback levee fill slope, therefore we report "meets criteria" for through seepage.

Slope Stability Analysis Results							
Station	Case Analyzed	Water Surface (ft)	Figure	Factor of Safety (Circular)		Factor of Safety (Non-Circular)	
				Waterside	Landside	Waterside	Landside
017+00 {	SS - 200yr	25.1	E-43-D	---	1.8	n/a	n/a
	SS - HTOL	26.7	E-43-E	---	1.7	n/a	n/a
	RDD	15.9	E-43-D	2.1	---	n/a	n/a
	PS	5.3	E-43-F	1.8	1.8	n/a	n/a
	Post-EQ	n/a	n/a	n/a	n/a	n/a	n/a

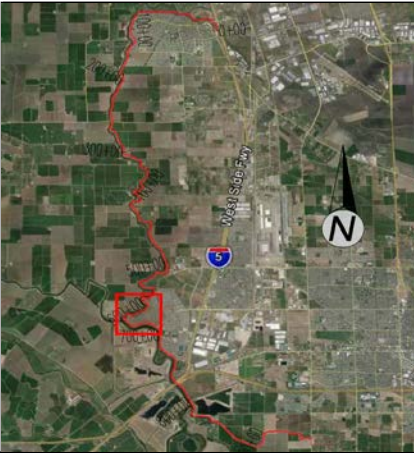
REACH L1 - STA 620+00							
Based on our evaluation, this reach meets the ULDC Criteria.							
Seepage Evaluation Summary				Slope Stability Evaluation Summary			
200-Year DWSEL, Under Seepage:		Meets Criteria		Steady State Seepage 200-Year DWSEL, LS:		Meets Criteria	
200-Year DWSEL, Through Seepage:		Meets Criteria		Steady State Seepage HTOL, LS:		Meets Criteria	
HTOL, Under Seepage:		Meets Criteria		Rapid Drawdown, WS:		Meets Criteria	
				Seismic Slope Stability, WS:		Meets Criteria	
				Seismic Slope Stability, LS:		Meets Criteria	
Reach Description				Reach Overview			
Station Limits: 608+00 to 655+00 Feature(s) at Upstream Station Limit: Agricultural land Feature(s) at Downstream Station Limit: Transition to setback levee (Reach K) Approx. Crown Elevation Range (feet, NAVD88): 30 to 31.5 Approx. Levee Height Range (feet): 15.5 to 24.5 Approx. Crown Width Range (feet): 14 to 67 Approx. Landside Slope (H:V) Range: 1.9:1 to 3.6:1 Approx. Waterside Slope (H:V) Range: 1.2:1 to 5:1 Waterside Constraint(s): Waterside bench from approximately STA 625+00 to 636+00 Landside Constraint(s): None - agricultural land Landside repairs associated with PL84-99: Yes. Berms at STA 610+50 to 619+50 and 640+00 to 650+00. Improvements associated with LSRP P1: None Improvements associated with LSRP P2: None Proposed Improvements associated with LSRP P3: Cutoff Wall

Generalized Subsurface Conditions							
Levee Prism Soils: 15 to 20 feet of Silty SAND, Lean Clay and Sandy SILT Landside Surface Layer: Lean CLAY to Clayey SILT, approx. 6-12 feet thick at toe of levee Soils below surface layer: Approx. 35-40 feet of SAND to Silty Sand (w/occasional clay lenses), over Lean CLAY							
Historic Performance							
Extensive seepage and landside boils (1986 & 1997), a waterside slide (1997 - STA 646+00) and waterside scour (1997, 2006) were reported in ULE's 2014 SGDR Addendum.							
Liquefiable Soils							
Based on our liquefaction assessment, we are not considering liquefiable soils in our slope stability analysis in the vicinity of 620+00. Refer to the							
Seepage Analysis Results							
Station	Water Surface	Figure	Exit Gradient			Through Seepage	Breakout Height (ft)*
			Levee Toe	Toe of Berm	Field		
620+00	200-Year	E-45-B	No Positive Gradient	---	0.22	No	n/a

HTOL	E-45-C	No Positive Gradient	---	0.24	n/a	n/a
*Vertical distance from the toe of the levee (ground surface) to where the phreatic surface is calculated to daylight on the levee slope. Through seepage under HTOL conditions are not part of this evaluation.							
Slope Stability Analysis Results							
Station	Case Analyzed	Water Surface	Figure	Factor of Safety (Circular)		Factor of Safety (Non-Circular)	
				Waterside	Landside	Waterside	Landside
620+00	SS - 200yr	25.4	E-45-D/E	---	1.7	---	2.0
	SS - HTOL	27.2	E-45-F	---	1.6	---	2.0
	RDD	16.1	E-45-D/E	1.2	---	1.3	---
	PS	5.3	E-45-G/H	1.1	1.3	1.1	1.5
	Post-EQ	n/a	n/a	n/a	n/a	n/a	n/a

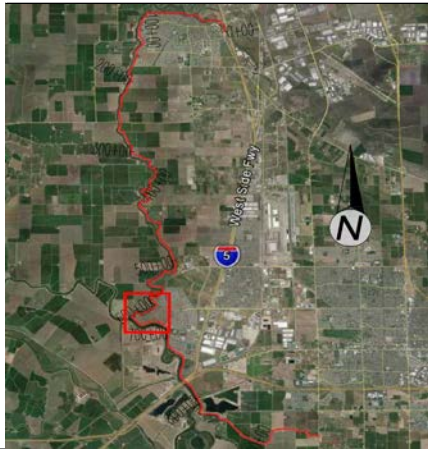
REACH L1 - STA 644+00							
Based on our evaluation, this reach meets the ULDC Criteria.							
Seepage Evaluation Summary				Slope Stability Evaluation Summary			
200-Year DWSEL, Under Seepage:		Meets Criteria		Steady State Seepage 200-Year DWSEL, LS:		Meets Criteria	
200-Year DWSEL, Through Seepage:		Meets Criteria		Steady State Seepage HTOL, LS:		Meets Criteria	
HTOL, Under Seepage:		Meets Criteria		Rapid Drawdown, WS:		Meets Criteria	
				Seismic Slope Stability, WS:		Meets Criteria	
				Seismic Slope Stability, LS:		Meets Criteria	
Reach Description				Reach Overview			
Station Limits: 608+00 to 655+00 Feature(s) at Upstream Station Limit: Agricultural land Feature(s) at Downstream Station Limit: Transition to setback levee (Reach K) Approx. Crown Elevation Range (feet, NAVD88): 30 to 31.5 Approx. Levee Height Range (feet): 15.5 to 24.5 Approx. Crown Width Range (feet): 14 to 67 Approx. Landside Slope (H:V) Range: 1.9:1 to 3.6:1 Approx. Waterside Slope (H:V) Range: 1.2:1 to 5:1 Waterside Constraint(s): Waterside bench from approximately STA 625+00 to 636+00 Landside Constraint(s): None - agricultural land Landside repairs associated with PL84-99: Yes. Berms at STA 610+50 to 619+50 and 640+00 to 650+00. Improvements associated with LSRP P1: None Improvements associated with LSRP P2: None Proposed Improvements associated with LSRP P3: Cutoff Wall

Generalized Subsurface Conditions							
Levee Prism Soils: 15 to 20 feet of Silty SAND, Lean Clay and Sandy SILT Landside Surface Layer: Lean CLAY to Clayey SILT, approx. 6-12 feet thick at toe of levee Soils below surface layer: Approx. 35-40 feet of SAND to Silty Sand (w/occasional clay lenses), over Lean CLAY							
Historic Performance							
Extensive seepage and landside boils (1986 & 1997), a waterside slide (1997 - STA 646+00) and waterside scour (1997, 2006) were reported in ULE's 2014 SGDR Addendum.							
Liquefiable Soils							
Based on our liquefaction assessment, we identified potentially liquefiable soils within this Reach (Refer to Appendix E and Appendix F)							
Seepage Analysis Results							
Station	Water Surface	Figure	Exit Gradient			Through Seepage	Breakout Height (ft)*
			Levee Toe	Toe of Berm	Field		
644+00	200-Year	E-47-B	No Positive Gradient	---	0.01	No	n/a
	HTOL	E-47-C	No Positive Gradient	---	0.02	n/a	n/a

*Vertical distance from the toe of the levee (ground surface) to where the phreatic surface is calculated to daylight on the levee slope. Through seepage under HTOL conditions are not part of this evaluation.							
Slope Stability Analysis Results							
Station	Case Analyzed	Water Surface	Figure	Factor of Safety (Circular)		Factor of Safety (Non-Circular)	
				Waterside	Landside	Waterside	Landside
644+00	SS - 200yr	25.8	E-47-D/E	---	3.1	---	3.4
	SS - HTOL	27.6	E-47-F	---	3.1	---	3.3
	RDD	16.3	E-47-D/E	2.7	---	2.4	---
	PS	5.3	E-47-G/H	1.6	2.1	1.7	2.4
	Post-EQ	5.3	E-47-I/J	1.8	3.1	1.7	5.3

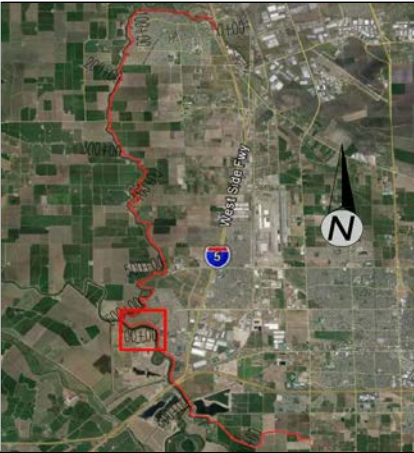
REACH L2 - STA 684+50							
Based on our evaluation, this reach meets the ULDC Criteria.							
Seepage Evaluation Summary				Slope Stability Evaluation Summary			
200-Year DWSEL, Under Seepage:		Meets Criteria		Steady State Seepage 200-Year DWSEL, LS:		Meets Criteria	
200-Year DWSEL, Through Seepage:		Meets Criteria		Steady State Seepage HTOL, LS:		Meets Criteria	
HTOL, Under Seepage:		Meets Criteria		Rapid Drawdown, WS:		Meets Criteria	
				Seismic Slope Stability, WS:		Meets Criteria	
				Seismic Slope Stability, LS:		Meets Criteria	
Reach Description				Reach Overview			
Station Limits: 655+00 to 703+00 Feature(s) at Upstream Station Limit: Transition to Phase II Seepage Berm Feature(s) at Downstream Station Limit: Agricultural land Approx. Crown Elevation Range (feet, NAVD88): 31 to 32 Approx. Levee Height Range (feet): 13 to 19 Approx. Crown Width Range (feet): 13 to 35 Approx. Landside Slope (H:V) Range: 2:1 to 3:1 Approx. Waterside Slope (H:V) Range: 1.5:1 to 3.2:1 Waterside Constraint(s): River Islands Parkway Bridge (Approx. STA 689+00) Landside Constraint(s): Landside improvements (residential, approach fills, etc.) between approx STA Waterside repairs associated with PL84-99: Riprap waterside (2006) Improvements associated with LSRP P1: None Improvements associated with LSRP P2: None Proposed Improvements associated with LSRP P3: Cutoff Wall

Generalized Subsurface Conditions Levee Prism Soils: Silty SAND to SAND Landside Surface Layer: Lean CLAY, approx. 5 to 10 feet thick at toe of levee Soils below surface layer: Approx. 15 to 20 feet of Silty SAND, over 25 to 30 feet of Poorly Graded SAND							
Historic Performance Seepage and landside boils (STA 668+00 to 669+00) during 1997 flood event and waterside erosion (STA 699+71 to 700+51) during 2006 flood event were reported in ULE's 2014 SGDR Addendum.							
Liquefiable Soils Based on our liquefaction assessment, we identified potentially liquefiable soils within this Reach (Refer to Appendix E and Appendix F)							
Seepage Analysis Results							
Station	Water Surface	Figure	Exit Gradient			Through Seepage	Breakout Height (ft)*
			Levee Toe	Toe of Berm	Field		
684+50	200-Year	E-50-B	No Positive Gradient	---	0.59	No	n/a
	HTOL	E-50-C	No Positive Gradient	---	0.62	n/a	n/a
*Vertical distance from the toe of the levee (ground surface) to where the phreatic surface is calculated to daylight on the levee slope. Through seepage under HTOL conditions are not part of this evaluation.

Slope Stability Analysis Results							
Station	Case Analyzed	Water Surface	Figure	Factor of Safety (Circular)		Factor of Safety (Non-Circular)	
				Waterside	Landside	Waterside	Landside
684+50	SS - 200yr	26.4	E-50-D/E	---	1.9	---	2.2
	SS - HTOL	28.5	E-50-F	---	1.9	---	2.2
	RDD	16.6	E-50-D/E	2.3	---	2.4	---
	PS	5.4	E-50-G/H	1.7	1.5	1.8	1.6
	Post-EQ	5.4	E-50 - I/J	2.2	2.0	2.0	3.7

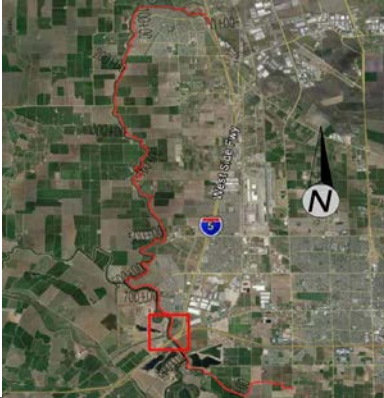
10.56 PROJECT REACH M3A, STATION 761+00

REACH M3A - STA 761+00							
Based on our evaluation, this reach meets the ULDC Criteria. An Operations and Maintenance plan should be implemented for seismic deformations following the 200-year event.							
Seepage Evaluation Summary				Slope Stability Evaluation Summary			
200-Year DWSEL, Under Seepage:		Meets Criteria		Steady State Seepage 200-Year DWSEL, LS:		Meets Criteria	
200-Year DWSEL, Through Seepage:		Meets Criteria		Steady State Seepage HTOL, LS:		Meets Criteria	
HTOL, Under Seepage:		Meets Criteria		Rapid Drawdown, WS:		Meets Criteria	
				Seismic Slope Stability, WS:		Fails Criteria	
				Seismic Slope Stability, LS:		Meets Criteria	
Reach Description				Reach Overview			
Station Limits: 760+50 to 763+00 Feature(s) at Upstream Station Limit: Railroad bridge approach fill Feature(s) at Downstream Station Limit: End of Phase 1 drained seepage berm Approx. Crown Elevation Range (feet, NAVD88): 32 to 33 Approx. Levee Height Range (feet): 13 to 14 Approx. Crown Width Range (feet): 20 to 30 Approx. Landside Slope (H:V) Range: 2.5:1 to 3:1 Approx. Waterside Slope (H:V) Range: 3:1 to 3.5:1 Waterside Constraint(s): Waterside toe of slope at the waterway - no waterside bench. Railroad bridge Landside Constraint(s): None - agricultural land Landside repairs associated with PL84-99: None Improvements associated with LSRP P1: None Improvements associated with LSRP P2: None Proposed Improvements associated with LSRP P3: Cutoff wall

Generalized Subsurface Conditions Levee Prism Soils: Poorly graded SAND to Silty SAND Landside Surface Layer: Lean CLAY, approx. 7 feet thick at toe of levee Soils below surface layer: Approx. 45 feet of SAND, over 30 feet of Lean CLAY							
Historic Performance Seepage and landside boils (STA 762+00 to 764+00) during 1997 flood event were reported in ULE's 2014 SGDR Addendum.							
Liquefiable Soils Based on our liquefaction assessment, we identified potentially liquefiable soils within this Reach (Refer to Appendix E and Appendix F)							
Seepage Analysis Results							
Station	Water Surface	Figure	Exit Gradient			Through Seepage	Breakout Height (ft)*
			Levee Toe	Toe of Berm	Field		
761+00	200-Year	E-56-B	No Positive Gradient	---	0.12	No	n/a
	HTOL	E-56-C	No Positive Gradient	---	0.14	n/a	n/a
*Vertical distance from the toe of the levee (ground surface) to where the phreatic surface is calculated to daylight on the levee slope. Through seepage under HTOL conditions are not part of this evaluation.

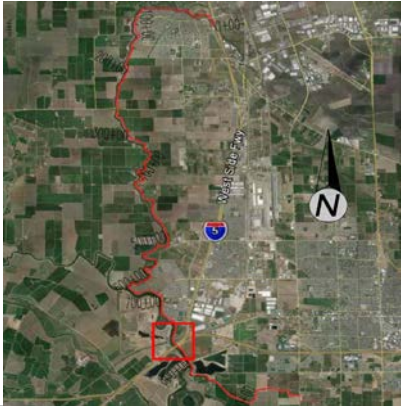
10.57 PROJECT REACH M3B, STATION 764+13

REACH M3B - STA 764+13							
Based on our evaluation, this reach meets the ULDC criteria. Seismic deformations are not anticipated to degrade below 10-Year WSE + 3 feet.							
Seepage Evaluation Summary				Slope Stability Evaluation Summary			
200-Year DWSEL, Under Seepage:	Meets Criteria			Steady State Seepage 200-Year DWSEL, LS:	Meets Criteria		
200-Year DWSEL, Through Seepage:	Meets Criteria			Steady State Seepage HTOL, LS:	Meets Criteria		
HTOL, Under Seepage:	Meets Criteria			Rapid Drawdown, WS:	Meets Criteria		
				Seismic Slope Stability, WS:	Fails Criteria		
				Seismic Slope Stability, LS:	Meets Criteria		
Reach Description				Reach Overview			
Station Limits: 763+00 to 768+00 Feature(s) at Upstream Station Limit: Manthey Road, I-5 approach fill/crossing Feature(s) at Downstream Station Limit: Railroad bridge approach fill Approx. Crown Elevation Range (feet, NAVD88): 32 to 33 Approx. Levee Height Range (feet): 12 to 17 Approx. Crown Width Range (feet): 20 to 33 Approx. Landside Slope (H:V) Range: 2:1 to 3:1 Approx. Waterside Slope (H:V) Range: 2:1 to 3:1 Waterside Constraint(s): Boat launch ramp, railroad bridge Landside Constraint(s): Mossdale County Park improvements Landside repairs associated with PL84-99: None Improvements associated with LSRP P1: None Improvements associated with LSRP P2: None Proposed Improvements associated with LSRP P3: Cutoff Wall/Drained Berm at RR Tracks

Generalized Subsurface Conditions							
Levee Prism Soils: Silty SAND to SAND Landside Surface Layer: Lean CLAY to Clayey SILT, approx. 3 to 13 feet thick at toe of levee Soils below surface layer: Approx. 40 to 50 feet of Silty SAND to SAND, over Lean CLAY							
Historic Performance							
Seepage and landside boils during 1997 flood event were reported in ULE's 2014 SGDR Addendum.							
Liquefiable Soils							
Based on our liquefaction assessment, we identified potentially liquefiable soils within this Reach (Refer to Appendix E and Appendix F)							
Seepage Analysis Results							
Station	Water Surface	Figure	Exit Gradient			Through Seepage	Breakout Height (ft)*
			Levee Toe	Toe of Berm	Field		
764+13	200-Year	E-57-B	No Positive Gradient	---	0.49	No	n/a
	HTOL	E-56-C	No Positive Gradient	---	0.52	n/a	n/a
*Vertical distance from the toe of the levee (ground surface) to where the phreatic surface is calculated to daylight on the levee slope. Through seepage under HTOL conditions are not part of this evaluation.

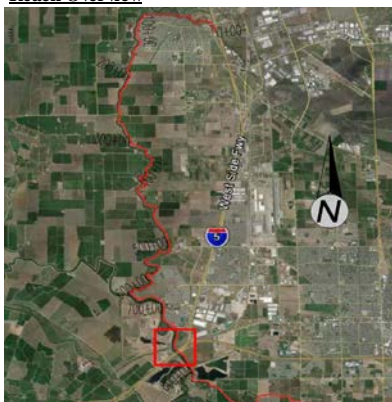
10.58 PROJECT REACH M3B, STATION 767+00

REACH M3B - STA 767+00							
Based on our evaluation, this reach meets the ULDC criteria. Seismic deformations are not anticipated to degrade below 10-Year WSE + 3 feet.							
Seepage Evaluation Summary				Slope Stability Evaluation Summary			
200-Year DWSEL, Under Seepage:		Meets Criteria		Steady State Seepage 200-Year DWSEL, LS:		Meets Criteria	
200-Year DWSEL, Through Seepage:		Meets Criteria		Steady State Seepage HTOL, LS:		Meets Criteria	
HTOL, Under Seepage:		Meets Criteria		Rapid Drawdown, WS:		Meets Criteria	
				Seismic Slope Stability, WS:		Fails Criteria	
				Seismic Slope Stability, LS:		Meets Criteria	
Reach Description				Reach Overview			
Station Limits: 763+00 to 768+00 Feature(s) at Upstream Station Limit: Manthey Road, I-5 approach fill/crossing Feature(s) at Downstream Station Limit: Railroad bridge approach fill Approx. Crown Elevation Range (feet, NAVD88): 32 to 33 Approx. Levee Height Range (feet): 12 to 17 Approx. Crown Width Range (feet): 20 to 33 Approx. Landside Slope (H:V) Range: 2:1 to 3:1 Approx. Waterside Slope (H:V) Range: 2:1 to 3:1 Waterside Constraint(s): Boat launch ramp, railroad bridge Landside Constraint(s): Mossdale County Park improvements Landside repairs associated with PL84-99: None Improvements associated with LSRP P1: None Improvements associated with LSRP P2: None Proposed Improvements associated with LSRP P3: Cutoff Wall/Drained Berm at RR Tracks

Generalized Subsurface Conditions							
Levee Prism Soils: Silty SAND to SAND Landside Surface Layer: Lean CLAY to Clayey SILT, approx. 3 to 13 feet thick at toe of levee Soils below surface layer: Approx. 40 to 50-feet of Silty SAND to SAND, over Lean CLAY							
Historic Performance							
Seepage and landside boils during 1997 flood event were reported in ULE's 2014 SGDR Addendum.							
Liquefiable Soils							
Based on our liquefaction assessment, we identified potentially liquefiable soils within this Reach (Refer to Appendix E and Appendix F)							
Seepage Analysis Results							
Station	Water Surface	Figure	Exit Gradient			Through Seepage	Breakout Height (ft)*
			Levee Toe	Toe of Berm	Field		
767+00	200-Year	E-58-B	No Positive Gradient	---	---	No	n/a
	HTOL	E-58-C	No Positive Gradient	---	---	n/a	n/a
*Vertical distance from the toe of the levee (ground surface) to where the phreatic surface is calculated to daylight on the levee slope. Through seepage under HTOL conditions are not part of this evaluation.

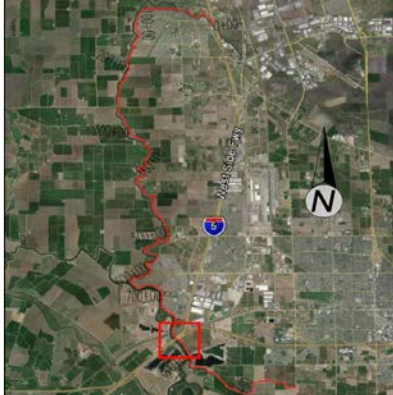
10.60 PROJECT REACH M4, STATION 795+87

REACH M4 - STA 795+87							
Based on our evaluation, this reach meets the ULDC Criteria. Seismic deformations are not anticipated to degrade below 10-Year WSE+ 3 feet.							
Seepage Evaluation Summary				Slope Stability Evaluation Summary			
200-Year DWSEL, Under Seepage:	Meets Criteria			Steady State Seepage 200-Year DWSEL, LS:	Meets Criteria		
200-Year DWSEL, Through Seepage:	Meets Criteria			Steady State Seepage HTOL, LS:	Meets Criteria		
HTOL, Under Seepage:	Meets Criteria			Rapid Drawdown, WS:	Meets Criteria		
				Seismic Slope Stability, WS:	Fails Criteria		
				Seismic Slope Stability, LS:	Meets Criteria		
Reach Description				Reach Overview			
Station Limits: 781+00 to 799+50 Feature(s) at Upstream Station Limit: Railroad alignment/approach Feature(s) at Downstream Station Limit: Phase II Berm, agricultural land Approx. Crown Elevation Range (feet, NAVD88): 33 to 34 Approx. Levee Height Range (feet): 13 to 18 Approx. Crown Width Range (feet): 30 to 44 Approx. Landside Slope (H:V) Range: 3:1 to 3:1 Approx. Waterside Slope (H:V) Range: 2.5:1 to 3.3:1 Waterside Constraint(s): Waterside toe of slope at the waterway - no waterside bench. Landside Constraint(s): High tension power lines and ag land Landside repairs associated with PL84-99: Gravel berm at STA 788+00 to 799+50 Improvements associated with LSRP P1: None Improvements associated with LSRP P2: Drained Seepage Berm Proposed Improvements associated with LSRP P3: None

Generalized Subsurface Conditions							
Levee Prism Soils: Silty SAND and Lean CLAY							
Landside Surface Layer: Lean CLAY, approx. 15 feet thick at toe of levee							
Soils below surface layer: Approx. 40 feet of Silty SAND and SAND, over 10 feet of lean CLAY							
Historic Performance							
Seepage and landside boils were reported during the 1997 high-water event and minor wave wash erosion on waterside slope between Station 790+00 to 799+00 during 1998 high-water event in ULE's 2014 SGDR Addendum.							
Liquefiable Soils							
Based on our liquefaction assessment, we identified potentially liquefiable soils within this Reach (Refer to Appendix E and Appendix F)							
Seepage Analysis Results							
Station	Water Surface	Figure	Exit Gradient			Through Seepage	Breakout Height (ft)*
			Levee Toe	Toe of Berm	Field		
795+87	200-Year	E-60-B	0.03	0.58	---	No	n/a
	HTOL	E-60-C	0.13	0.71	---	n/a	n/a

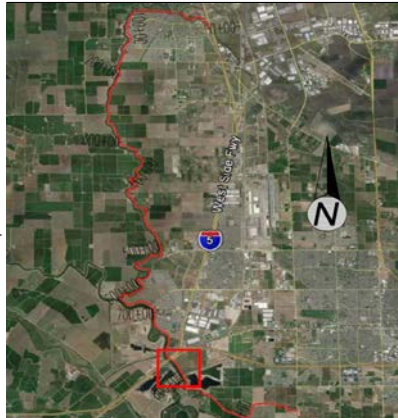
10.61 PROJECT REACH N1, STATION 804+50

REACH N1 - STA 804+50							
Based on our evaluation, this reach meets the ULDC Criteria.							
Seepage Evaluation Summary				Slope Stability Evaluation Summary			
200-Year DWSEL, Under Seepage:		Meets Criteria		Steady State Seepage 200-Year DWSEL, LS:		Meets Criteria	
200-Year DWSEL, Through Seepage:		Meets Criteria		Steady State Seepage HTOL, LS:		Meets Criteria	
HTOL, Under Seepage:		Meets Criteria		Rapid Drawdown, WS:		Meets Criteria	
				Seismic Slope Stability, WS:		Meets Criteria	
				Seismic Slope Stability, LS:		Meets Criteria	
Reach Description				Reach Overview			
Station Limits: 799+50 to 806+00 Feature(s) at Upstream Station Limit: LSRP Phase 3 Cutoff Wall Feature(s) at Downstream Station Limit: RR-Xing Approx. Crown Elevation Range (feet, NAVD88): 34 to 35 Approx. Levee Height Range (feet): 9 to 12 Approx. Crown Width Range (feet): 50 to 50 Approx. Landside Slope (H:V) Range: 3:1 to 5:1 Approx. Waterside Slope (H:V) Range: 1.5:1 to 2:1 Waterside Constraint(s): Waterside toe of slope at the waterway - no waterside bench. Landside Constraint(s): Pond, RR X-ing Landside repairs associated with PL84-99: Gravel berm at STA 799+50 to 806+00 (excluding RR X-ing) Improvements associated with LSRP P1: None Improvements associated with LSRP P2: None Proposed Improvements associated with LSRP P3: None

Generalized Subsurface Conditions							
Levee Prism Soils: Silty SAND Landside Surface Layer: Lean CLAY, approx. 5 to 15 feet thick near toe of levee Soils below surface layer: Approx. 20 feet of lean CLAY, over 60 feet of Poorly Graded SAND							
Historic Performance							
Seepage and landside boils (sandbag rings) were reported in ULE's 2014 SGDR Addendum.							
Liquefiable Soils							
Based on our liquefaction assessment, we identified potentially liquefiable soils within this Reach (Refer to Appendix E and Appendix F)							
Seepage Analysis Results							
Station	Water Surface	Figure	Exit Gradient			Through Seepage	Breakout Height (ft)*
			Levee Toe	Toe of Berm	Field		
804+50	200-Year	E-61-B	No Positive Gradient	---	0.06	No	n/a
	HTOL	E-61-C	No Positive Gradient	---	0.08	n/a	n/a
*Vertical distance from the toe of the levee (ground surface) to where the phreatic surface is calculated to daylight on the levee slope. Through seepage under HTOL conditions are not part of this evaluation.

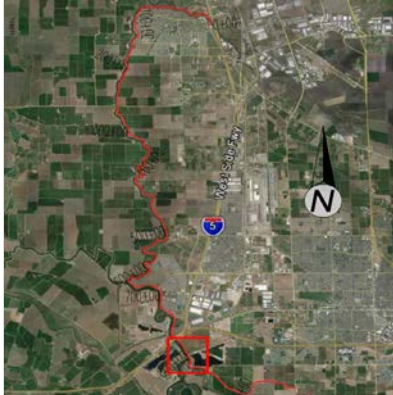
10.62 PROJECT REACH N2, STATION 813+05

REACH N2 - STA 813+05							
Based on our evaluation, this reach meets the ULDC Criteria. Seismic deformations are not anticipated to degrade below 10-Year WSE+3 feet.							
Seepage Evaluation Summary				Slope Stability Evaluation Summary			
200-Year DWSEL, Under Seepage:		Meets Criteria		Steady State Seepage 200-Year DWSEL, LS:		Meets Criteria	
200-Year DWSEL, Through Seepage:		Meets Criteria		Steady State Seepage HTOL, LS:		Meets Criteria	
HTOL, Under Seepage:		Meets Criteria		Rapid Drawdown, WS:		Meets Criteria	
				Seismic Slope Stability, WS:		Fails Criteria	
				Seismic Slope Stability, LS:		Meets Criteria	
Reach Description				Reach Overview			
Station Limits: 806+00 to 825+00 Feature(s) at Upstream Station Limit: Beginning of Phase II Seepage Berm Feature(s) at Downstream Station Limit: End of landside residential Approx. Crown Elevation Range (feet, NAVD88): 34 to 35 Approx. Levee Height Range (feet): 12.5 to 20 Approx. Crown Width Range (feet): 12 to 18 Approx. Landside Slope (H:V) Range: 2.5:1 to 2.5:1 Approx. Waterside Slope (H:V) Range: 2:1 to 2.5:1 Waterside Constraint(s): Waterside toe of slope at the waterway - no waterside bench. Landside Constraint(s): Residential/Oakwood Lake Landside repairs associated with PL84-99: Gravel berm from 1806+00 to 1808+00 Improvements associated with LSRP P1: None Improvements associated with LSRP P2: None Proposed Improvements associated with LSRP P3: Fully Penetrating Cutoff Wall

Generalized Subsurface Conditions Levee Prism Soils: Clayey SAND Landside Surface Layer: Lean CLAY, approx. 20 feet thick at toe of levee Soils below surface layer: Approx. 35 feet of SAND, over 30 feet of lean CLAY							
Historic Performance							
Seepage and landside boils during 1997 flood event were reported in ULE's 2014 SGDR Addendum. In the mid 2000's a 24 foot deep sheet pile wall was installed in levee crown between Station 822+00 to 825+00.							
Liquefiable Soils							
Based on our liquefaction assessment, we identified potentially liquefiable soils within this Reach (Refer to Appendix E and Appendix F)							
Seepage Analysis Results							
Station	Water Surface	Figure	Exit Gradient			Through Seepage	Breakout Height (ft)*
			Levee Toe	Toe of Berm	Field		
813+05	200-Year	E-62-B	No Positive Gradient	---	---	No	n/a
	HTOL	E-62-C	No Positive Gradient	---	---	n/a	n/a
*Vertical distance from the toe of the levee (ground surface) to where the phreatic surface is calculated to daylight on the levee slope. Through seepage under HTOL conditions are not part of this evaluation.

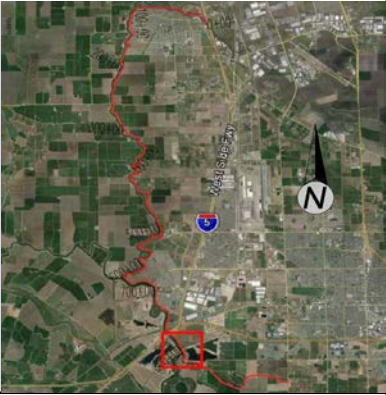
10.63 PROJECT REACH N2, STATION 820+69

REACH N2 - STA 820+69							
Based on our evaluation, this reach meets the ULDC Criteria. An Operations and Maintenance plan should be implemented for seismic deformations following the 200-year event.							
Seepage Evaluation Summary				Slope Stability Evaluation Summary			
200-Year DWSEL, Under Seepage:		Meets Criteria		Steady State Seepage 200-Year DWSEL, LS:		Meets Criteria	
200-Year DWSEL, Through Seepage:		Meets Criteria		Steady State Seepage HTOL, LS:		Meets Criteria	
HTOL, Under Seepage:		Meets Criteria		Rapid Drawdown, WS:		Meets Criteria	
				Seismic Slope Stability, WS:		Fails Criteria	
				Seismic Slope Stability, LS:		Meets Criteria	
Reach Description				Reach Overview			
Station Limits: 806+00 to 825+00 Feature(s) at Upstream Station Limit: Beginning of Phase II Seepage Berm Feature(s) at Downstream Station Limit: End of landside residential /RR Crossing Approx. Crown Elevation Range (feet, NAVD88): 34 to 35 Approx. Levee Height Range (feet): 12.5 to 20 Approx. Crown Width Range (feet): 12 to 18 Approx. Landside Slope (H:V) Range: 2.5:1 to 2.5:1 Approx. Waterside Slope (H:V) Range: 2:1 to 2.5:1 Waterside Constraint(s): Waterside toe of slope at the waterway - no waterside bench. Landside Constraint(s): Residential/Oakwood lake Landside repairs associated with PL84-99: None Improvements associated with LSRP P1: None Improvements associated with LSRP P2: None Proposed Improvements associated with LSRP P3: Fully Penetrating Cutoff Wall

Generalized Subsurface Conditions							
Levee Prism Soils: Clayey SAND to Lean CLAY Landside Surface Layer: Lean CLAY, approx. 13 feet thick at toe of levee Soils below surface layer: Approx. 40 feet of SAND, over 12 feet of Lean CLAY							
Historic Performance							
Seepage and landside boils during 1997 flood event were reported in ULE's 2014 SGDR Addendum. In the mid 2000's a 24 foot deep sheet pile wall was installed in levee crown between Station 822+00 to 825+50.							
Liquefiable Soils							
Based on our liquefaction assessment, we identified potentially liquefiable soils within this Reach (Refer to Appendix E and Appendix F)							
Seepage Analysis Results							
Station	Water Surface	Figure	Exit Gradient			Through Seepage	Breakout Height (ft)*
			Levee Toe	Toe of Berm	Field		
820+69	200-Year	E-63-B	No Positive Gradient	---	---	No	n/a
	HTOL	E-63-C	No Positive Gradient	---	---	n/a	n/a
*Vertical distance from the toe of the levee (ground surface) to where the phreatic surface is calculated to day light on the levee slope. Through seepage under HTOL conditions are not part of this evaluation.

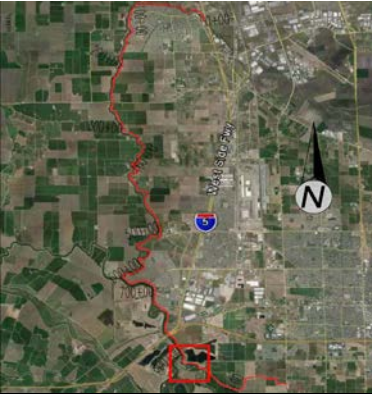
10.65 PROJECT REACH 01, STATION 825+86

REACH 01 - STA 825+86							
Based on our evaluation, this reach meets the ULDC Criteria. An Operations and Maintenance plan should be implemented for seismic deformations following the 200-year event.							
Seepage Evaluation Summary				Slope Stability Evaluation Summary			
200-Year DWSEL, Under Seepage:		Meets Criteria		Steady State Seepage 200-Year DWSEL, LS:		Meets Criteria	
200-Year DWSEL, Through Seepage:		Meets Criteria		Steady State Seepage HTOL, LS:		Meets Criteria	
HTOL, Under Seepage:		Meets Criteria		Rapid Drawdown, WS:		Meets Criteria	
				Seismic Slope Stability, WS:		Fails Criteria	
				Seismic Slope Stability, LS:		Meets Criteria	
Reach Description				Reach Overview			
Station Limits: 825+00 to 835+00 Feature(s) at Upstream Station Limit: Residential Lots and Street Feature(s) at Downstream Station Limit: Begin LSRP P2 Berm Approx. Crown Elevation Range (feet, NAVD88): 34 to 35 Approx. Levee Height Range (feet): 14.5 to 16.5 Approx. Crown Width Range (feet): 32 to 42 Approx. Landside Slope (H:V) Range: 3:1 to 3:1 Approx. Waterside Slope (H:V) Range: 1.7:1 to 2.3:1 Waterside Constraint(s): Waterside toe of slope at the waterway - no waterside bench. Landside Constraint(s): Seepage Berm and Residential Landside repairs associated with PL84-99: Berm Improvements associated with LSRP P1: None Improvements associated with LSRP P2: Drained Seepage Berm Proposed Improvements associated with LSRP P3: None

Generalized Subsurface Conditions							
Levee Prism Soils: Clayey SAND to SILT Landside Surface Layer: Lean CLAY, approx. 20 feet thick at levee toe, Approx. 4 feet of Silty SAND at Berm toe Soils below surface layer: Approx. 40 feet of silty SAND, over 12 feet of Lean CLAY							
Historic Performance							
Seepage, landside boils, and waterside wavewash erosion during 1997 flood event, along with longitudinal cracking in 1993 were reported in ULE's 2014 SGDR Addendum.							
Liquefiable Soils							
Based on our liquefaction assessment, we identified potentially liquefiable soils within this Reach (Refer to Appendix E and Appendix F)							
Seepage Analysis Results							
Station	Water Surface	Figure	Exit Gradient			Through Seepage	Breakout Height (ft)*
			Levee Toe	Toe of Berm	Field		
825+86	200-Year	E-64-B	No Positive Gradient	0.35	0.46	No	n/a
	HTOL	E-64-C	No Positive Gradient	0.47	0.59	n/a	n/a

*Vertical distance from the toe of the levee (ground surface) to where the phreatic surface is calculated to day light on the levee slope. Through seepage under HTOL conditions are not part of this evaluation.							
Slope Stability Analysis Results							
Station	Case Analyzed	Water Surface (ft)	Figure	Factor of Safety (Circular)		Factor of Safety (Non-Circular)	
				Waterside	Landside	Waterside	Landside
825+86	SS - 200yr	30	E-64-D	---	2.4	n/a	n/a
	SS - HTOL	32.6	E-64-E	---	2.1	n/a	n/a
	RDD	18.7	E-64-D	1.1	---	n/a	n/a
	PS	10.4	E-64-F	1.0	1.6	n/a	n/a
	Post-EQ	10.4	E-64-G/H	0.6	1.7	0.6	1.8
Post 200-Year Seismic Event Restoration Estimates							
Reach	Damage Length (feet)	Estimated Lateral Movement (feet)	Estimated Vertical Movement (feet)	Fill Volume (10 year WSE+3 feet Freeboard) (cubic yards)	Fill Volume (Fully Restored Levee Geometry) (cubic yards)		
01	745	14	10	1,500	3,900

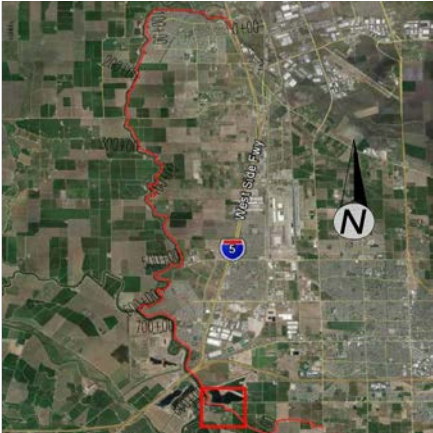
10.66 PROJECT REACH O2A, STATION 844+81

REACH O2A - STA 844+81							
Based on our evaluation, this reach meets the ULDC Criteria.							
Seepage Evaluation Summary				Slope Stability Evaluation Summary			
200-Year DWSEL, Under Seepage:		Meets Criteria		Steady State Seepage 200-Year DWSEL, LS:		Meets Criteria	
200-Year DWSEL, Through Seepage:		Meets Criteria		Steady State Seepage HTOL, LS:		Meets Criteria	
HTOL, Under Seepage:		Meets Criteria		Rapid Drawdown, WS:		Meets Criteria	
				Seismic Slope Stability, WS:		Meets Criteria	
				Seismic Slope Stability, LS:		Meets Criteria	
Reach Description				Reach Overview			
Station Limits:		835+00 to 849+65

Feature(s) at Upstream Station Limit: End of LSRP P2 berm, Start of LSRP P3							
Feature(s) at Downstream Station Limit: LSRP P2 Berm continuation							
Approx. Crown Elevation Range (feet, NAVD88):		34 to 35					
Approx. Levee Height Range (feet):		13.5 to 16					
Approx. Crown Width Range (feet):		35 to 37

Approx. Landside Slope (H:V) Range:		3:1 to 3:1					
Approx. Waterside Slope (H:V) Range:		1.9:1 to 3:1					
Waterside Constraint(s): Waterside toe of slope at the waterway - no waterside bench.							
Landside Constraint(s): Graded residential lots and streets							
Landside repairs associated with PL84-99: None							
Improvements associated with LSRP P1: None							
Improvements associated with LSRP P2: Drained Seepage Berm w/chimney drain							
Proposed Improvements associated with LSRP P3: None							
Generalized Subsurface Conditions							
Levee Prism Soils: Clayey SAND and Lean CLAY							
Landside Surface Layer: FAT CLAY, approx. 10 to 15 feet thick							
Soils below surface layer: Poorly Graded SAND							
Historic Performance							
Seepage, landside boils, and waterside wavewash erosion at Station 845+00 to 846+00 during 1997 flood event were reported in ULE's 2014 SGDR Addendum.

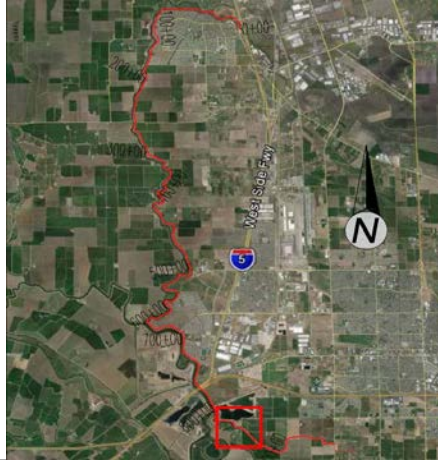
10.67 PROJECT REACH O2B, STATION 850+50

REACH O2B - STA 850+50							
Based on our evaluation, this reach meets the ULDC Criteria.							
Seepage Evaluation Summary				Slope Stability Evaluation Summary			
200-Year DWSEL, Under Seepage:		Meets Criteria		Steady State Seepage 200-Year DWSEL, LS:		Meets Criteria	
200-Year DWSEL, Through Seepage:		Meets Criteria		Steady State Seepage HTOL, LS:		Meets Criteria	
HTOL, Under Seepage:		Meets Criteria		Rapid Drawdown, WS:		Meets Criteria	
				Seismic Slope Stability, WS:		Meets Criteria	
				Seismic Slope Stability, LS:		Meets Criteria	
Reach Description				Reach Overview			
Station Limits: 849+65 to 853+50 Feature(s) at Upstream Station Limit: Approach fill for S. Williamson Road Feature(s) at Downstream Station Limit: Phase II Berm improvement transition Approx. Crown Elevation Range (feet, NAVD88): 34 to 35 Approx. Levee Height Range (feet): 13.5 to 16 Approx. Crown Width Range (feet): 12 to 12 Approx. Landside Slope (H:V) Range: 3:1 to 3:1 Approx. Waterside Slope (H:V) Range: 2:1 to 2:1 Waterside Constraint(s): Waterside bench/docks/pipe penetration Landside Constraint(s): Trees and residential lots, retaining walls Landside repairs associated with PL84-99: None Improvements associated with LSRP P1: None Improvements associated with LSRP P2: None Proposed Improvements associated with LSRP P3: Drained Seepage Berm w/chimney drain

Generalized Subsurface Conditions							
Levee Prism Soils: Silty SAND, SAND and SILT Landside Surface Layer: Lean CLAY and SILT, approx. 10-13 feet thick at toe of levee Soils below surface layer: Approx. 40 feet of SAND, over 15 feet of Lean CLAY							
Historic Performance							
No seepage or slope stability performance issues reported.							
Liquefiable Soils							
Based on our liquefaction assessment, we are not considering liquefiable soils in our slope stability analyses.							
Seepage Analysis Results							
Station	Water Surface	Figure	Exit Gradient			Through Seepage	Breakout Height (ft)*
			Levee Toe	Toe of Berm	Field		
850+50	200-Year	E-66-B	No Positive Gradient	0.19	---	No	n/a
	HTOL	E-66-C	No Positive Gradient	0.36	---	n/a	n/a
*Vertical distance from the toe of the levee (ground surface) to where the phreatic surface is calculated to daylight on the levee slope. Through seepage under HTOL conditions are not part of this evaluation.

Slope Stability Analysis Results							
Station	Case Analyzed	Water Surface (ft)	Figure	Factor of Safety (Circular)		Factor of Safety (Non-Circular)	
				Waterside	Landside	Waterside	Landside
850+50	SS - 200yr	29.8	E-66-D	---	2.4	n/a	n/a
	SS - HTOL	32.8	E-66-E	---	2.4	n/a	n/a
	RDD	18.9	E-66-D	1.7	---	n/a	n/a
	PS	10.4	E-66-F	1.5	1.7	n/a	n/a
	Post-EQ	n/a	n/a	n/a	n/a	n/a	n/a

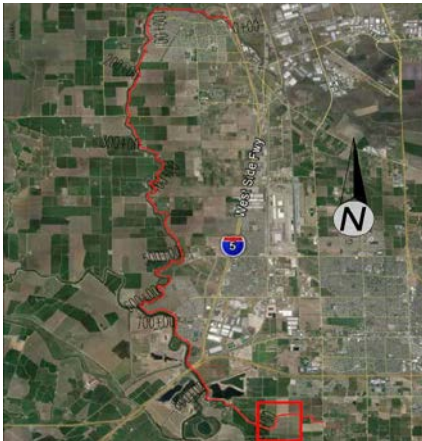
10.71 PROJECT REACH Q1, STATION 915+50

REACH Q1 - STA 915+50							
Based on our evaluation, this reach does not meet the ULDC Criteria.							
Seepage Evaluation Summary				Slope Stability Evaluation Summary			
200-Year DWSEL, Under Seepage:		Meets Criteria		Steady State Seepage 200-Year DWSEL, LS:		Meets Criteria	
200-Year DWSEL, Through Seepage:		Fails Criteria		Steady State Seepage HTOL, LS:		Meets Criteria	
HTOL, Under Seepage:		Meets Criteria		Rapid Drawdown, WS:		Meets Criteria	
				Seismic Slope Stability, WS:		Meets Criteria	
				Seismic Slope Stability, LS:		Meets Criteria	
Reach Description				Reach Overview			
Station Limits:		909+00 to 944+00

Feature(s) at Upstream Station Limit: Agriculture road							
Feature(s) at Downstream Station Limit: Agriculture road							
Approx. Crown Elevation Range (feet, NAVD88):		34 to 35					
Approx. Levee Height Range (feet):		11 to 14					
Approx. Crown Width Range (feet):		16 to 42

Approx. Landside Slope (H:V) Range:		4:1 to 7:1					
Approx. Waterside Slope (H:V) Range:		3.5:1 to 7:1					
Waterside Constraint(s): Orchards							
Landside Constraint(s): Agriculture							
Landside repairs associated with PL84-99: None							
Improvements associated with LSRP P1: None							
Improvements associated with LSRP P2: None							
Proposed Improvements associated with LSRP P3: None							
Generalized Subsurface Conditions							
Levee Prism Soils: Silty SAND and Poorly Graded SAND with SILT							
Landside Surface Layer: Silty Sand, approx. 15 feet thick							
Soils below surface layer: SILT and CLAY							
Historic Performance							
According to the DWR Walthall Slough GER Draft 2, some underseepage was observed by KSN somewhere along the dryland levee after an upstream levee breached during the 1996-1997 high-water event. The locations of underseepage are unknown however.							
Liquefiable Soils

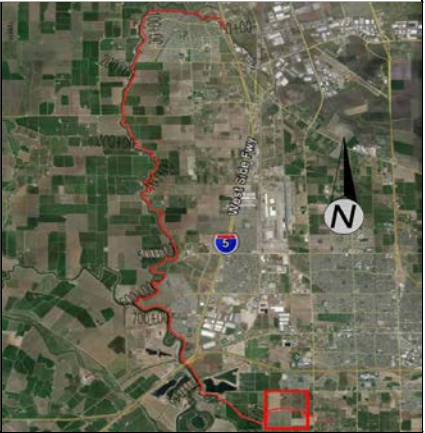
10.72 PROJECT REACH R1, STATION 955+00

REACH R1 - STA 955+00							
Based on our evaluation, this reach does not meet the ULDC Criteria.							
Seepage Evaluation Summary				Slope Stability Evaluation Summary			
200-Year DWSEL, Under Seepage:		Meets Criteria		Steady State Seepage 200-Year DWSEL, LS:		Meets Criteria	
200-Year DWSEL, Through Seepage:		Fails Criteria		Steady State Seepage HTOL, LS:		Meets Criteria	
HTOL, Under Seepage:		Meets Criteria		Rapid Drawdown, WS:		Meets Criteria	
				Seismic Slope Stability, WS:		Meets Criteria	
				Seismic Slope Stability, LS:		Meets Criteria	
Reach Description				Reach Overview			
Station Limits: 944+00 to 959+00 Feature(s) at Upstream Station Limit: Agriculture road Feature(s) at Downstream Station Limit: Agriculture road Approx. Crown Elevation Range (feet, NAVD88): 32 to 35 Approx. Levee Height Range (feet): 9 to 13 Approx. Crown Width Range (feet): 13 to 23 Approx. Landside Slope (H:V) Range: 2.5:1 to 3.5:1 Approx. Waterside Slope (H:V) Range: 2.9:1 to 5:1 Waterside Constraint(s): Dryland levee, orchard Landside Constraint(s): None - agricultural land Landside repairs associated with PL84-99: None Improvements associated with LSRP P1: None Improvements associated with LSRP P2: None Proposed Improvements associated with LSRP P3: None

Generalized Subsurface Conditions							
Levee Prism Soils: Silty SAND Landside Surface Layer: Silty Sand, approx. 4.5 feet thick Soils below surface layer: Silty CLAY, Poorly Graded SAND, and Silty SAND							
Historic Performance							
According to the DWR Walthall Slough GER Draft 2, some underseepage was observed by KSN after an upstream levee breached during the 1996-1997 high-water event. The locations of underseepage are unknown however.							
Liquefiable Soils							
Based on our liquefaction assessment, we are not considering liquefiable soils in our slope stability analyses.							
Seepage Analysis Results							
Station	Water Surface	Figure	Exit Gradient			Through Seepage	Breakout Height (ft)*
			Levee Toe	Toe of Berm	Field		
955+00	200-Year	E-71-B	0.49	---	---	Yes	2.8
	HTOL	E-71-C	0.64	---	---	n/a	n/a
*Vertical distance from the toe of the levee (ground surface) to where the phreatic surface is calculated to daylight on the levee slope. Through seepage under HTOL conditions are not part of this evaluation.

Slope Stability Analysis Results							
Station	Case Analyzed	Water Surface (ft)	Figure	Factor of Safety (Circular)		Factor of Safety (Non-Circular)	
				Waterside	Landside	Waterside	Landside
955+00	SS - 200yr	30.4	E-71-D	---	1.7	n/a	n/a
	SS - HTOL	33.0	E-71-E	---	1.5	n/a	n/a
	RDD	19.5	E-71-D	3.0	---	n/a	n/a
	PS	10.4	E-71-F	2.2	1.8	n/a	n/a
	Post-EQ	n/a	n/a	n/a	n/a	n/a	n/a
