URBAN LEVEE DESIGN CRITERIA EVALUATION

MOSSDALE TRACT
RECLAMATION DISTRICT NO. 17
SAN JOAQUIN COUNTY, CALIFORNIA

Project No:
5747.005.000

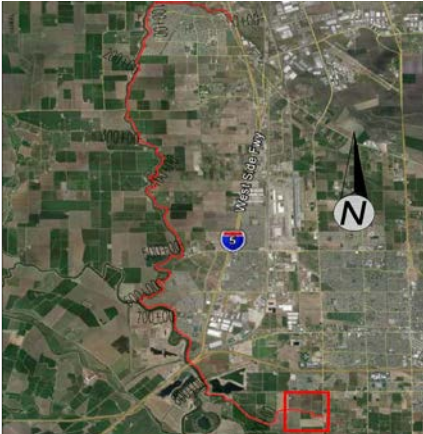
10.73 PROJECT REACH S1, STATION 965+00

REACH S1 - STA 965+00							
Based on our evaluation, this reach does not meet the ULDC Criteria.							
Seepage Evaluation Summary				Slope Stability Evaluation Summary			
200-Year DWSEL, Under Seepage:		Meets Criteria		Steady State Seepage 200-Year DWSEL, LS:		Meets Criteria	
200-Year DWSEL, Through Seepage:		Fails Criteria		Steady State Seepage HTOL, LS:		Meets Criteria	
HTOL, Under Seepage:		Meets Criteria		Rapid Drawdown, WS:		Meets Criteria	
				Seismic Slope Stability, WS:		Meets Criteria	
				Seismic Slope Stability, LS:		Meets Criteria	
Reach Description				Reach Overview			
Station Limits: 959+00 to 972+00 Feature(s) at Upstream Station Limit: 90 degree bend in levee Feature(s) at Downstream Station Limit: 90 degree bend in levee Approx. Crown Elevation Range (feet, NAVD88): 34 to 35 Approx. Levee Height Range (feet): 9 to 11 Approx. Crown Width Range (feet): 12 to 14 Approx. Landside Slope (H:V) Range: 2.0:1 to 4.5:1 Approx. Waterside Slope (H:V) Range: 2.5:1 to 3.0:1 Waterside Constraint(s): Orchard and ditch at waterside toe, 15 to 34 feet wide, 3 to 4 feet deep Landside Constraint(s): None - agricultural land Landside repairs associated with PL84-99: None Improvements associated with LSRP P1: None Improvements associated with LSRP P2: None Proposed Improvements associated with LSRP P3: None

Generalized Subsurface Conditions							
Levee Prism Soils: Silty SAND Landside Surface Layer: Silty Sand, approx. 2 to 10 feet thick Soils below surface layer: Poorly Graded SAND and Lean CLAY							
Historic Performance							
According to the DWR Walthall Slough GER Draft 2, some underseepage was observed by KSN after an upstream levee breached during the 1996-1997 high-water event. The locations of underseepage are unknown however.							
Liquefiable Soils							
Based on our liquefaction assessment, we are not considering liquefiable soils in our slope stability analyses.							
Seepage Analysis Results							
Station	Water Surface	Figure	Exit Gradient			Through Seepage	Breakout Height (ft)*
			Levee Toe	Toe of Berm	Field		
965+00	200-Year	E-72-B	0.26	---	---	Yes	1
	HTOL	E-72-C	0.45	---	---	n/a	n/a
*Vertical distance from the toe of the levee (ground surface) to where the phreatic surface is calculated to daylight on the levee slope. Through seepage under HTOL conditions are not part of this evaluation.

Slope Stability Analysis Results							
Station	Case Analyzed	Water Surface (ft)	Figure	Factor of Safety (Circular)		Factor of Safety (Non-Circular)	
				Waterside	Landside	Waterside	Landside
965+00	SS - 200yr	30.5	E-72-D	---	1.5	n/a	n/a
	SS - HTOL	33.0	E-72-E	---	1.3	n/a	n/a
	RDD	19.5	E-72-D	1.9	---	n/a	n/a
	PS	10.4	E-72-F	1.7	1.5	n/a	n/a
	Post-EQ	n/a	n/a	n/a	n/a	n/a	n/a

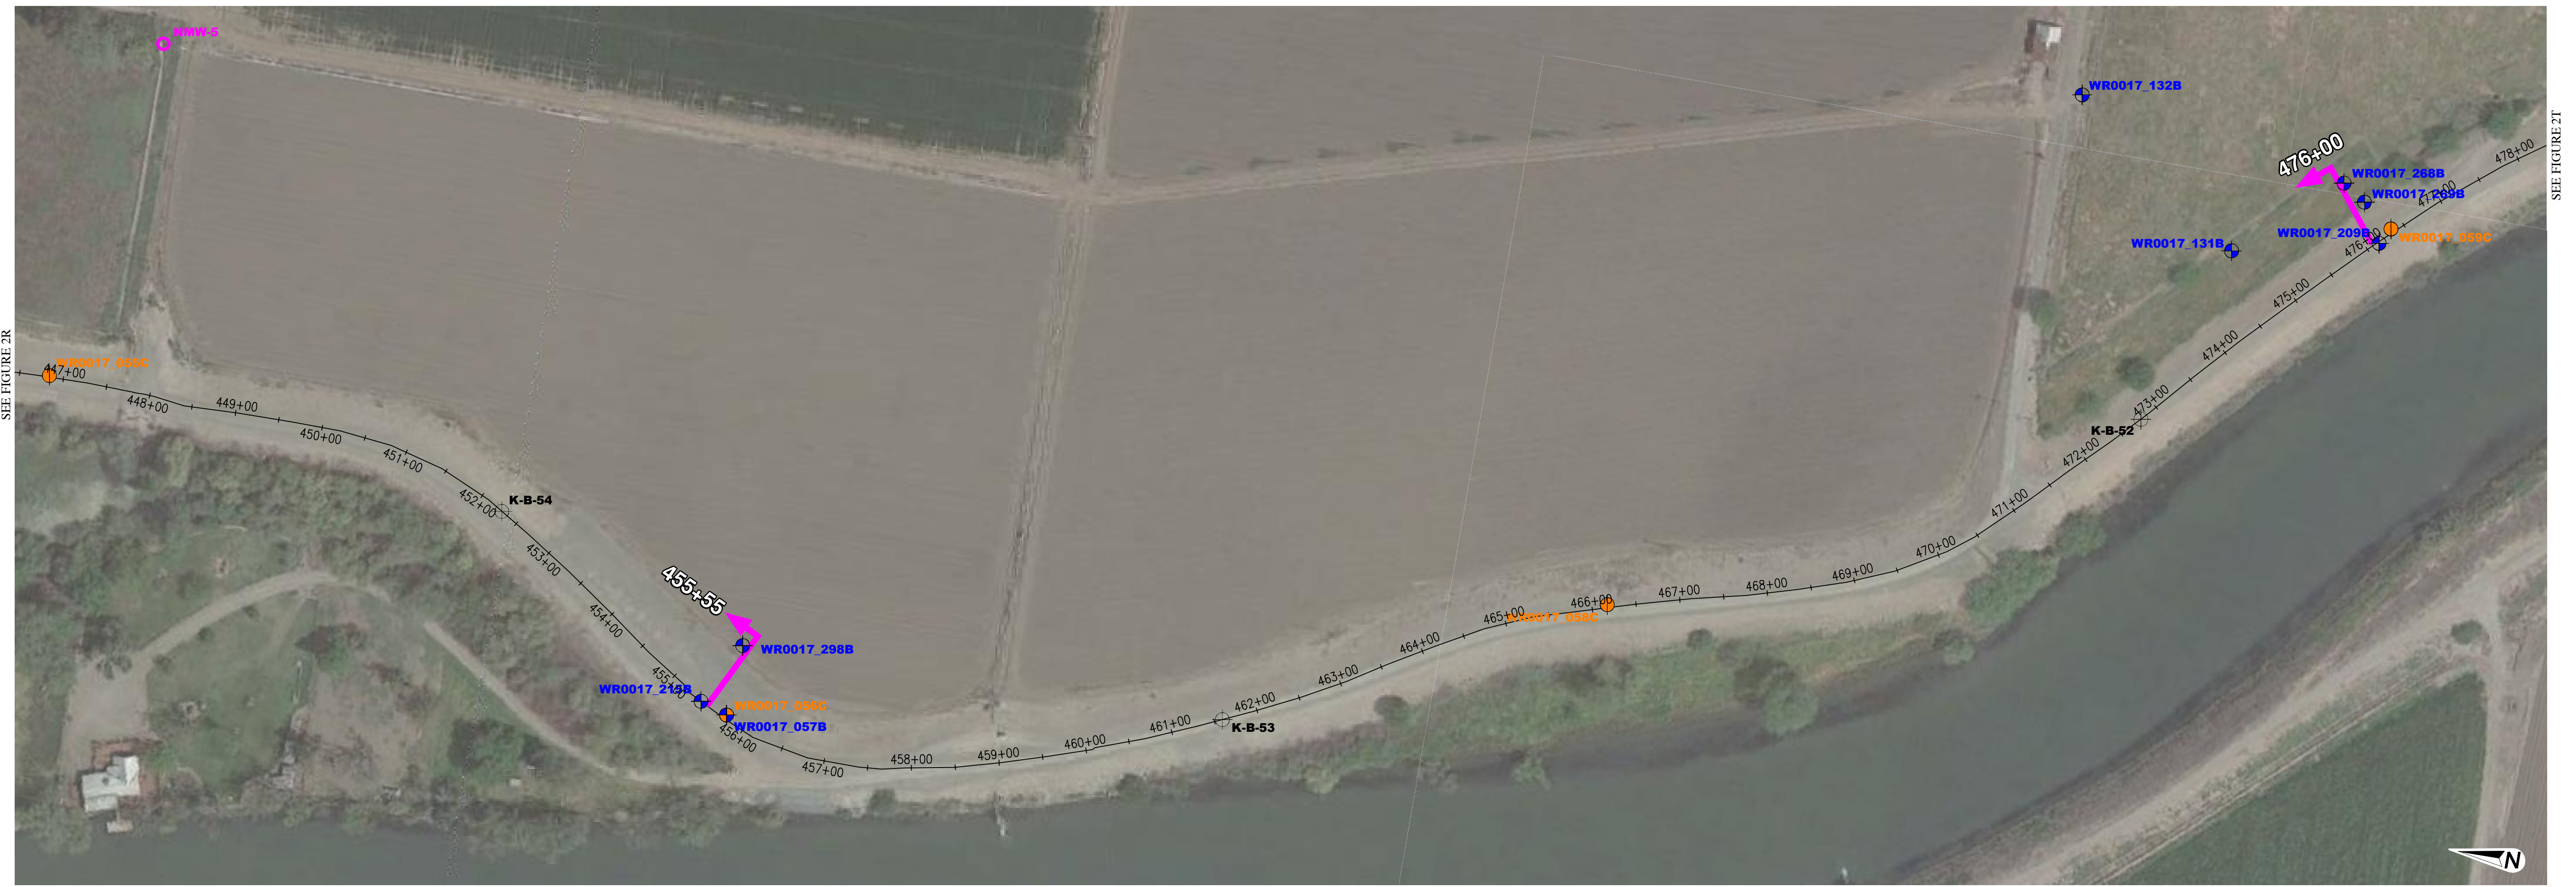
PLAN
SCALE: 1"=100'
