RD 2062

**RIVER ISLANDS AT LATHROP  
STAGE 1 LEVEE SYSTEM**

**REPORT OF ADEQUATE PROGRESS  
TOWARDS AN URBAN LEVEL OF FLOOD  
PROTECTION**

**JUNE 2016**

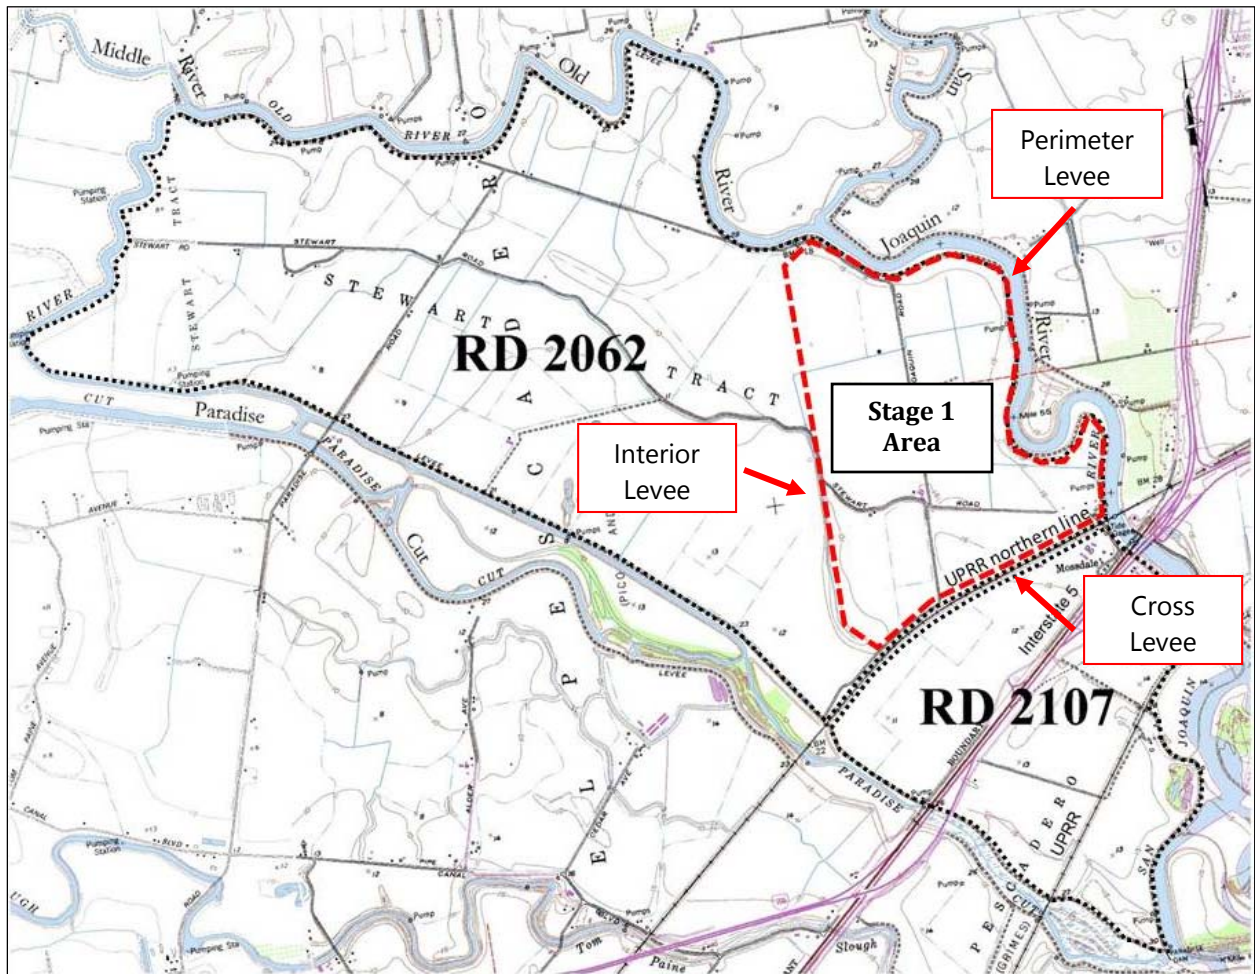
**Figure 1 – River Islands at Lathrop, Stage 1 Levee System**

Stewart Tract is an island in the Sacramento-San Joaquin Delta and is surrounded by federally authorized “Project” levees with RD 2062 comprising the area of the Stewart Tract north of the Union Pacific Railroad and Reclamation District 2017 (RD 2107) comprising the southern portion. As Project levees, these levees fall within the State Plan of Flood Control. In addition to the Project levees surrounding Stewart Tract there are two non-Project levees within RD 2062’s jurisdiction: the Interior Levee and the Cross Levee, which are certified for the 100-year event and accredited by the FEMA, but are not federally authorized. These levees are not in the SPFC. The Interior Levee and Cross Levee together create a smaller ring levee within the larger ring levee surrounding Stewart Tract. The area within this smaller ring levee is called Stage 1 of the River Islands at Lathrop development. Figure 1 depicts the Stage 1 area and levees.

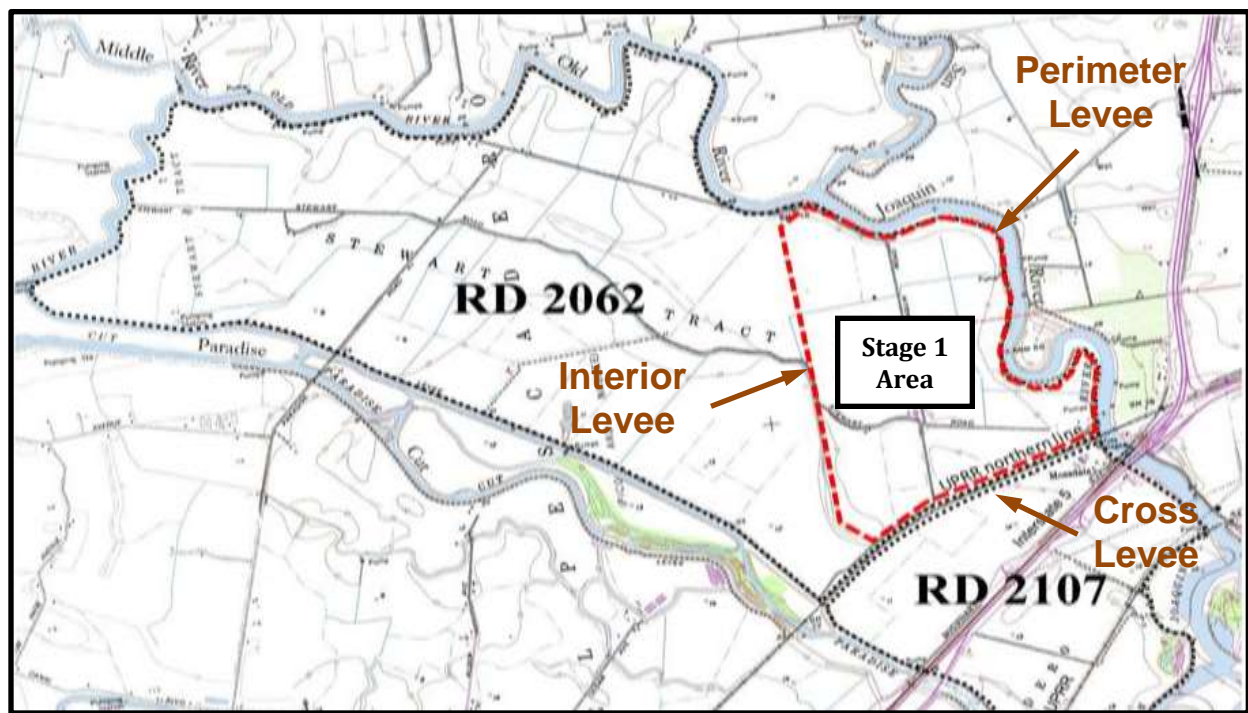
**Figure 1: River Islands at Lathrop Stage 1 Project (adapted from MBK, 2016)**

- **Cross Levee** – The Cross Levee is the segment of the Stage 1 ring levee that parallels the northwestern UPRR embankment. It is approximately 6,000 feet long and has a minimum levee crown width of about 50 feet. It is normally a dry-land levee that provides flood protection only if certain portions of either the San Joaquin River, Old River, or Paradise Cut levees fail and flood Stewart Tract. Stewart Tract was flooded in 1997 as a result of a levee failure along Paradise Cut.

- **Interior Levee** – The Interior Levee is the segment of the Stage 1 ring levee on the west side of the Stage 1 project area and runs between the Cross Levee and the Perimeter Levee. The Interior Levee joins the Perimeter Levee near the junction of the San Joaquin River with Old River. It is approximately 10,000 feet long and has a minimum levee crown width of about 40 feet. It is also a normally dry-land levee that provides flood protection only if certain portions of either the San Joaquin River, Old River, or Paradise Cut levees fail and flood Stewart Tract.

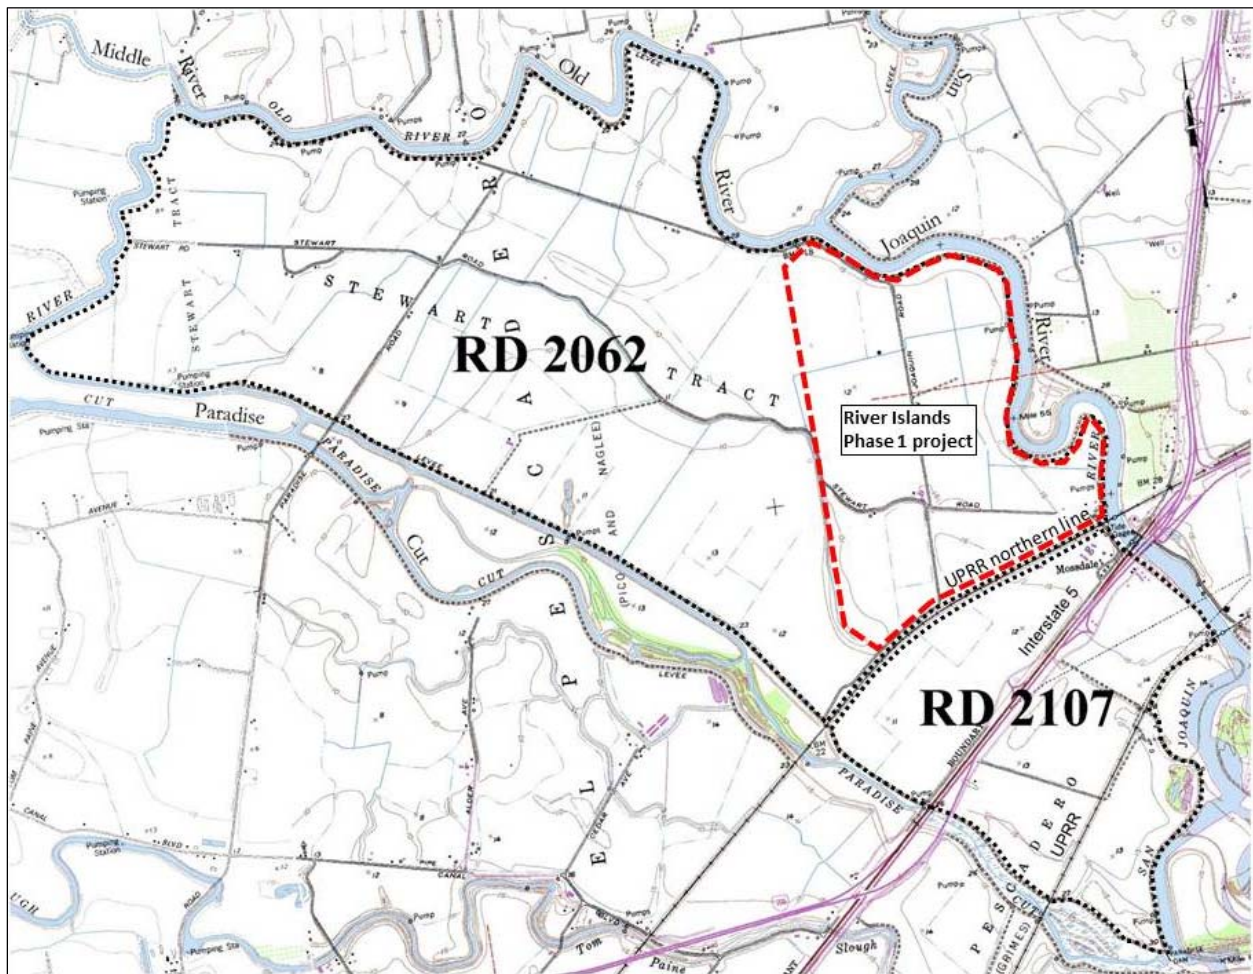
Figure 1. River Islands at Lathrop Project Location Map

The River Islands at Lathrop project is a master planned community located within the limits of the City of Lathrop on Stewart Tract. Stewart Tract is an island in the Sacramento-San Joaquin Delta that is surrounded by levees. The island can be divided into two sections delineated by the Union Pacific Railroad (UPRR) embankment, which coincides with the jurisdictional boundary between Reclamation District (RD) 2062 and RD 2107 (Figure 1).

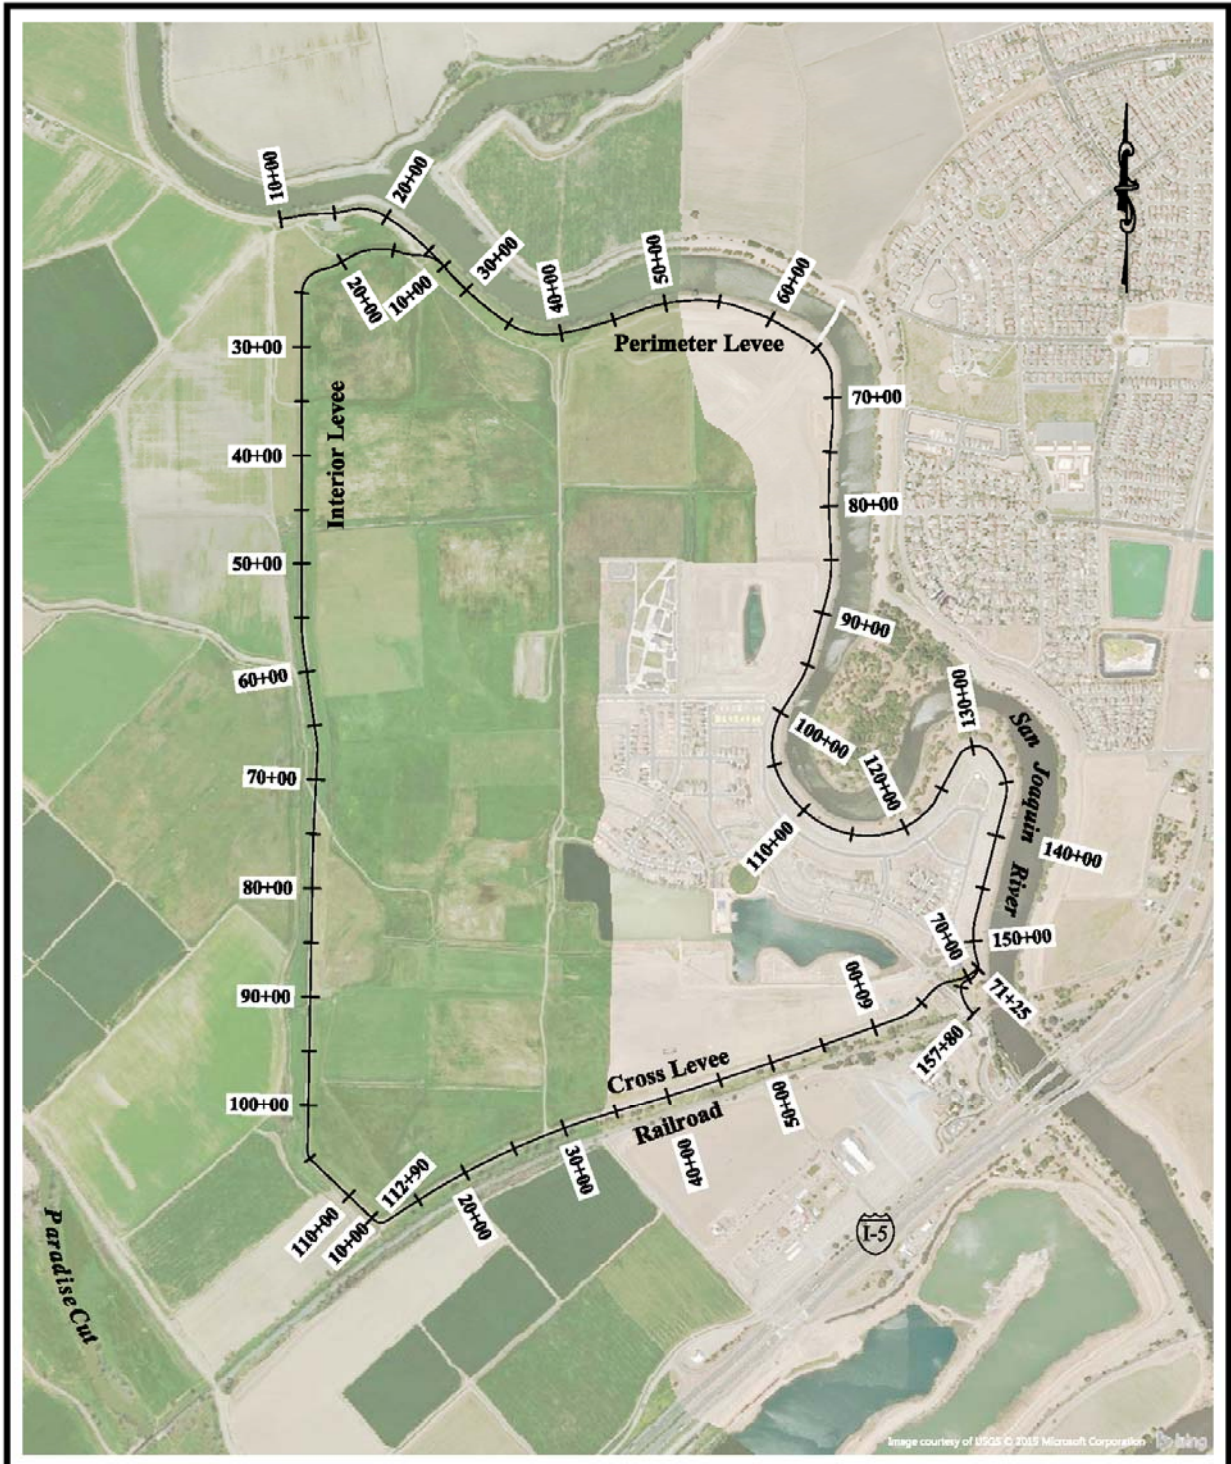
**Figure 2. River Islands at Lathrop Stage 1 Project Levee Segments**

RD 2062 can be further delineated by the Interior and Cross levees (Figure 2) into two areas that correspond to the Stage 1 and Phase 2 project areas of the River Islands at Lathrop development. The Stage 1 area is surrounded by the Perimeter Levee, Interior Levee, and Cross Levee, which comprise an interior ring levee. RD 2062 maintains all three levees.

455 University Ave, Suite 100 Sacramento, California 95825 Phone: (916) 456-4400 • Fax: (916) 456-0253	RECLAMATION DISTRICT NO. 2062	SCALE: 1" = 1,500' JOB NUMBER: 4458 DRAWN BY: MB/AR DATE: 11/12/2015 SHEET: 1 OF 1
	DISTRICT MAP
